SUBJECT: An Apprentice Mechanic Died When the Truck Tire He Was Standing Over Exploded

SUMMARY
California FACE Report #05CA007

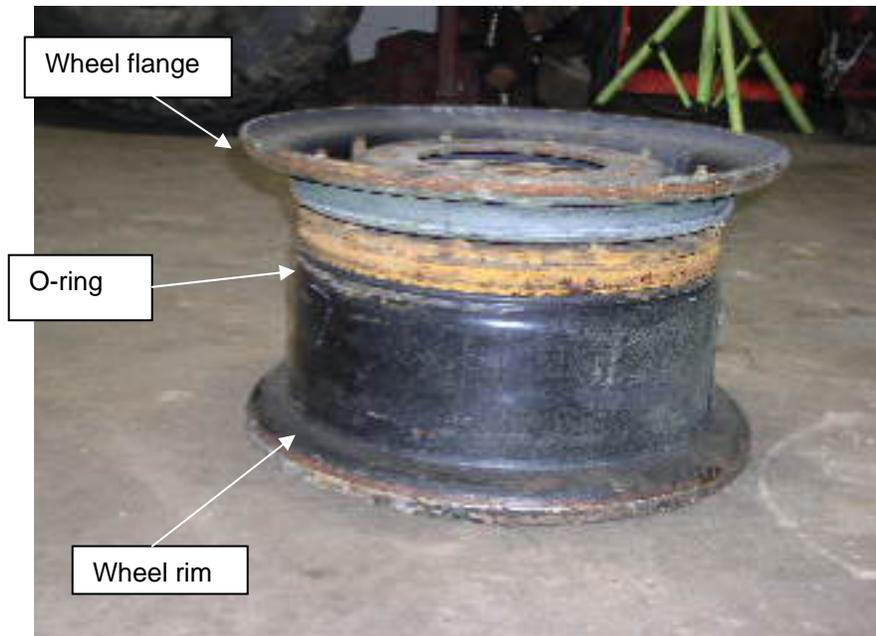
Exhibit 2: A picture of a military wheel showing the rim and flange and O-ring.
