SUBJECT: A laborer dies in a street work zone after being backed over by a dump truck

SUMMARY
California FACE Report #07CA001

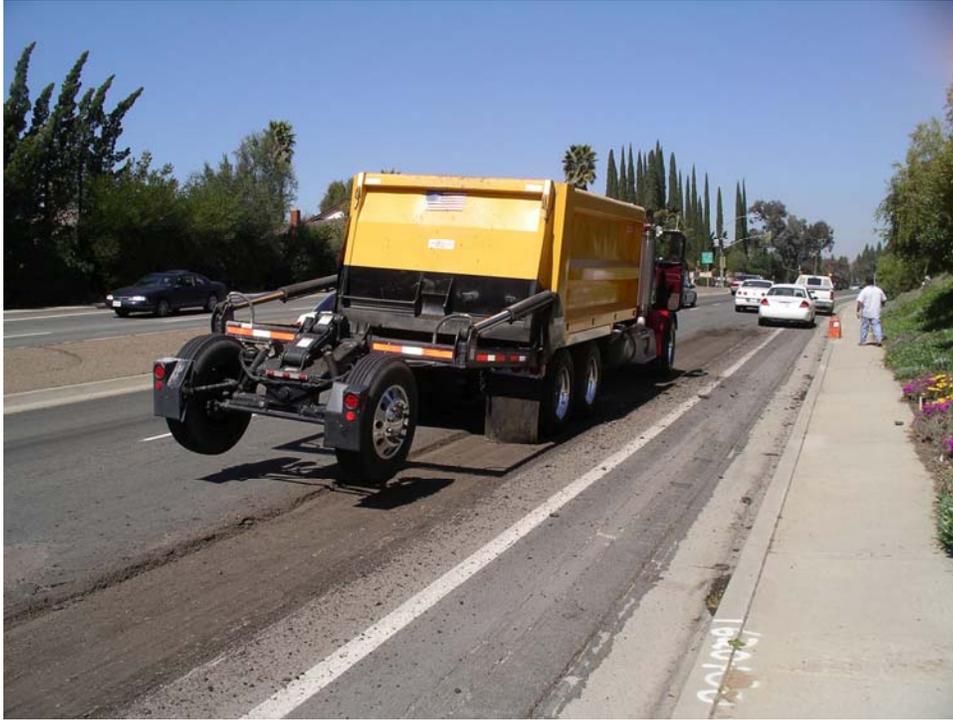
The vehicle involved in the incident was a three-axle dump truck. The truck had a trailing axle which was a load-bearing axle added to the rear of the truck to allow increased payloads. The axle was also referred to as a "strong-arm". The local police conducted a basic safety inspection of the truck after the incident and found no violations and the truck to be well maintained and in good condition.

Exhibit 1. The dump truck involved in the incident.

Recommendation #4: Consider using additional safety devices for dump trucks to warn workers of a backing vehicle and to warn drivers when someone is in their blind spots.

Discussion: Workers on construction sites often work in close proximity to moving trucks and heavy equipment. Being exposed on a daily basis to the noise and warning devices of backing equipment can desensitize individuals to the presence of such vehicles. Other devices such as a strobe light or different noises should be considered as additions to the standard back-up alarm to warn workers of a backing vehicle. There are also devices available that can detect the presence of persons in the blind spots of vehicles and provide a warning to the driver. These additions should be considered especially when the standard practice has failed. If such a device had been used this incident may have been prevented.

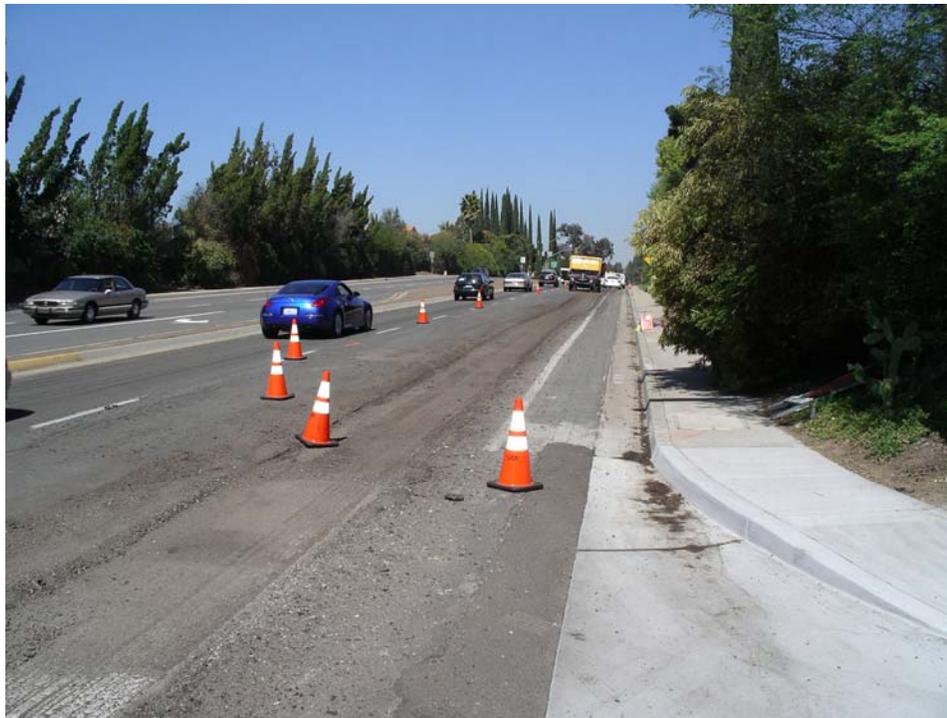
The site of the incident was a street construction work zone that ran in a north/south direction. The work being performed was the removal of the street asphalt using a street grinder. The job site had a valid Traffic Control Permit (TCP) and the street had been coned off in accordance with the filed construction work zone plans. The incident occurred at approximately 10:30 a.m. on a clear day.

Discussion: The distance the asphalt dump trucks had to back up in this incident was approximately 300 feet of straight unobstructed road before engaging the asphalt grinder. Although the vicinity may have been checked for obstructions prior to backing, conditions are constantly changing in a construction environment. Periodic turnouts closer to the work area should be used to minimize the distance required for backing. In this case, the street intersection at the beginning of the work zone could have been used for that purpose.

Exhibit 2. The highway work zone where the incident occurred, looking north.

Recommendation #3: Minimize the distance heavy equipment needs to back up in order to gain access to the work area.

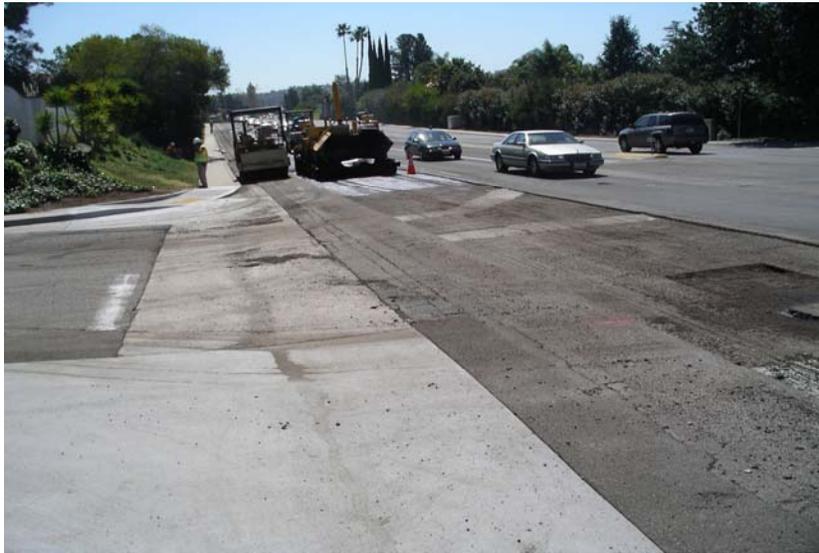
Exhibit 3. The highway work zone looking south.
