FROM: California Fatality Assessment and Control Evaluation (CA/FACE) Program

SUBJECT: Maintenance Worker Dies When He Falls Off the Roof of an Apartment Building.

SUMMARY
California FACE Report #08CA001

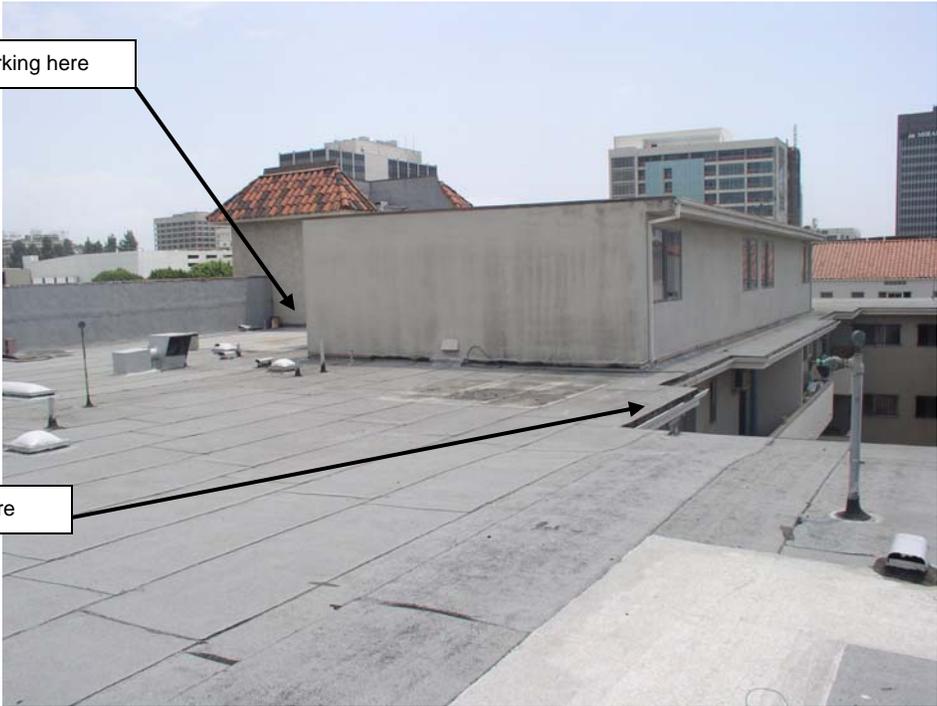
The victim was working here

The victim fell here

Exhibit 1. The roof where the incident took place.

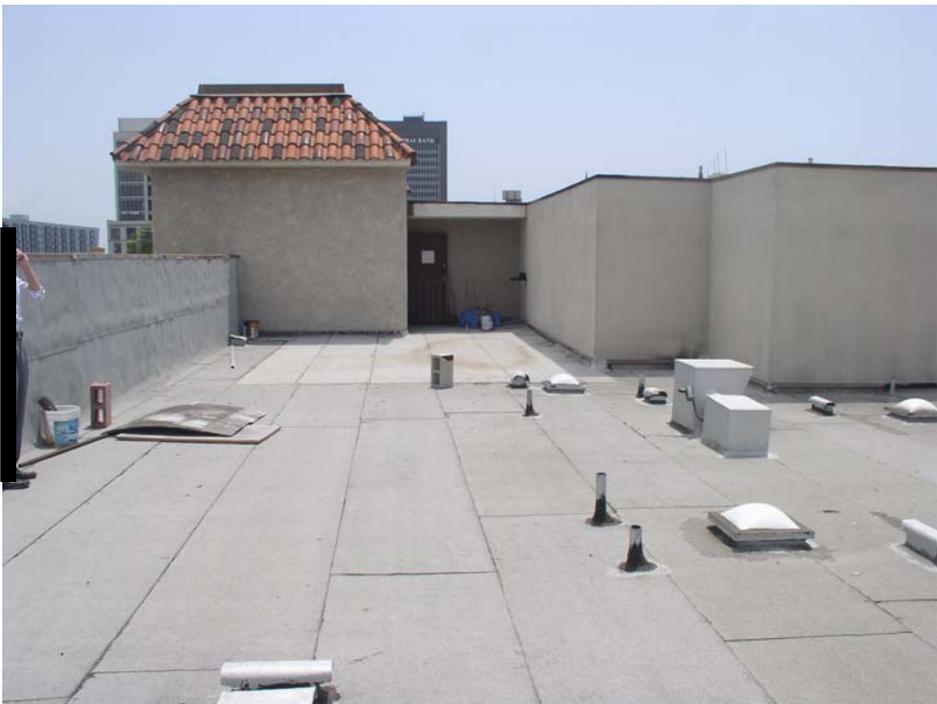
Exhibit 2. A picture of the north/east corner of the roof where the victim was repairing a leak.

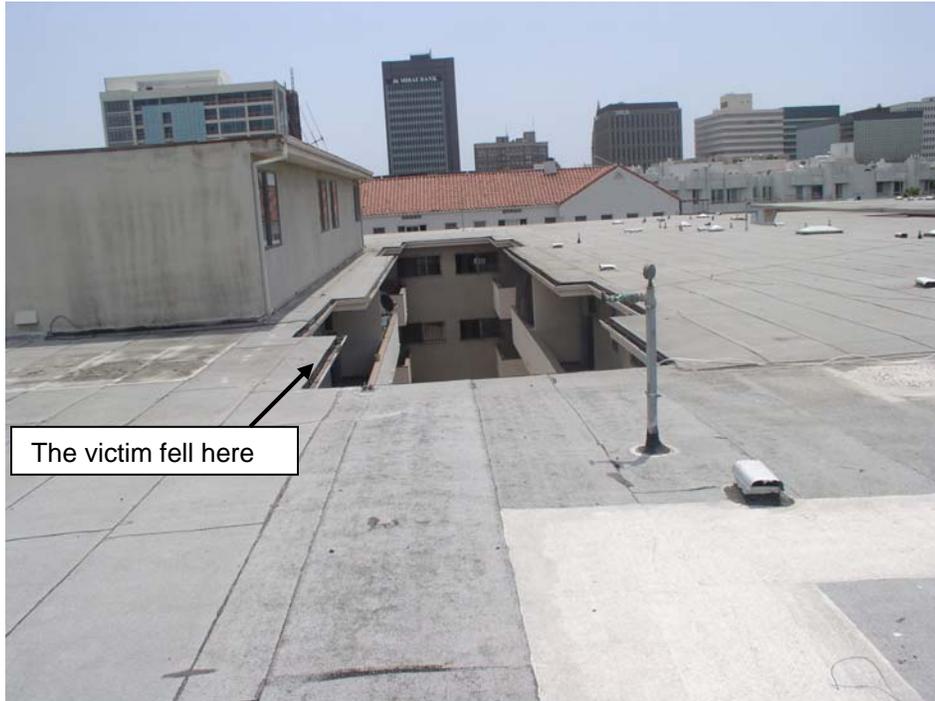
Exhibit 3. The roof opening where the victim fell.

Recommendation #3: Building owners should consider the installation of permanent guardrails around the unprotected edges of flat roofs wherever feasible.

Discussion: Flat-roofed buildings are different from angled-roof buildings because heating, ventilation, and air conditioning (HVAC) systems and other types of equipment are more likely to be placed on the roof of flat-top buildings. This means that a flat-top roof is commonly accessed by workers to maintain and repair roof-top equipment as well as to maintain and repair the roofing surface. Since many of these workers are employed by companies other than the building's owner, the building owner does not control the level or uniformity of fall protection training and skills these workers possess. A way to insure the safety of all these workers over the entire rooftop, even to the edge of the building, is to install a guardrail around all unprotected edges. In this case that would include guardrails around the entire building's perimeter and the central roof opening for the building's patio.

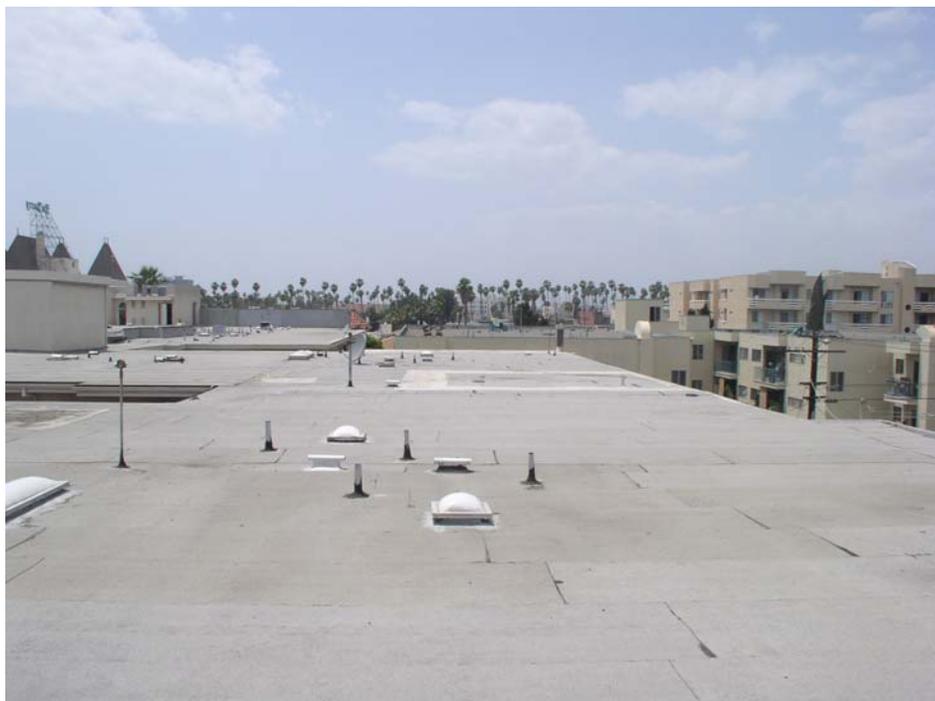
Exhibit 4. A picture of the roof looking south.

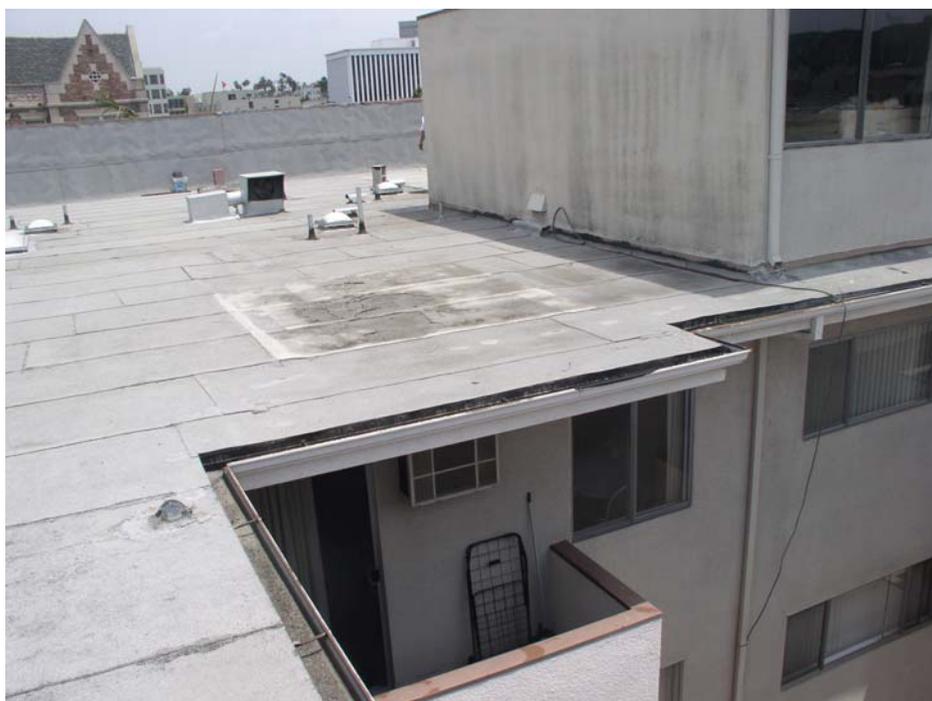
Exhibit 5. The spot on the roof where the victim fell.

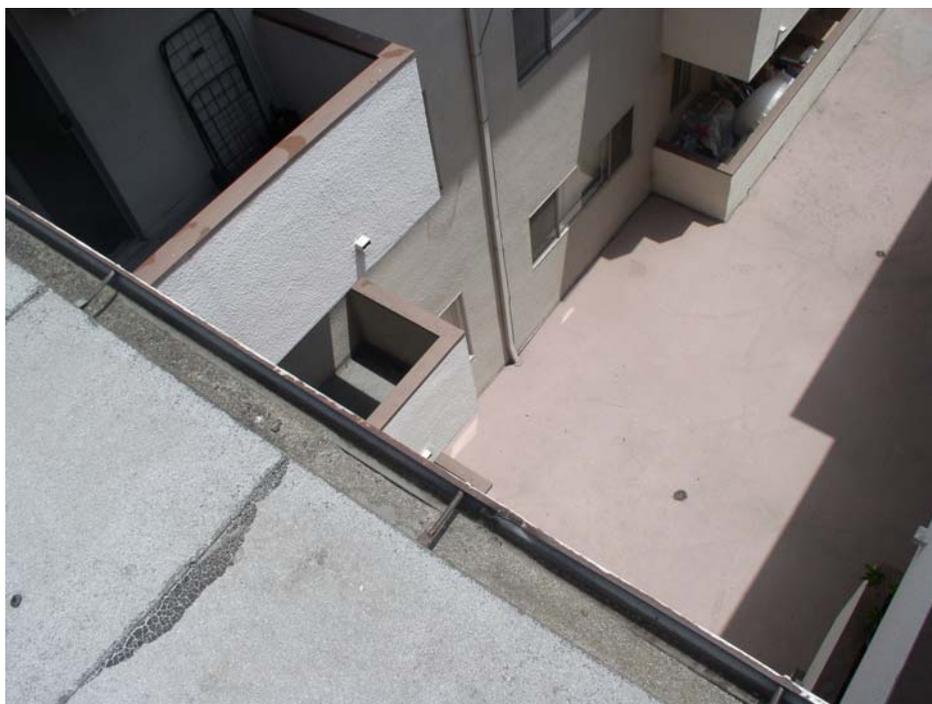
Exhibit 6. A picture of the patio area where the victim landed after his fall.
