**SUBJECT:** A Diesel Mechanic Dies When he is Crushed Between the Tire and the Cab of a Fire Truck.

**SUMMARY**  
**California FACE Report #08CA009**

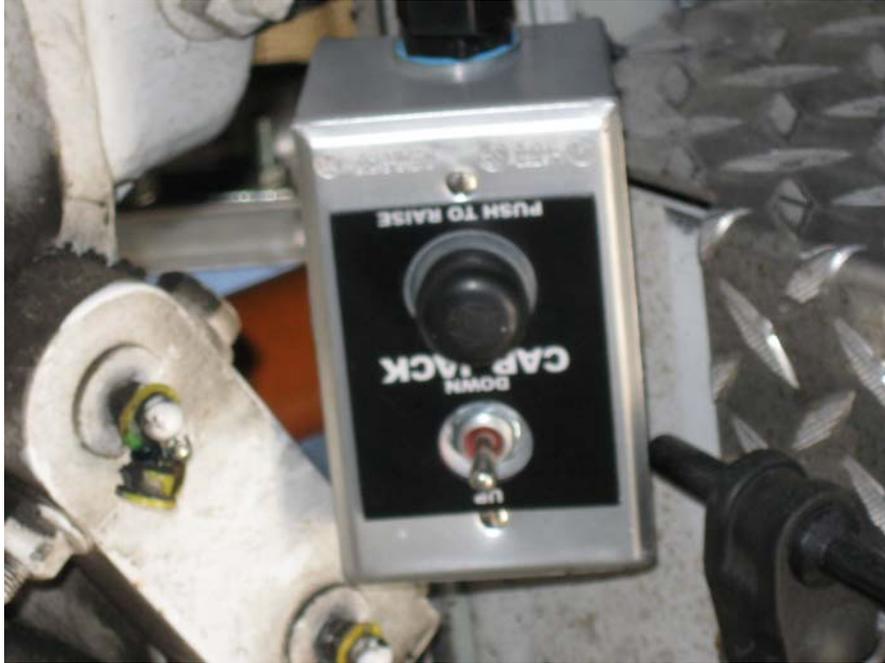
**Exhibit 1. The control box used to raise and lower the cab.**

Discussion: In this incident, the push button in the control box had to be held down continuously as the cab was being raised, but not when being lowered. In this design, the operator does not have control of the downward cab movement because it continues moving downward even if the control box should become separated from the operator. Having a “dead man” switch incorporated into the down position would allow the operator to have continuous control over the cab movement up and down, particularly if the control box should become physically separated from the operator. Had a dead man switch been part of the down position on the control box, this incident might have been prevented.

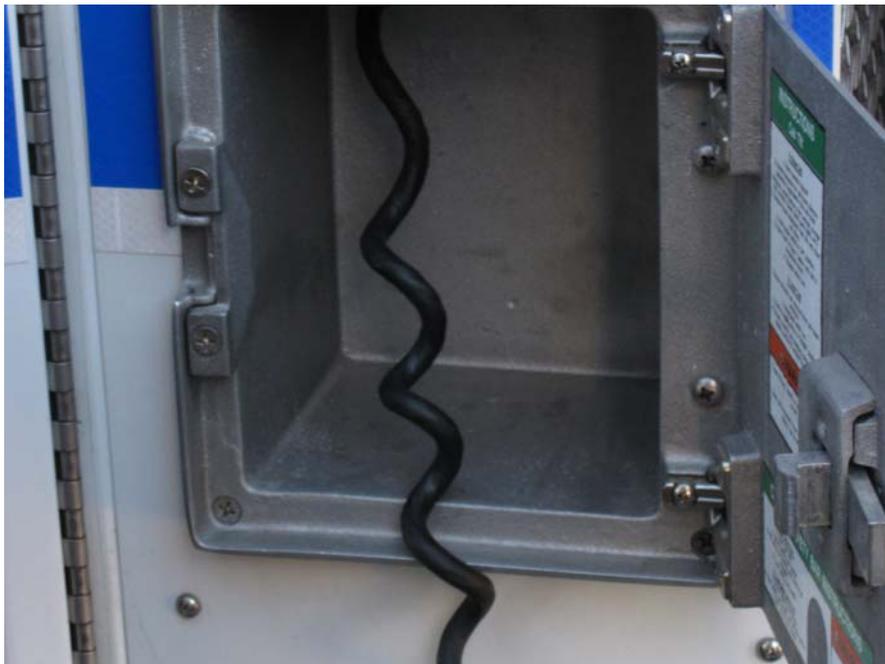
**Exhibit 2. The storage area for the control box showing the spiral cord that attaches to the control box.**

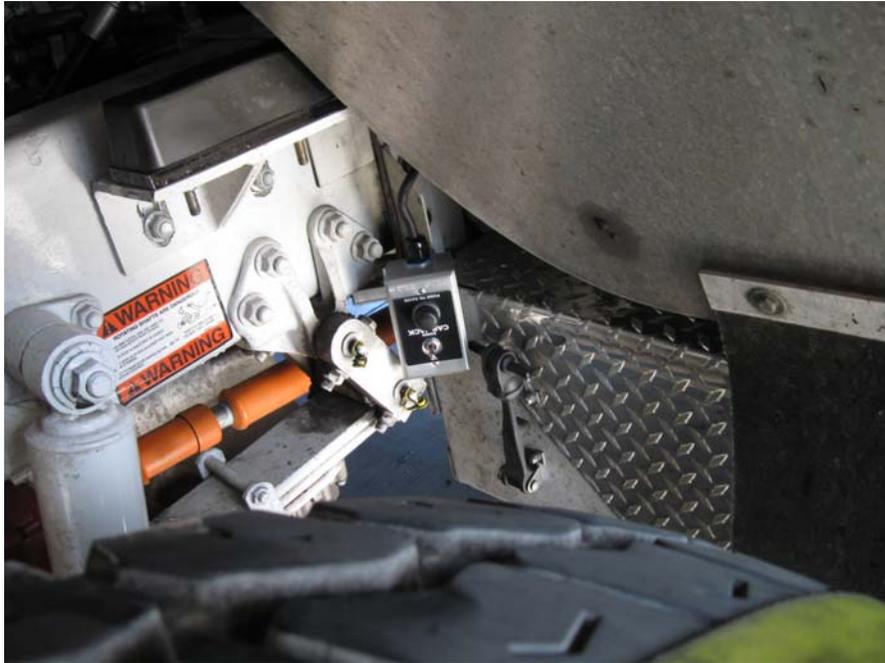
**Exhibit 3. The location of the control box - next to the tire wheel well.**

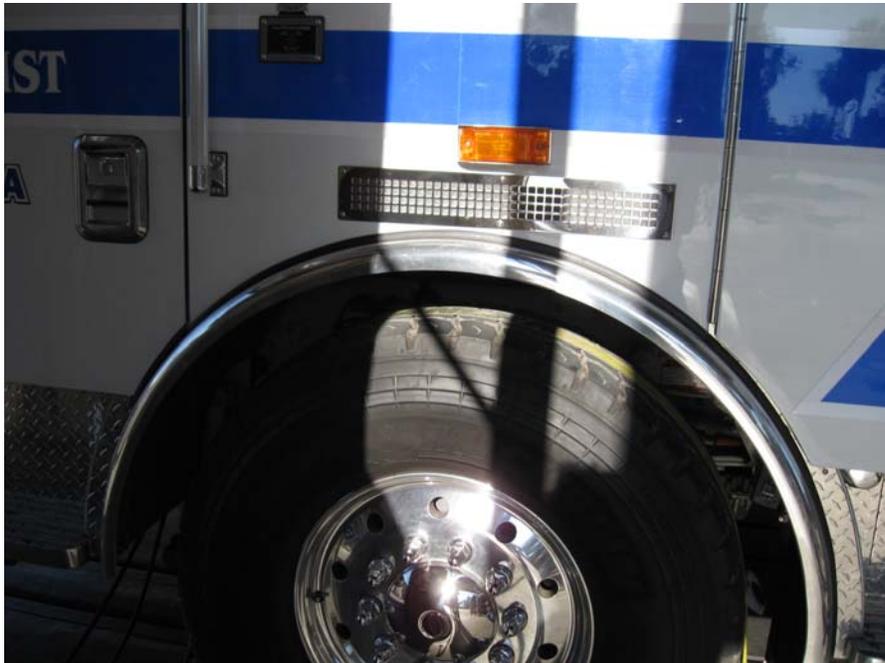
Discussion: The victim was crushed between the fire engine cab and tire. It is not known exactly what the victim was doing at the time of the incident. Evidence suggests the victim might have been trying to prevent the sensor cables from becoming entangled by the lowering cab, or he was trying to retrieve the control box that might have slipped out of his hand as he was lowering the cab prior to performing the dynamometer testing. If sensor cables become entangled while the cab is lowering, the cab should be stopped, and then raised and locked into place before attempting to reroute the cables. If the control box slips or is dropped from the mechanic's hand, the mechanic should stand clear and allow the cab to lower regardless of damage that may occur. In this incident, the fatality may have been prevented had the victim stood clear of the cab while it was lowering.

**Exhibit 4. The tire and fender of the cab where the victim was pinned.**

### **Recommendation #1: Employers should ensure that diesel mechanics always stand clear of lowering cabs.**

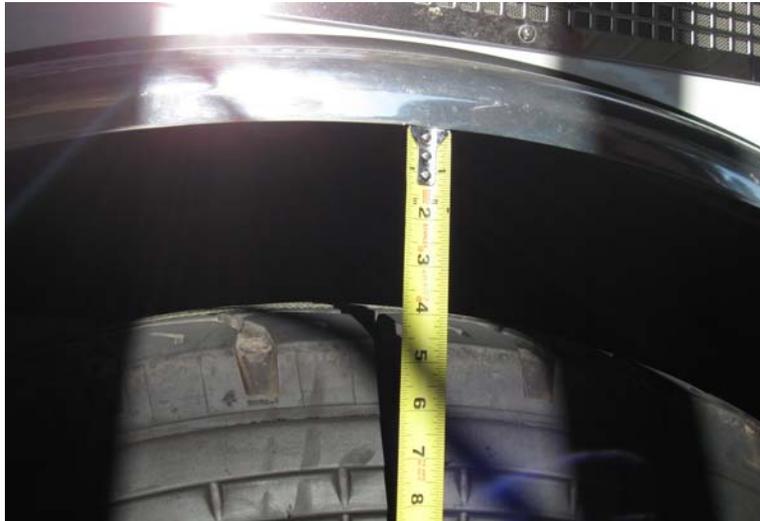
**Exhibit #5. The distance between the tire and fender of the cab was approximately 4.5 inches.**
