**REPORT#:** 21CA004

**REPORT DATE:** January 5, 2022

## Construction Laborer Died When Struck by an Excavator Bucket that Detached from a Quick Coupler — California

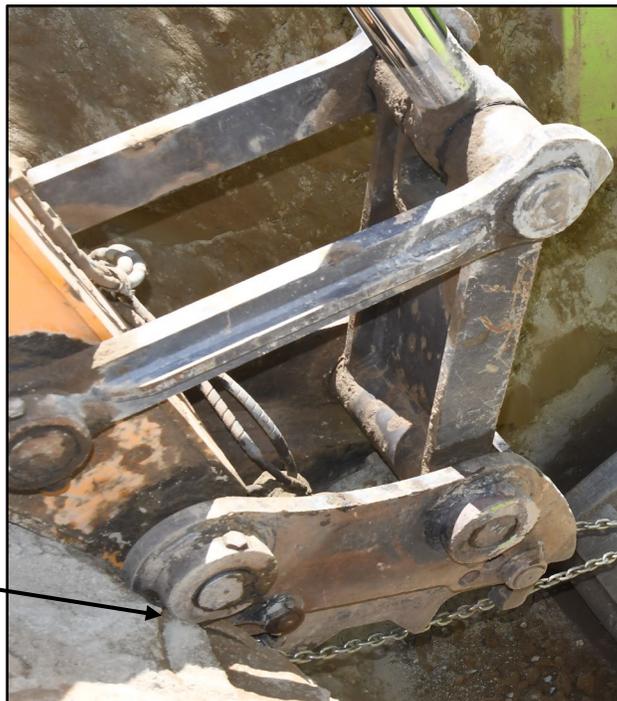
Quick coupler

The machine involved in this incident was a Sany SY365C large excavator (Exhibit 1). The excavator weighed approximately 80,000 pounds. and had the ability to dig a trench approximately 24 feet deep. Attached to the end of the excavator boom was the original equipment quick coupler (Exhibit 2) to which the bucket attached. Quick couplers are hydraulic devices that are installed at the end of booms by pins that would normally be the mountings for the bucket or attachment. Quick couplers facilitate the rapid exchange of working tools or buckets.

*Exhibit 2. A close-up of the quick coupler in this incident. Photo courtesy of police department.*

Discussion: In this incident, the bucket released unexpectedly from the quick coupler when it was being lowered into the trench. It is unknown if the operator performed an inspection of the quick coupler prior to use. To prevent injuries or fatalities from excavators with quick coupler devices, employers should:

- Ensure that machine operators always perform [pre- and post-operation inspections](#) on the excavator
- Adhere to regular maintenance of the quick coupler device according to manufacturer guidelines
- Train workers in the proper use of quick couplers, including making visual inspections,

- proper procedures for engaging attachments, and methods for testing connections
- Prior to using an attachment, ensure the operator performs a connection test as specified by the manufacturer

- Ensure that the quick coupler is properly engaged by using approved safety checks, visual indicators, and/or warning devices. If required by the manufacturer, the safety locking pin must be in place prior to lifting the attachment off the ground

- Use only manufacturer-approved and compatible attachments
  - Install retrofit safety kits on older quick coupler devices or upgrade to newer quick couplers with built-in safety mechanisms. Human detection systems may also be available in some newer excavators to prevent contact with a worker who is within the swing radius

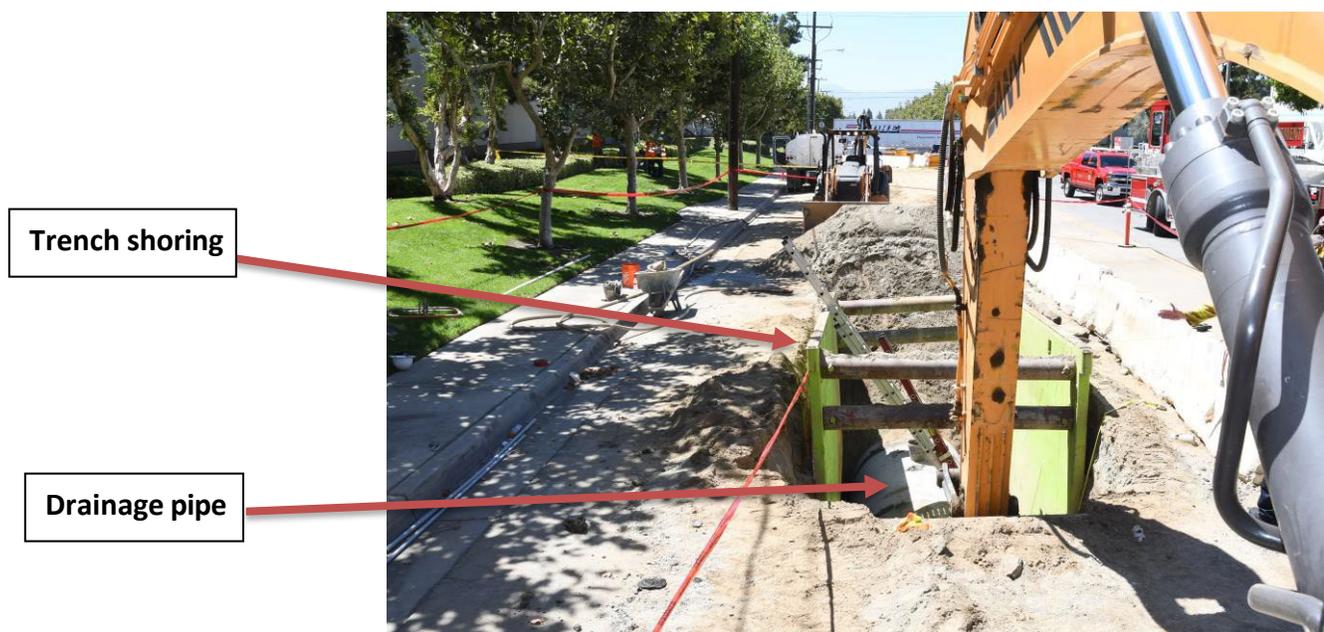
The incident scene was a residential street construction site in southern California (Exhibit 3). The company was installing an underground storm drainage system that expanded the existing system. The installation had been underway at this site for two weeks. The concrete lined drainage pipes were 8 feet long with a diameter of 60 inches. The trench was approximately 20 feet deep, and 5 feet wide. The length of the open trench was just enough to accommodate one piece of pipe at a time, and it was equipped with shoring to prevent the sides of the trench from caving in.

Exhibit 3. The Incident scene. Photo courtesy of police department

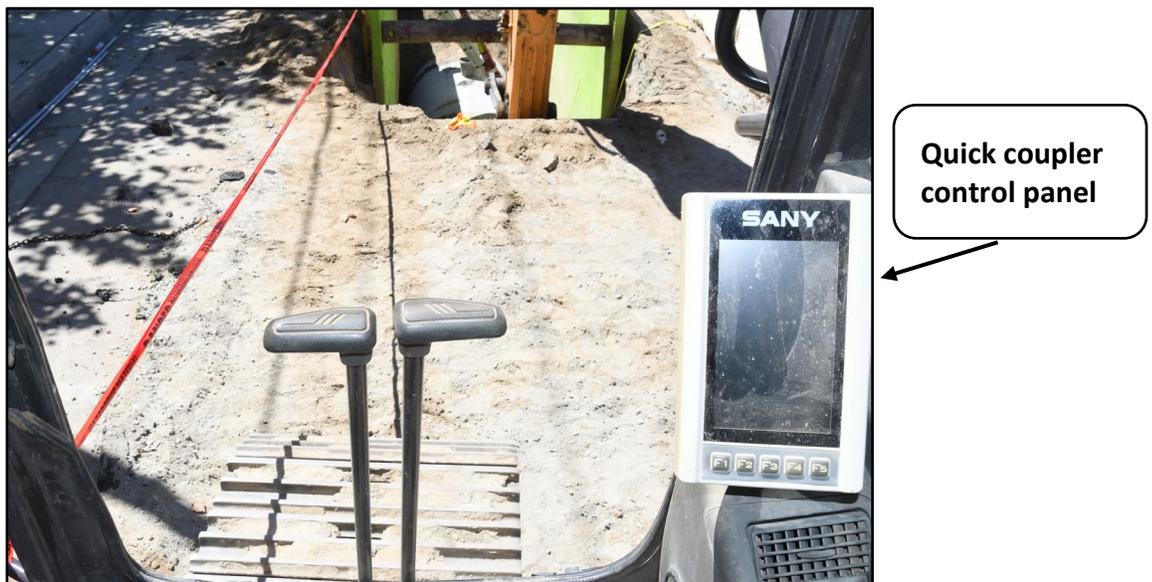
excavator operator where to position the boom before lowering the pipe into the trench. After the excavator operator dug a portion of the trench with the bucket, he swung the boom off to the side of the trench and pushed a button on a control panel (Exhibit 4) to disconnect the bucket that was attached to the quick coupler.

*Exhibit 4. The control panel used to operate the quick disconnect. Photo courtesy of police department.*

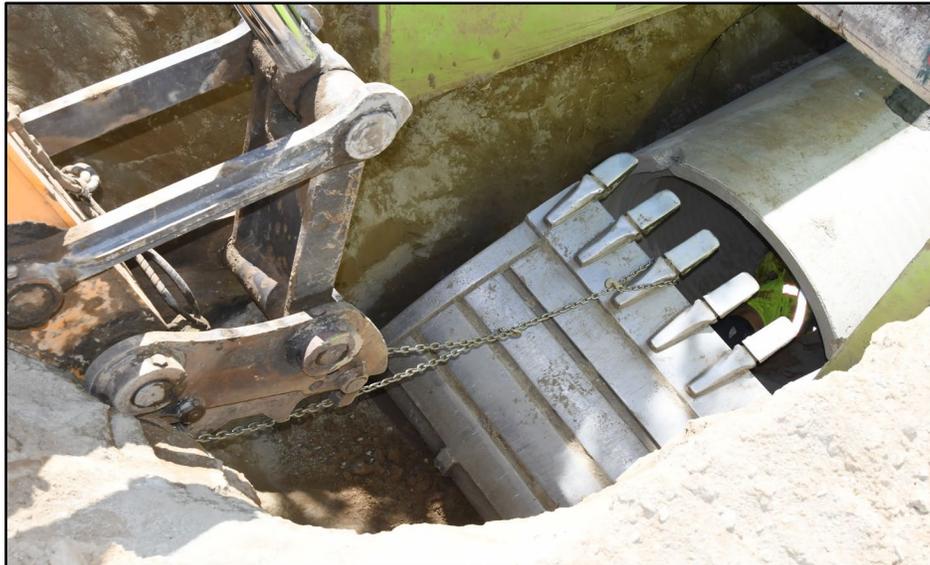
*Exhibit 5. View into the trench where the victim was standing and where the bucket detached from the quick coupler. Photo courtesy of police department.*

Discussion: In this incident, the victim was in the trench below the excavator boom swing radius when the bucket detached from the quick coupler. All heavy equipment poses serious, even potentially fatal, risks to operators and workers in the vicinity. If a load falls, either from improper attachment of a quick coupler device or a mechanical failure, death or serious injury can occur.

***Recommendation #1: Establish procedures that will ensure workers are not working within the excavator boom swing radius or beneath an elevated load.***

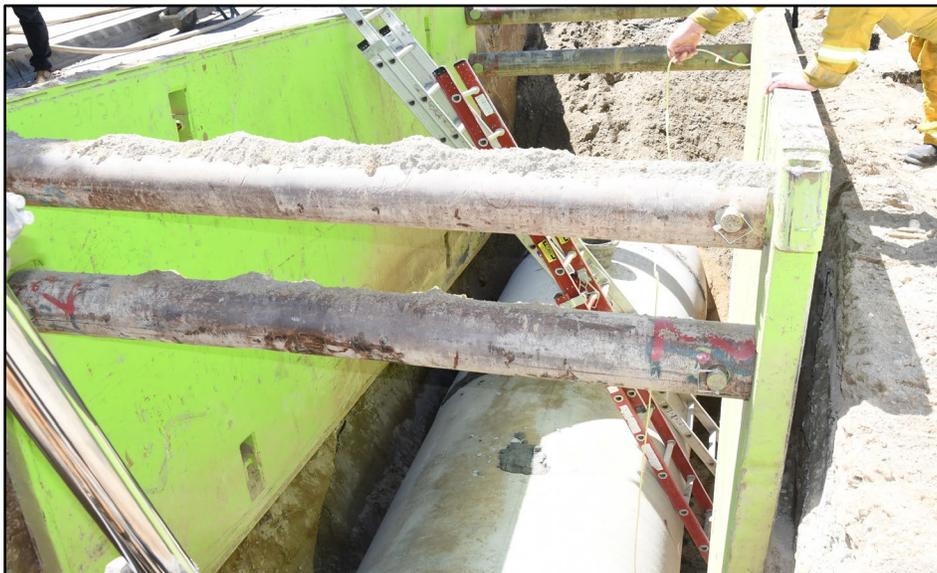
*Exhibit 5. The ladder the victim was going to use to exit the trench. Photo courtesy of police department.*
