REPORT#: 22CA001

REPORT DATE: March 24, 2023

Forklift Operator Dies After Falling Into a Recycling Baler — California

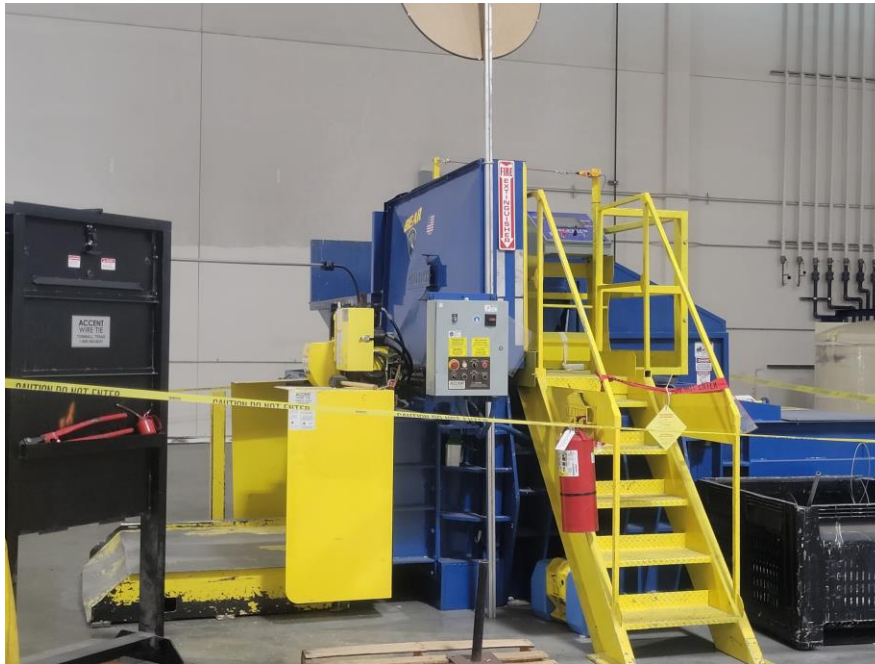
At approximately 6:00 a.m., one of the day shift employees noticed that the victim had not returned with the forklift. He notified his supervisor, who then tried to reach the victim on the radio, but he did not respond. A co-worker searched the area where the recycling baler was located and observed the victim's forklift next to the hopper with a bin loaded on the forks. When the co-worker was not able to locate the victim, he notified the supervisor. The supervisor arrived at the baler and turned the key switch on the control panel to the off position. A second co-worker opened the compactor's side compartment and observed blood on multiple pieces of cardboard, and the victim's body inside. Emergency services were called at 6:32 a.m. Police, fire, and paramedics arrived at 6:41 and secured the incident scene. The coroner declared the victim dead at the scene. After the incident, review of the security video camera showed the victim climbing the stairs to the control panel (Exhibit 5), but stacked material blocked the view of his subsequent activities.

Exhibit 5. The stairs leading to the control panel. Photo by CA/FACE program.

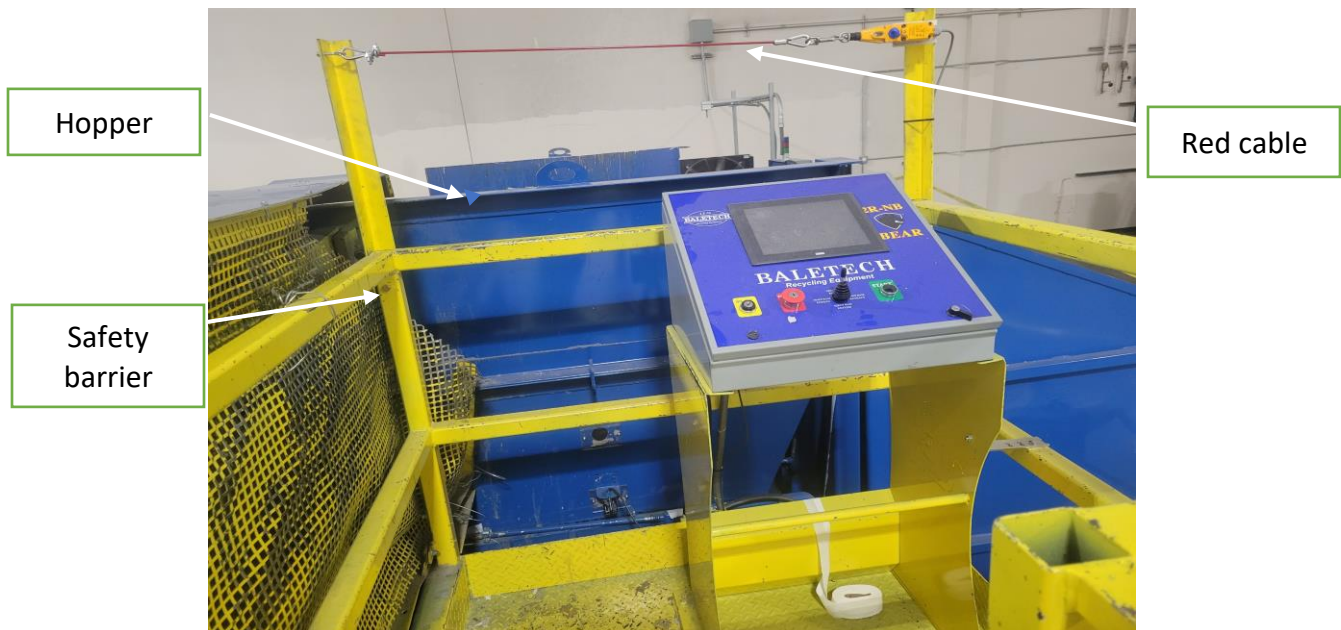
Discussion: In this incident, the victim was able to gain access to moving parts of the recycling baler while it was in operation. The design of the bale hopper had physical barriers (yellow), but they did not prevent access to moving parts (Exhibit 6). Collaboration between employers and machine manufacturers may result in additional safety devices that could be added to the machine to ensure worker safety when working in close proximity to moving parts.

Exhibit 6. The yellow barrier around the control panel to prevent access to the hopper. The red cable was added after the incident occurred. Photo by CA/FACE program.

Recommendation #2: Design and install safety features to keep workers away from moving parts.
