# **INCIDENT HIGHLIGHTS**

**REPORT#:** 22CA002

# Warehouse Worker Dies When Material Falling Off of Pallet Strikes Him — California

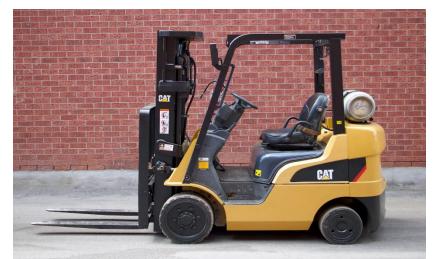
The primary piece of equipment involved with this incident was a CAT<sup>®</sup> model 2C6000 forklift (Exhibit 2). The forklift is a relatively small indoor/outdoor, liquid propane fueled forklift that has a lifting capacity of about 6000 pounds and weighs about 9,440 pounds. Safety features include overhead guards (to protect the driver from falling objects), side/rearview mirrors, a backup alarm, strobe lights and a loud, audible horn.

Exhibit 2. A CAT<sup>®</sup> model 2C6000 forklift (similar model, not actual used in the incident). Photo by CA/FACE program.

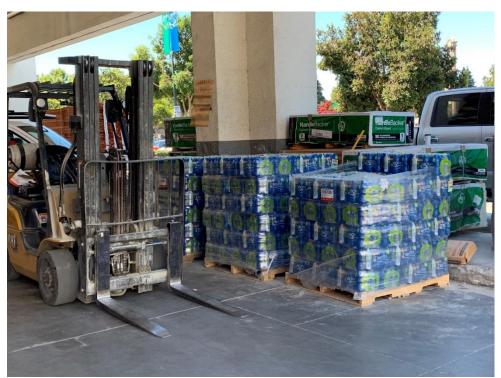
backwards slightly and causing it to tilt at a slight angle. The cased water on the top pallet further shifted against the shrink wrap, which gave way and dumped the entire pallet of cased water on the victim.

Exhibit 3. Incident location with CAT<sup>®</sup> forklift (similar model, not actual used in incident) and pallets of product identical to those that struck the victim. Photo by CA/FACE program.

In this incident, the forklift's forks were placed under the top pallet which created a tilted, unstable load. If a method had been used to manually break down the unbalanced/unstable pallet, this death could have been prevented.
