**FROM:** California Fatality Assessment and Control Evaluation (FACE) Program

**SUBJECT:** An elevator mechanic helper died when he was crushed in an escalator while performing maintenance.

**SUMMARY**  
**California FACE Report #01CA009**

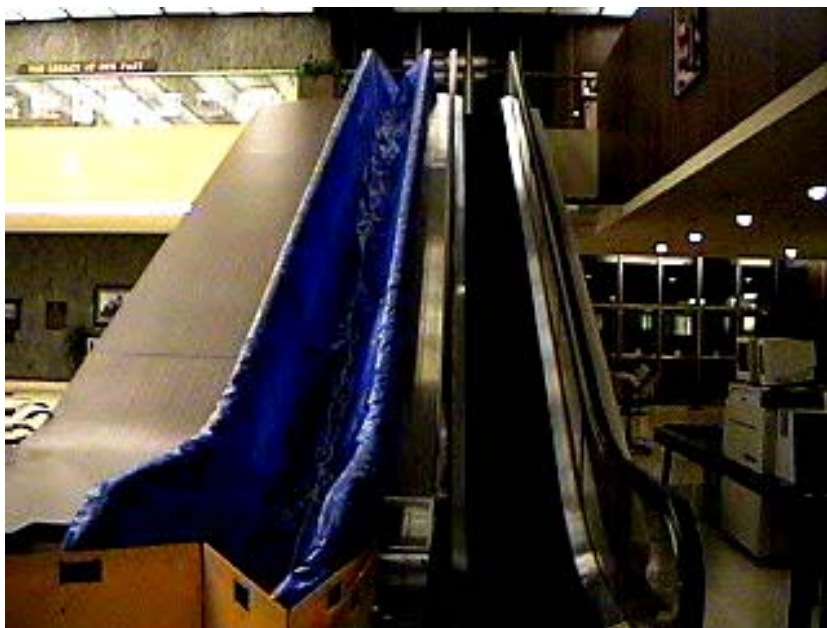
Exhibit #1

The site of the incident was a county court multi-story facility. The escalator involved in this incident was the #2 escalator located in the main lobby between the first and second floors (**see exhibit #1**). The #2 escalator was used mainly to transport people down to the first floor from the second floor. The floor plate at the second floor escalator landing covered a small compartment referred to as the machine room, which contained the electrical and mechanical components to operate the escalator (**exhibit #6**).

View of the escalators running between the lobby and second floor of the courthouse. The escalator on the left was involved in the incident.

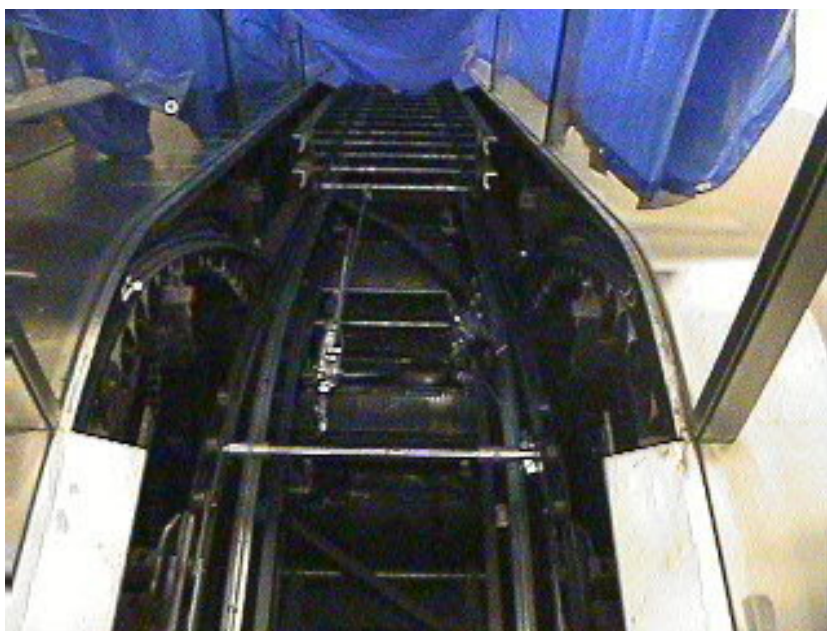
Exhibit #2

View of the #2 escalator landing with the stairs removed exposing the escalator truss.

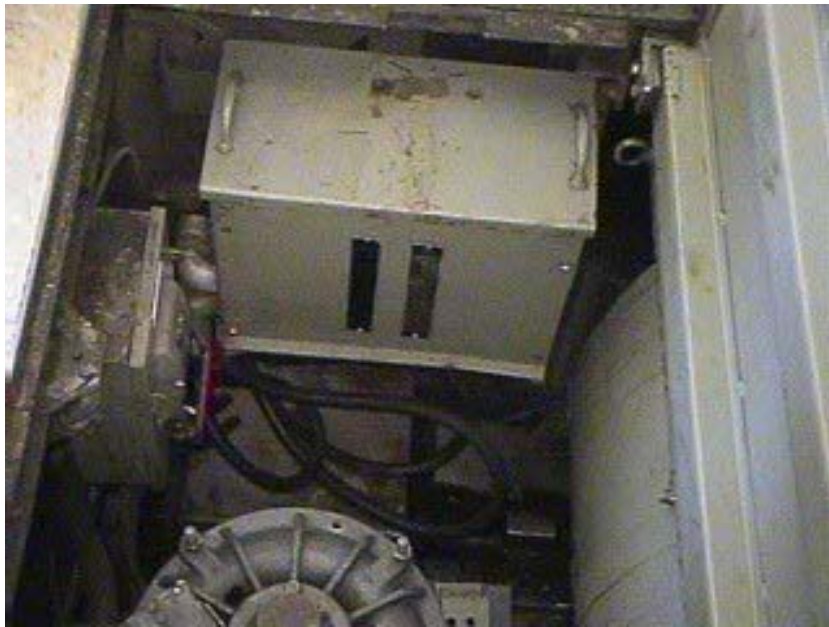
Exhibit #4

Discussion: The company adopted and implemented the elevator industry's policy on lock-out/tag-out. In this incident there were no lockout/tagout procedures used although it was required. The victim and his co-worker depended solely on the main line disconnect switch to remain in the off or open position. The flex-cable attached to the electrical control box turned the main line disconnect switch on when the electrical box was picked up. A lock on that switch would have prevented this from occurring. The main control panel supplying power to the escalators within the building should have been opened and locked and tagged as well. This was not done. The safety practices and procedures noted in the elevator industry's safety handbook are specific for this type of work. Had these general rules been followed, this incident might have been prevented.

A view of the machine room showing the electrical control box in the center and the main line disconnect with a bar handle to the left.
