SUBJECT: An industrial washing machine operator died when pulled inside a machine while loading sheets.

SUMMARY
California FACE Report #01CA010

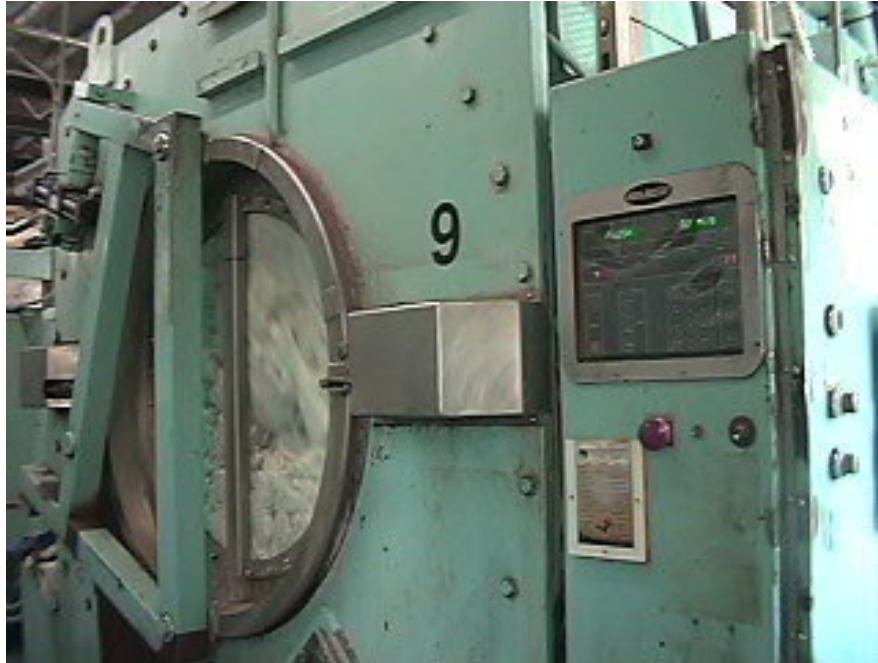
Exhibit #2

Discussion: When the basket button is depressed and released, the washing machine drum rotates approximately three revolutions. Holding the switch in will allow the drum to continue to rotate until released. Changing the switch to a mechanism that would only allow the drum to inch forward with every depression would remove any potential hazard created with a rotating drum when the drum door is opened.

Front view of industrial washing machine and control panel

Recommendation #2: Consider changing the basket button to a switch that only allows the drum to inch forward with every depression.

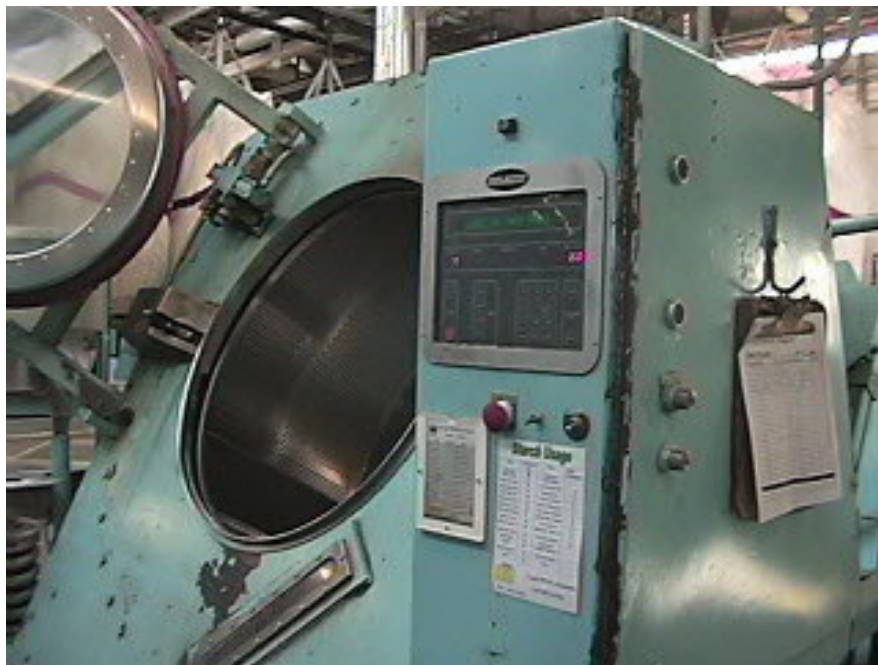
Exhibit #3

View of industrial washing machine in tilt position with loading door open.

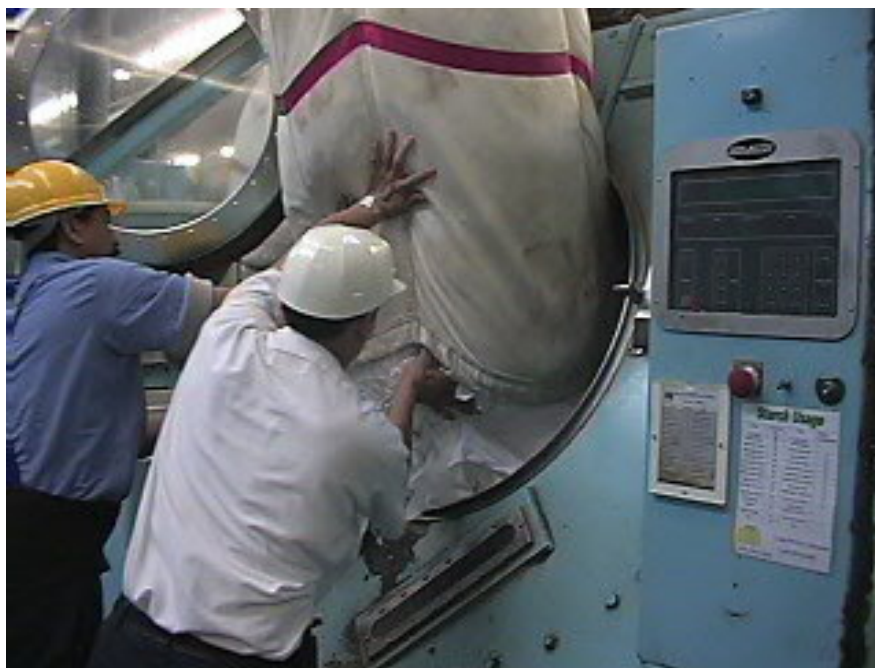
0CA010
Exhibit #7

View of the laundry sling being unloaded into the industrial washing machine.
