SUBJECT: A heavy equipment spotter died when he was backed over by a front-end loader inside a trash collection transfer station.

SUMMARY
California FACE Report #01CA012

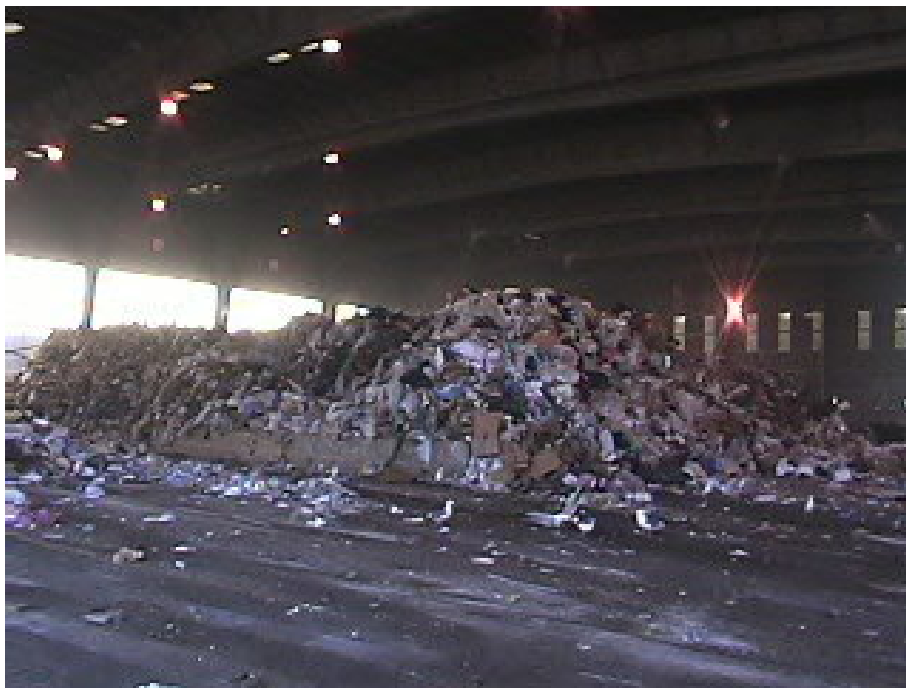
Exhibit #2

View from inside transfer station looking north at dumped waste in a designated bin.

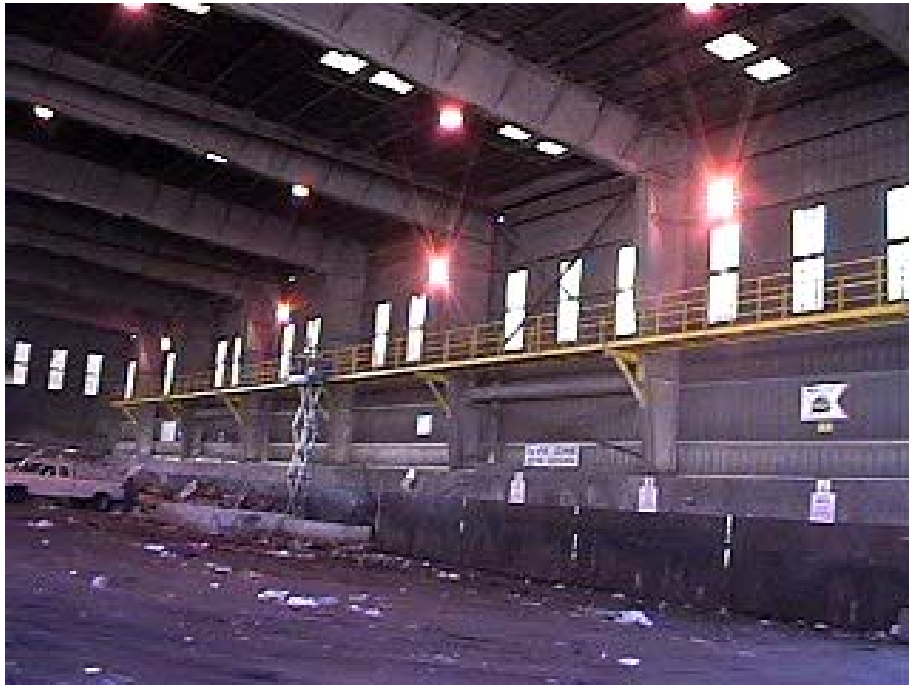
Exhibit #3

View from inside the transfer station looking at the south wall where trucks park to clean out.

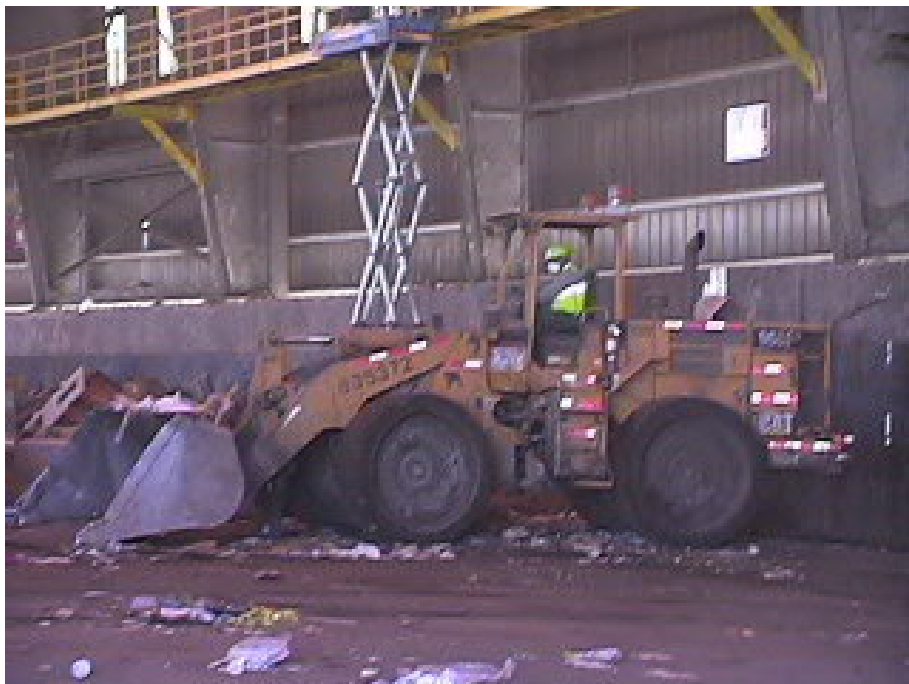
Exhibit #4

View of the left side of the front-end loader involved in the incident.
