SUBJECT: A heavy equipment operator died when the dump truck he was backing slid down an embankment and then tumbled over.

SUMMARY
California FACE Report #02CA001

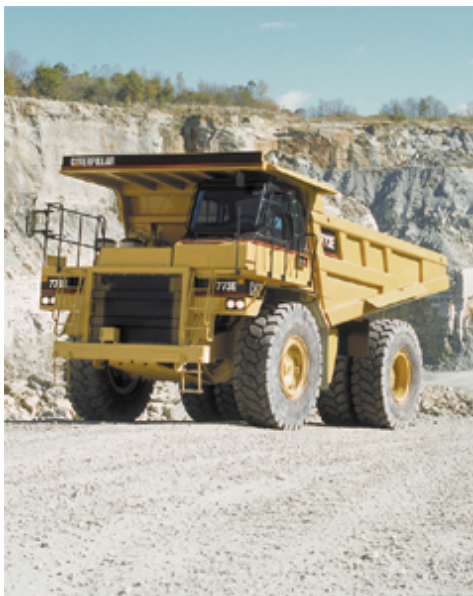
Exhibit #1

View of an off-road dump similar to the one involved in the incident.

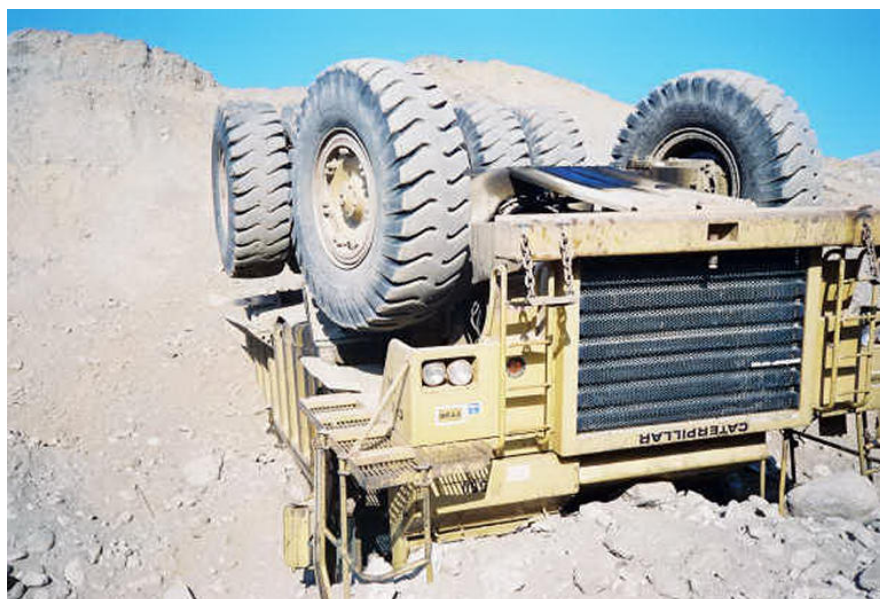
Exhibit #2

The ground beneath the rear tires gave way and the dump truck started to slide down the embankment. It continued down the embankment slowly for about 50 feet, then the rear of the bed of the truck wedged into the dirt causing the front of the truck to go vertical and then it rapidly turned over rear to front with the victim belted in the cab. The dump truck finally came to rest in an upside down position with the cab intact. Witnesses to the incident ran to the dump

View of the truck as it came to rest after tumbling over the embankment.

Discussion: The victim died from blunt force head trauma because of the lack of restraint for the upper body. When properly restrained, the upper body would be secured and unable to be tossed around when in a rolling or tumbling condition. The restraint could also help prevent injuries.

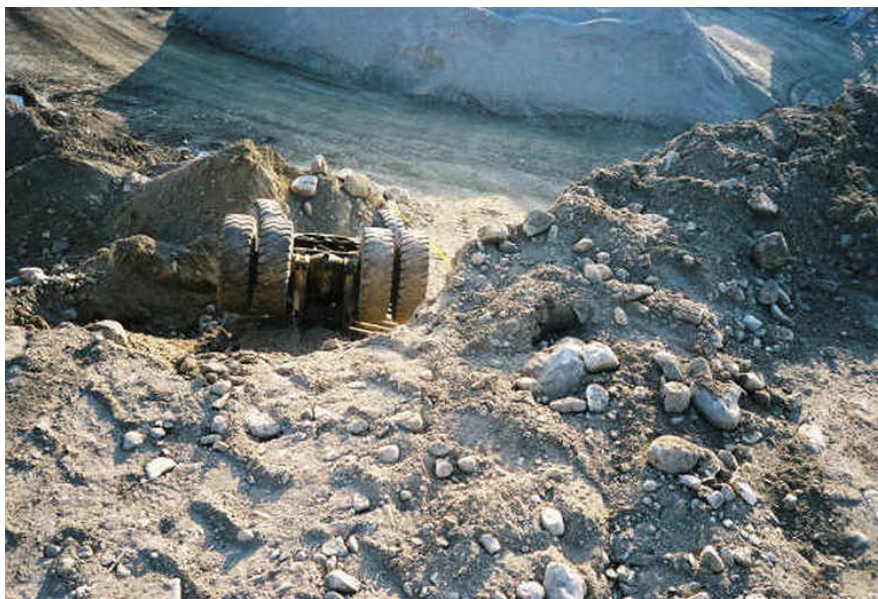
Exhibit #3

View of the truck looking down from the top of the embankment.

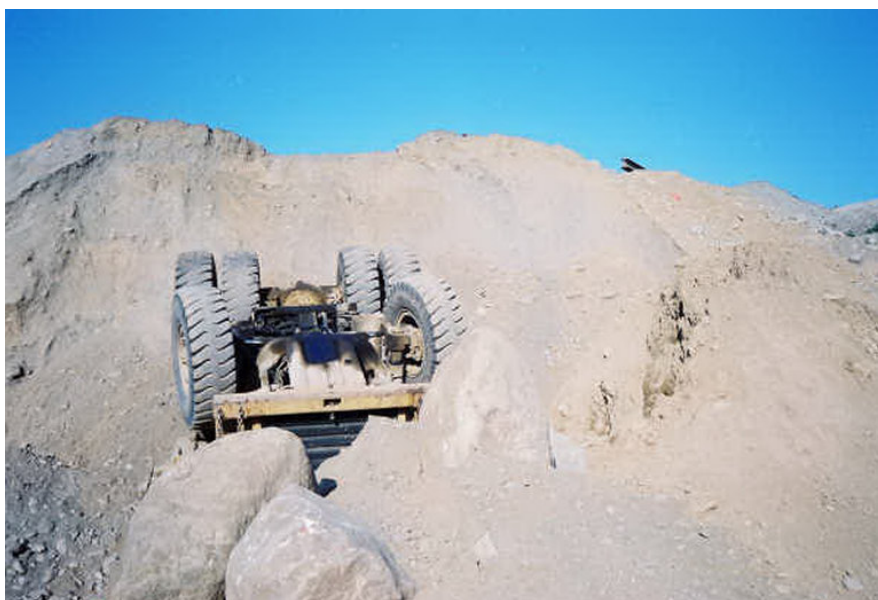
Exhibit #4

View of the truck looking up from the bottom of the embankment.

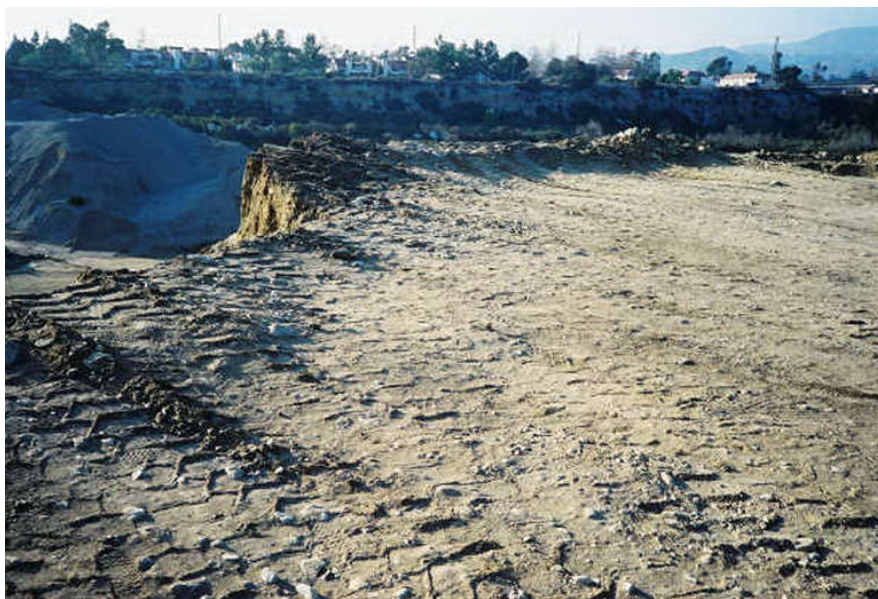
Exhibit #5

The site of the incident was a gravel pit that crushed rock and dirt. The rock and dirt were excavated in a separate area of the pit, then transported by truck to a designated area called the "dump pad" which was located on top of an embankment approximately 70 feet high (**see Exhibits #5&6**). Trucks would back up to the dump pad and dump their load as close to the edge of the embankment as possible. A bulldozer would then push the rock and dirt over the embankment and reestablish the berm. A berm is a mound of gravel and dirt at the edge of an embankment that is piled high enough to prevent trucks from over-traveling and over-turning. The truck involved in this incident was a 58 ton rock dump truck that was constructed for this purpose only and not subject to vehicle registration. The victim was not required to have a special license or certification to operate the truck.

Discussion: Berms, when properly installed, should prevent trucks from over-traveling and over-turning at dumping locations. In this particular case, the berm was inadequate in height and width to stop the truck. Had the berm been properly installed at this job site, this incident might have been prevented.

View of the area looking north where the truck went over the embankment.

Recommendation #1: Ensure berms are adequately built to prevent trucks from over-traveling and over-turning at dumping locations.

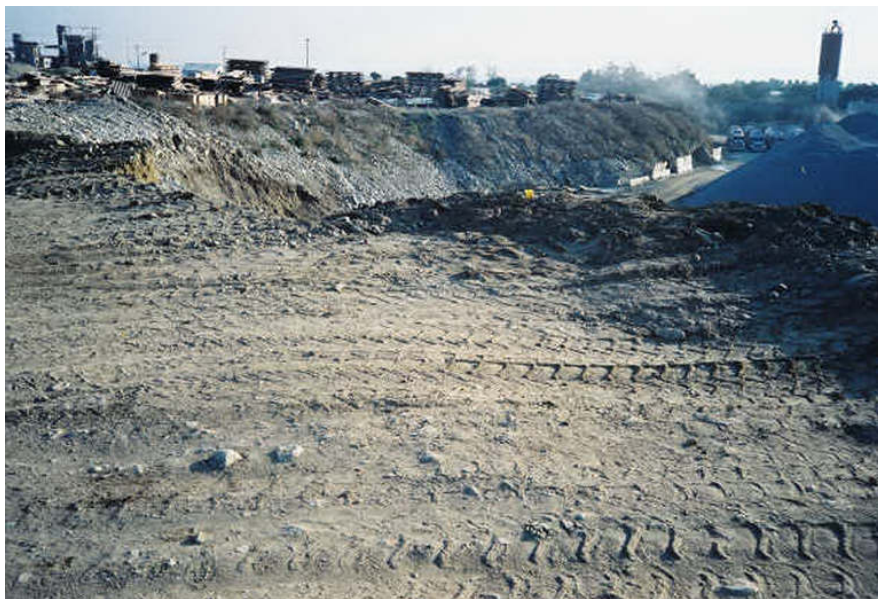
Exhibit #6

View of the area looking south where the truck went over the embankment.
