SUBJECT: A welder dies after being crushed by a hydraulic door on a scrap metal shredding machine.

SUMMARY
California FACE Report #02CA004

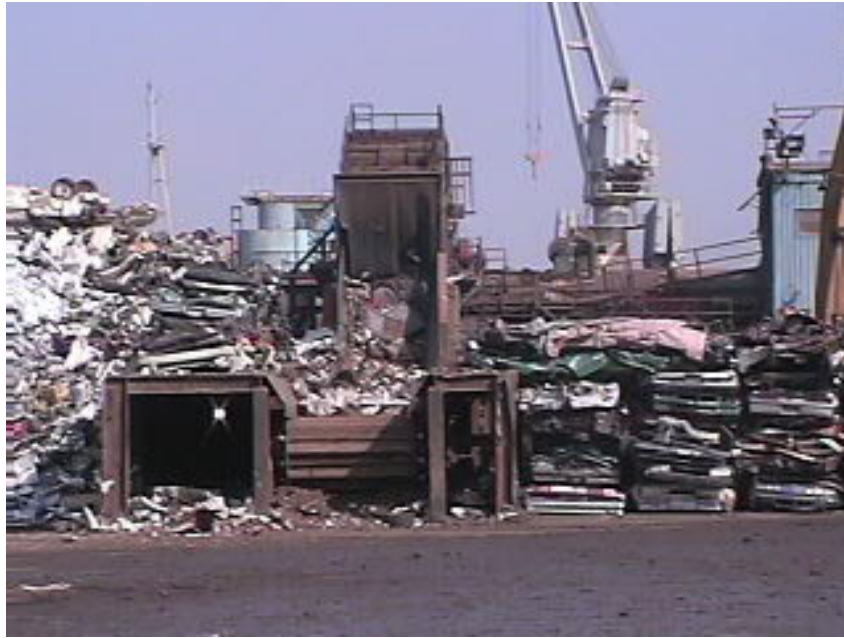
Exhibit #1

Front view of the shredding machine called the "Mill" involved in this incident.

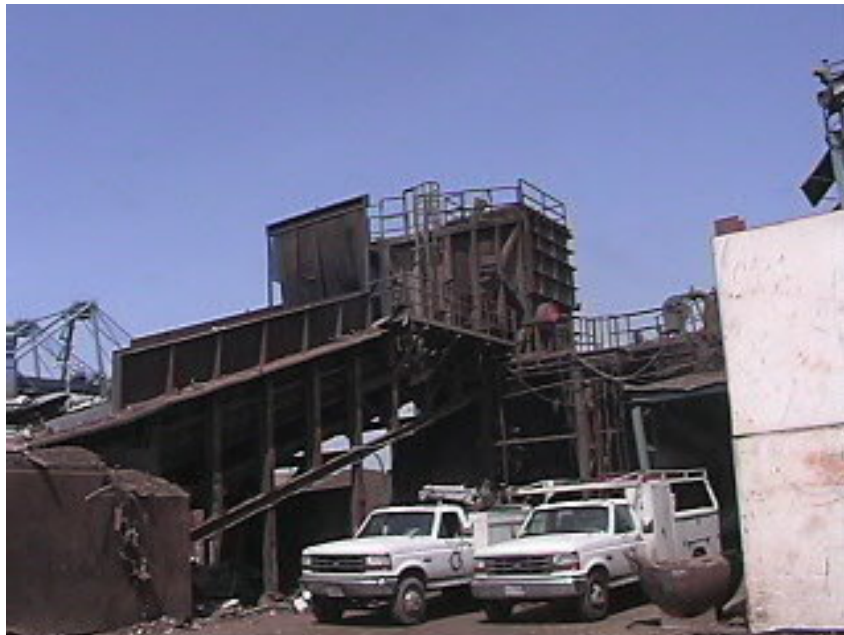
Exhibit #2

Side view of the mill showing the conveyor rail and hopper.

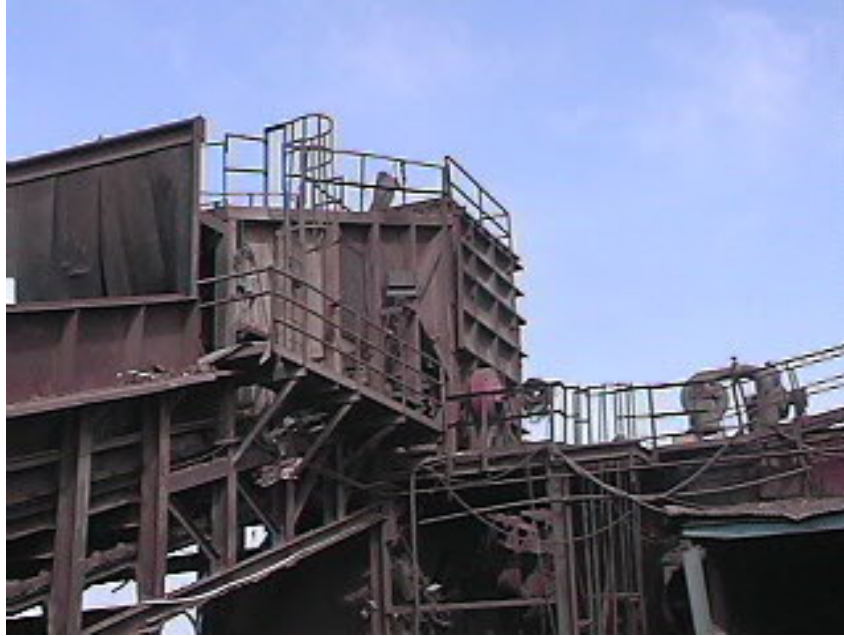
Exhibit #3

View of the hopper containing the metal shaker, drum, hammers and throw-out door.

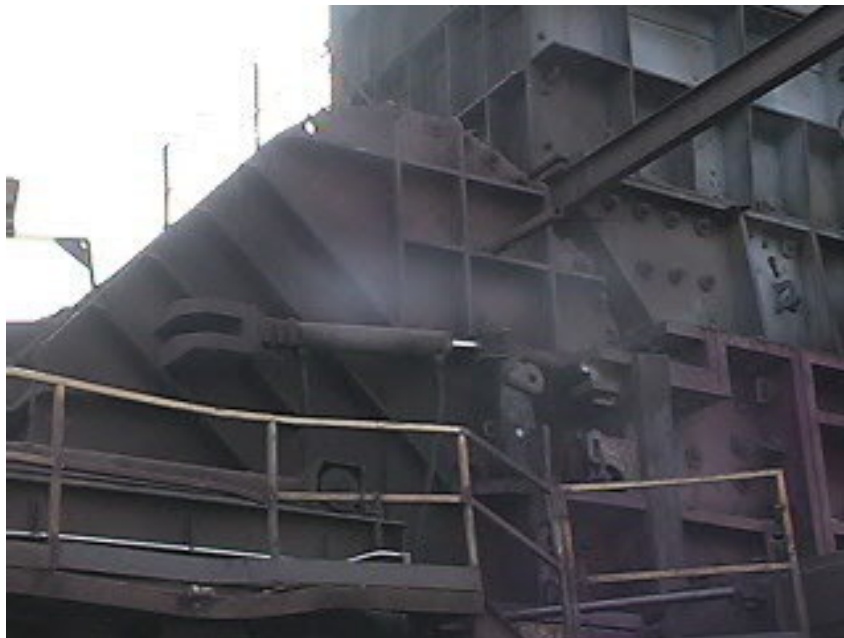
Exhibit #4

View of the hydraulic cylinder used to open and close the throw-out door.

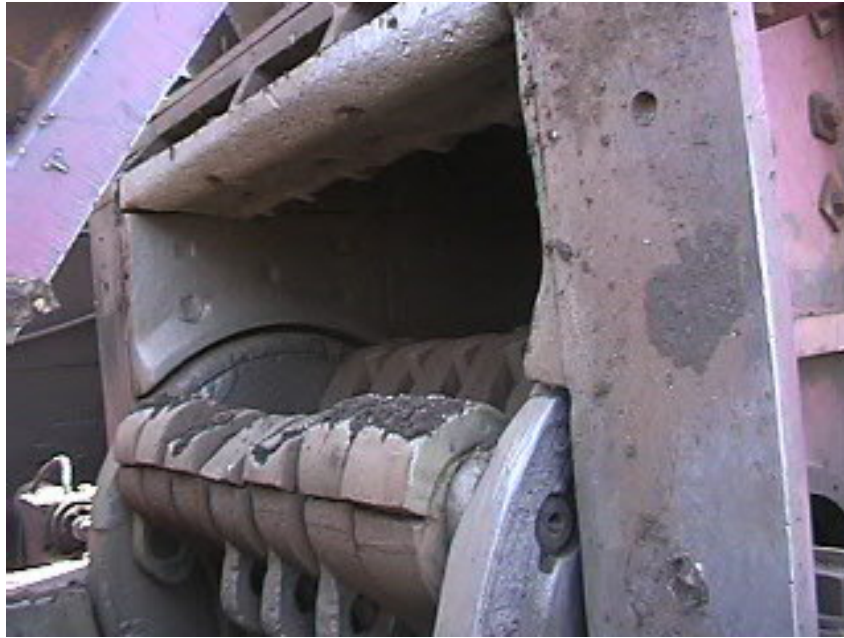
Exhibit #5

Left side view of the drum and hammers within the hopper.

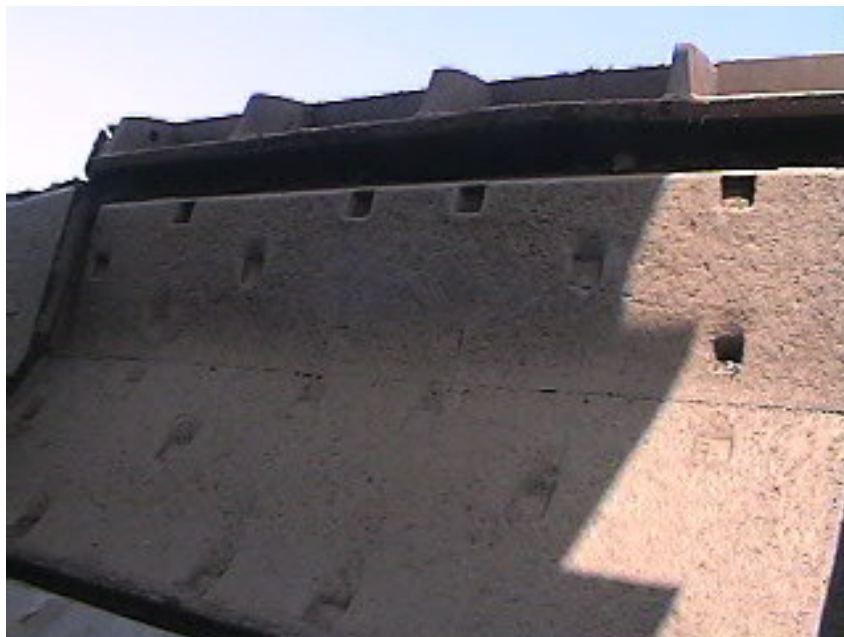
Exhibit #6

The victim was sent to remove the jam by his supervisor. The victim had performed this maintenance activity frequently in the past. He got a ladder, torch and padlock and went to the hopper. The victim used the ladder to gain access to the jammed door. Although two co-workers stated that the victim told them that he had locked out the system, the system had not been locked-out or de-energized. The victim laid across the top edge of the door and cut away the obstruction with the torch. When the piece of metal was cut away, the hydraulic door, which was still under pressure, closed upward on the victim. The supervisor, who was observing the operation, was knocked off the ladder he was standing on when the door slammed shut. He sustained a severe back injury. A co-worker was able to activate the hydraulic door and release the pressure on the victim. He was then removed from the door to an adjacent catwalk where CPR was performed. The paramedics arrived and checked for spontaneous pulse and respiration and found none. He was pronounced dead at the scene. The lock that was supposed to be used to lock out the system was recovered from the victims clothing.

Right side view of the hydraulic throw-out door that crushed the victim.

Recommendation #2: Ensure employees block mechanisms from moving prior to performing repairs or maintenance.

Discussion: Even though a mechanism may be disconnected, drained, isolated, dissipated, or turned off, it still may be necessary to block the device if it is capable of movement. Many manufactures make blocking devices for their products used in conjunction with other machines. A blocking device is added protection to assure no unwanted movement especially when employee safety is involved. Had a blocking device been used to prevent the throw-out door from moving, this incident might have been prevented.

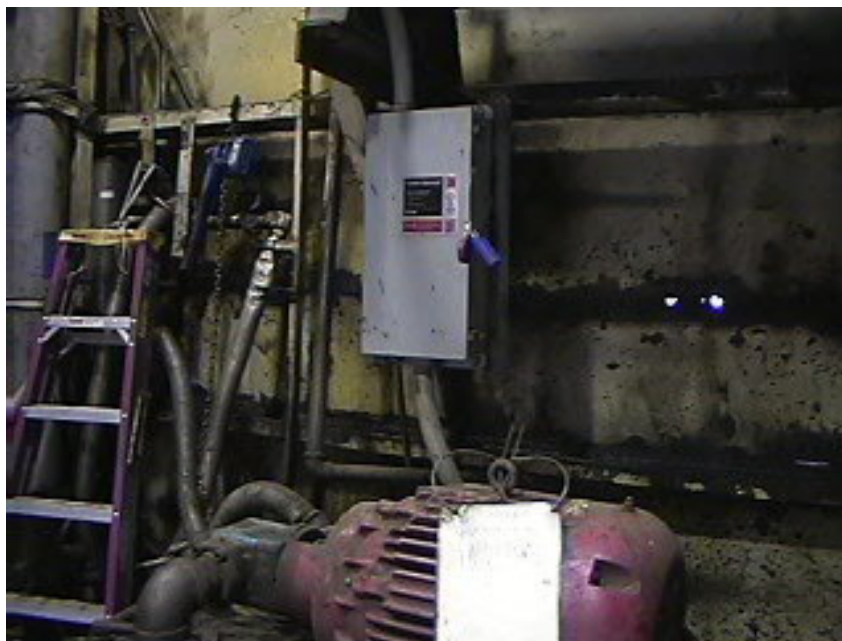
Exhibit #7

View of the electrical panel and motor controlling the hydraulic system.

Recommendation #1: Ensure all employees follow the company's established procedures for de-energizing of energy sources and lockout / tagout.

Discussion: It is essential that machinery should be de-energized, disengaged, or isolated prior to any cleaning or maintenance. In addition, the source of energy must be locked out so others cannot re-energize the machine when an employee is in an area of danger. It is also necessary to place tags at the energy sources to warn others that the machine is locked out of service. The company had an extensive written lock out/tag out procedure in which the victim was trained. Employers need to ensure that employees are properly implementing required safety procedures.
