FROM: California Fatality Assessment and Control Evaluation (FACE) Program

SUBJECT: A construction laborer was killed when a rubber tire bulldozer backed over him as he was doing a grade check.

California FACE Report #02CA002

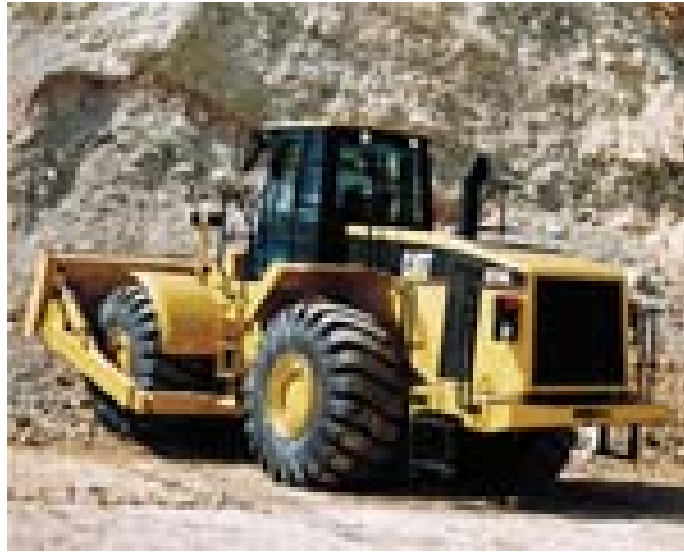
Exhibit #1

View of a rubber tire bulldozer similar to the one involved in the incident
