SUBJECT: An apprentice mechanic died when crushed in a machine that stacks wooden pallets.

SUMMARY
California FACE Report #03CA003

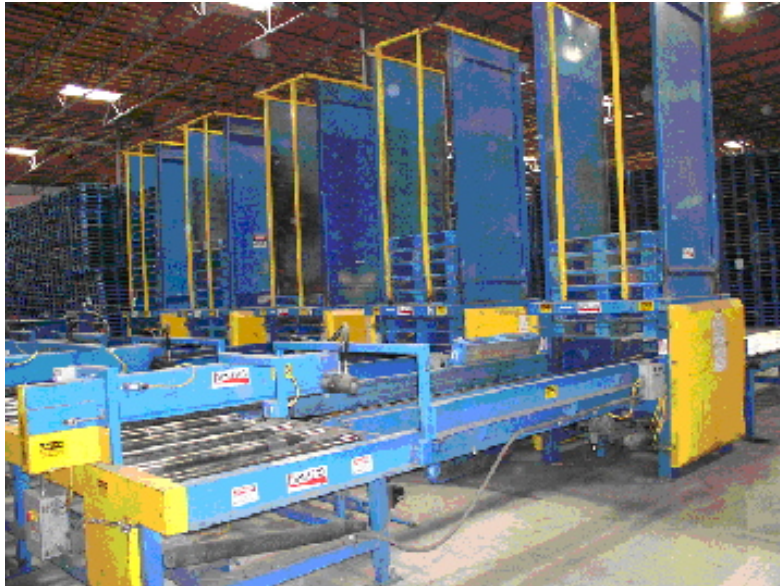
Exhibit #1

On March 17, 2003, at approximately 8:00 p.m., a 44-year-old apprentice mechanic was killed when he got caught in the hydraulic mechanism of a pallet stacking machine (**Exhibit #1**). The CA/FACE investigator learned of this incident on March 27, 2003, through the Legal Unit of the Division of Occupational Safety and Health (Cal/OSHA). On April 23, 2003, the CA/FACE investigator traveled to the victim's place of employment where he interviewed company personnel and employees who responded to the incident. The investigator also inspected the incident site and took pictures of the machine involved in the incident.

View of the pallet stackers from the front or loading end.

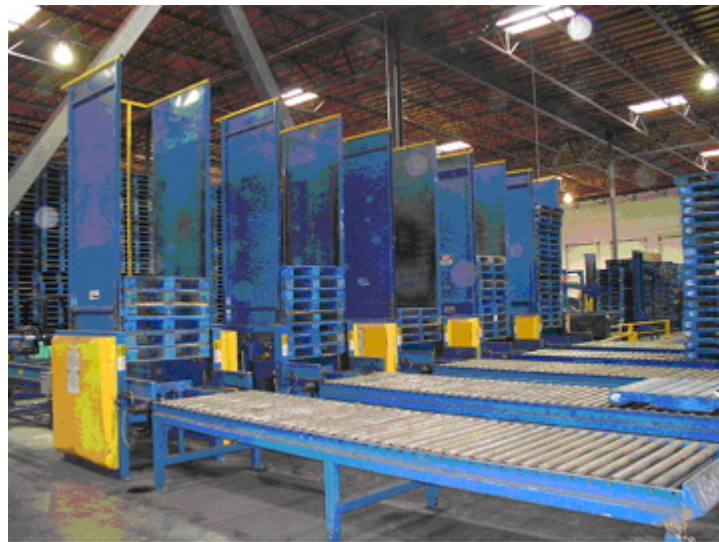
Exhibit #2

The site of the incident was a warehouse complex. The facility within the complex where the incident occurred manufactured, inspected, repaired, and distributed wooden pallets. It used a high-speed pallet sorting and stacking machine for this process. The fully automated system took the sorted pallets off a roller conveyor and stacked them to a designated number (1-20) (**Exhibit #1**). The automated system was controlled through a series of electric eye sensors. When the pallet passed the first sensor, the automatic device used to pull the pallet into place was activated. When the pallet was pulled in place, another sensor was activated to start the stacking cycle. The hydraulic stacker lifted the pallet onto lifting dogs, and then went back down completing the cycle (**Exhibit #4**). Lifting dogs are mechanical holding devices that grasp an object (usually on its edge) and hold it in place. A chain mechanism took the pallet into the stacking mechanism and passed another sensor, which counted the number of pallets stacked. When the desired number of pallets was reached, the machine ejected the stack onto the outgoing roller conveyor for removal and storage or shipping (**Exhibit #2**).

View of the pallet stackers from the rear or unloading end.

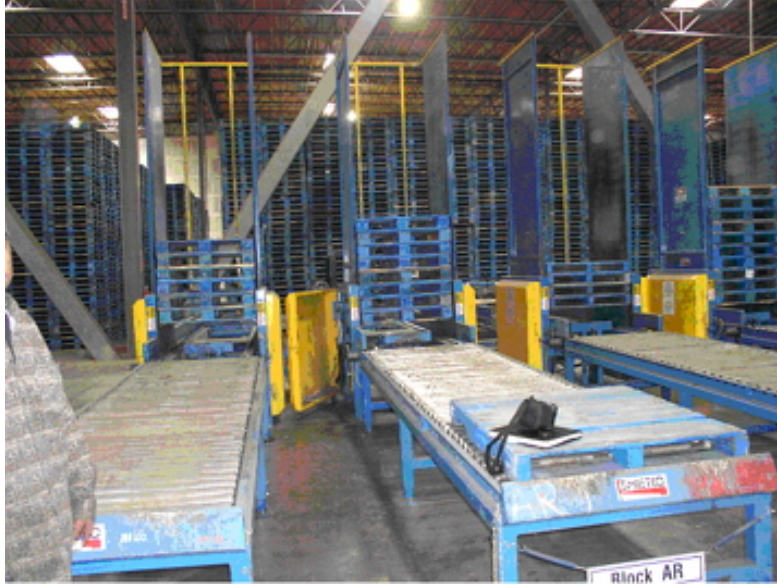
Exhibit #3

View of the pallet stacker involved in the incident.

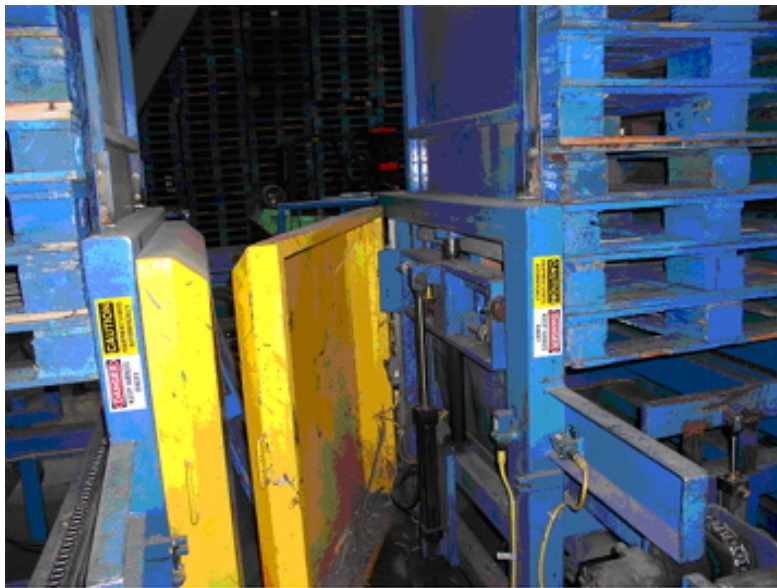
Exhibit #4

View of the hydraulic mechanism and electronic eyes used in the stacking process.

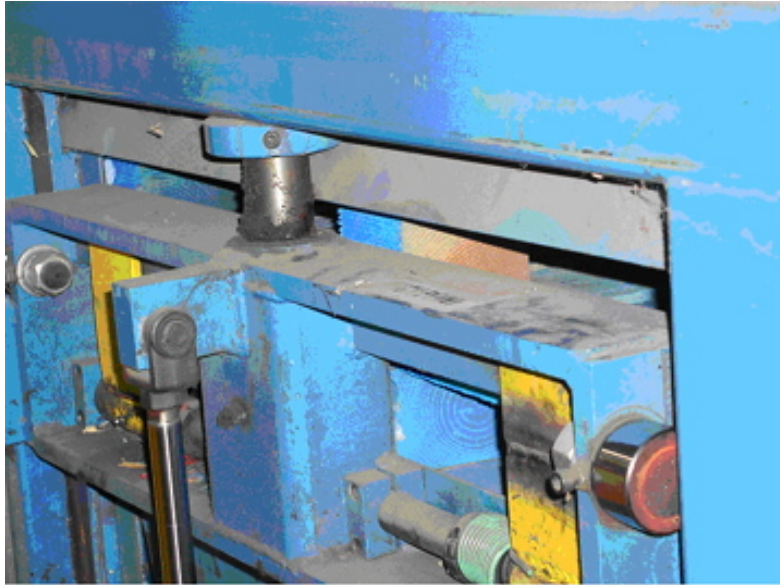
Exhibit #5

On the day of the incident, the victim was performing maintenance on the pallet stacker adjusting the hydraulic stacker mechanism. Access to the lifting mechanism was obtained by opening the guard or door protecting the device. The machine was not locked or tagged out before the victim put his head and chest between the hydraulic ram and the frame of the machine. Evidence suggests the victim completed his adjustment and was reaching inside the mechanism to pick up a wrench he dropped on the floor. While the victim was in this position, he broke the beam that started the machine cycle. When the machine cycled, the victim was unable to get out in time. The journeyman mechanic in charge of the victim came around to check on his progress and saw that he was caught in the machine. He immediately shut off the power and cut the hydraulic lines in order to release the pressure and free the victim. Paramedics responded after being called and treated the victim, then transported him to a local hospital where death was pronounced.

A view of the hydraulic mechanism that crushed the victim.

Recommendation #1: Ensure that the lockout / tagout procedure is implemented whenever maintenance or repair is being performed on pallet stacking machines.

Discussion: The purpose behind a lockout / tagout procedure is to release any stored energy within a machine, then lock that source out while the machine is being worked on to protect the worker. It also prevents accidental starting of a machine while it is being worked on. A lockout / tagout program with an energy control procedure specific to the equipment involved might have prevented this incident. Even the company's generic lockout/tagout program, had it been implemented, might have prevented this incident.

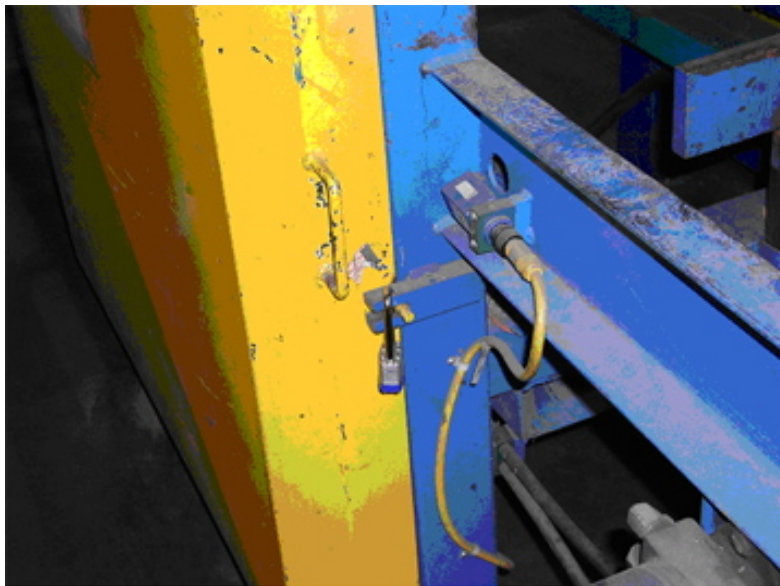
Exhibit #6

A view of the electronic eye sensor that activates the hydraulic mechanism.
