FROM: California Fatality Assessment and Control Evaluation (FACE) Program

SUBJECT: A machine operator died when caught in a plastic injection mold machine.

SUMMARY
California FACE Report #03CA004

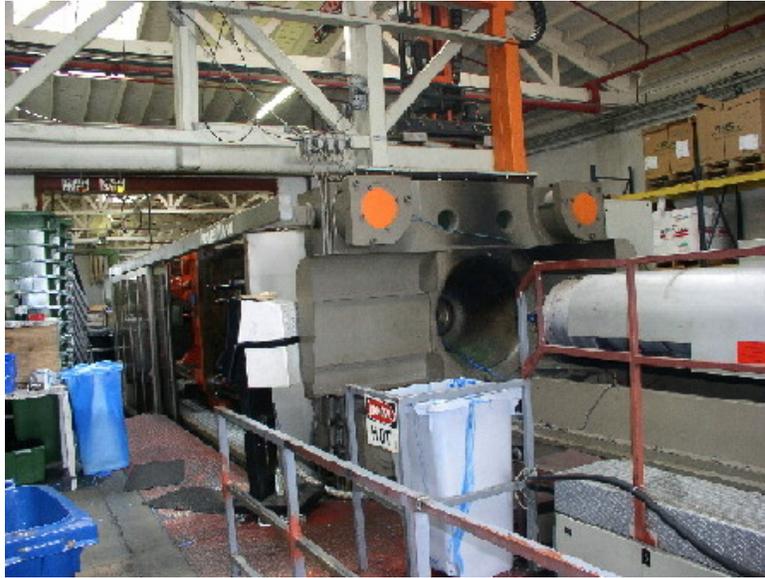
03CA004
Exhibit #1

View of the plastic injector mold involved in this incident.

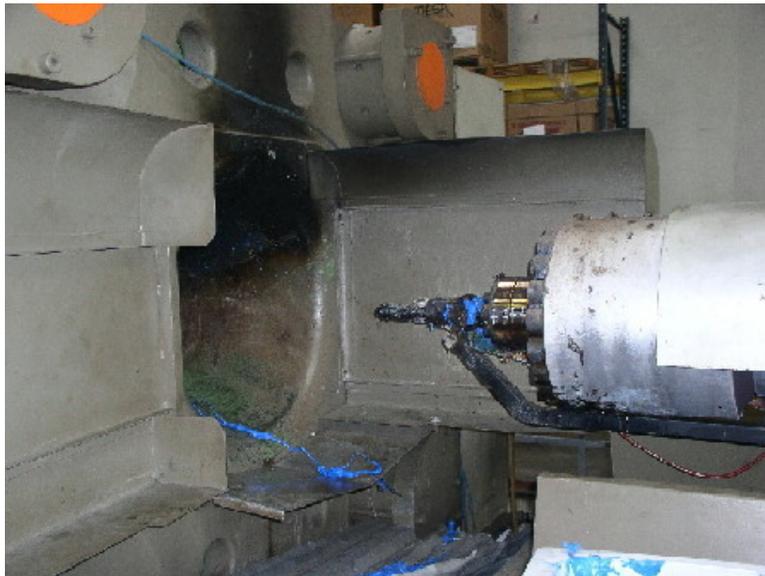
03CA004
Exhibit #2

View of the area where the victim was caught.

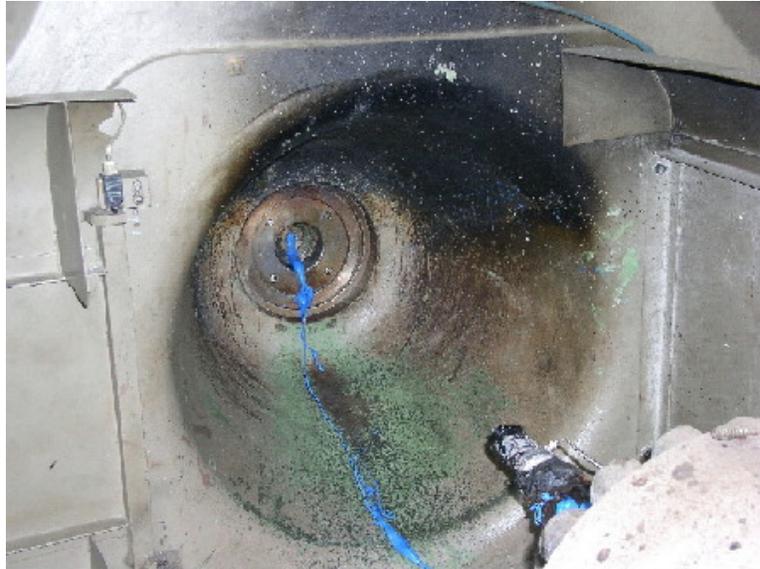
Exhibit #3

Closer view of the area where the victim was caught.

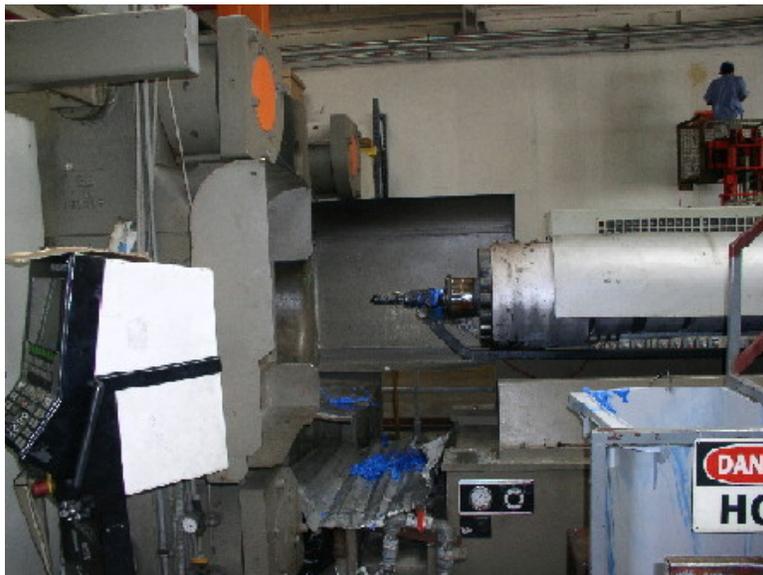
Exhibit #4

Discussion: The machine involved in this incident had a safety interlock device attached to the front side hinged metal shield. This device should have automatically shut off the machine when the victim opened the hinged shield to gain access to the injector. This device was non-operative. Safety devices should be checked daily to assure their working order. A log should also be kept documenting these daily checks. Workers should not be allowed to operate machines that have identified hazards such as disabled or inoperative safety interlock devices. Had this machine been properly maintained or removed from service until maintenance was completed, this incident might have been prevented.

View of the injector with the protective shield open.

Recommendation #2: Ensure all machine safety interlock devices are in working condition.

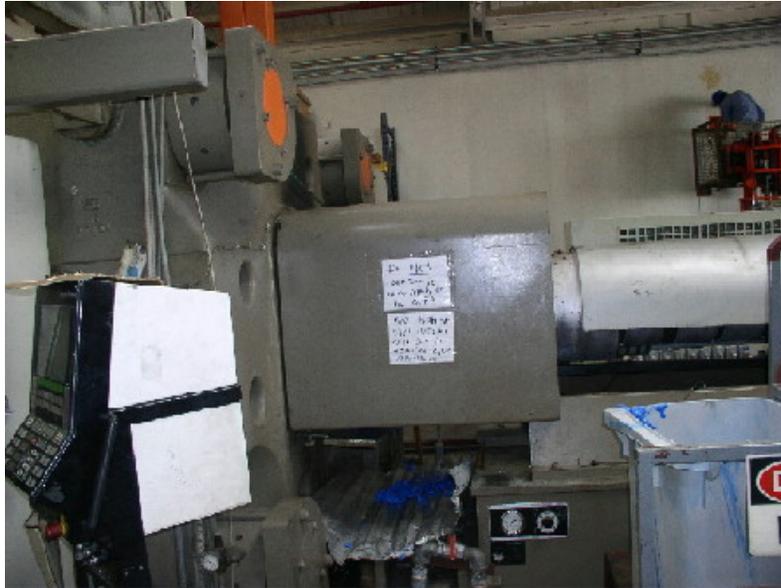
Exhibit #5

View of the injector mold with protective shield in place.

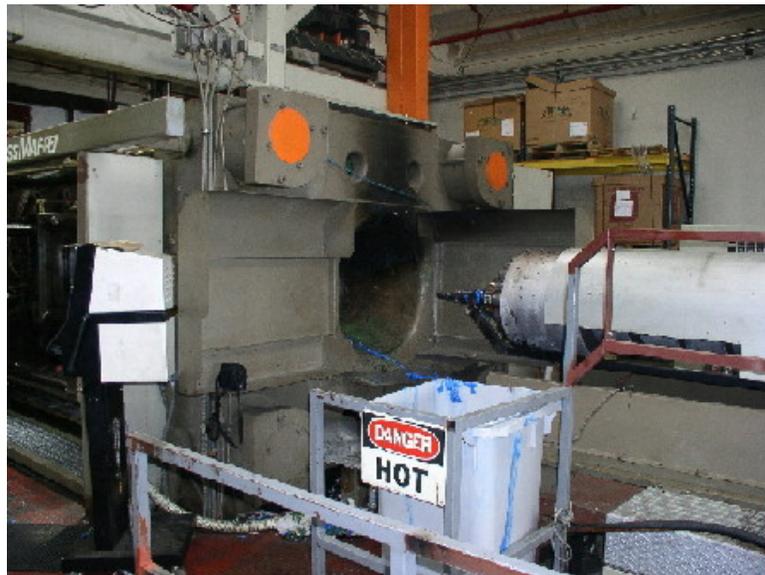
Exhibit #6

View of the injector mold that injects the heated plastic into the mold.

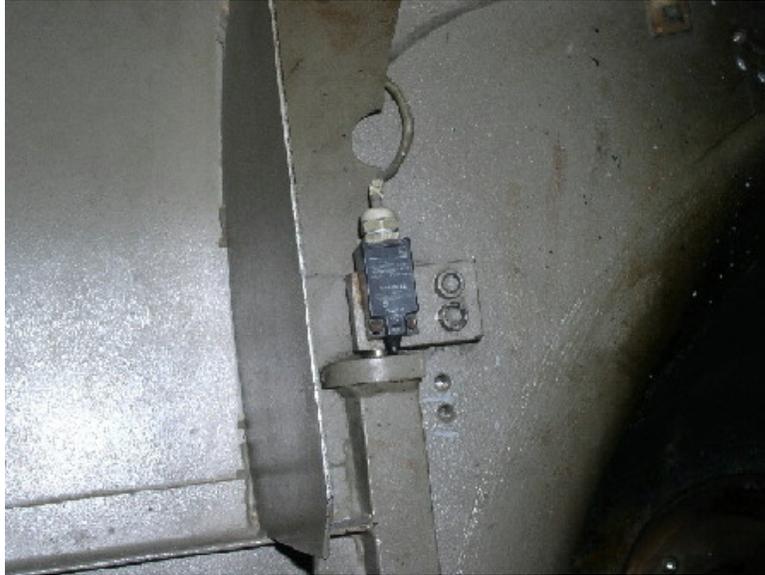
Exhibit #7

View of the safety switch that cuts the power to the machine when the door is open.

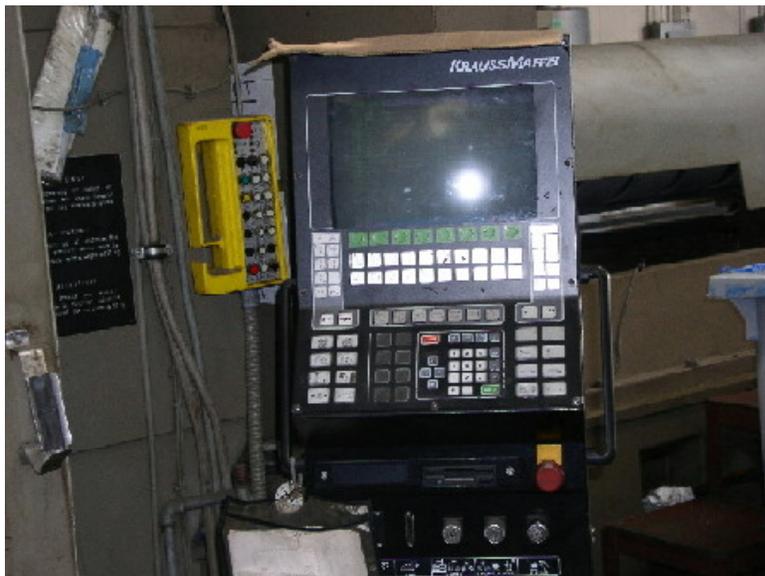
Exhibit #8

View of the control panel for the machine.
