SUBJECT: A machine operator died when crushed in a plastic injection molding machine.

California FACE Report #03CA006

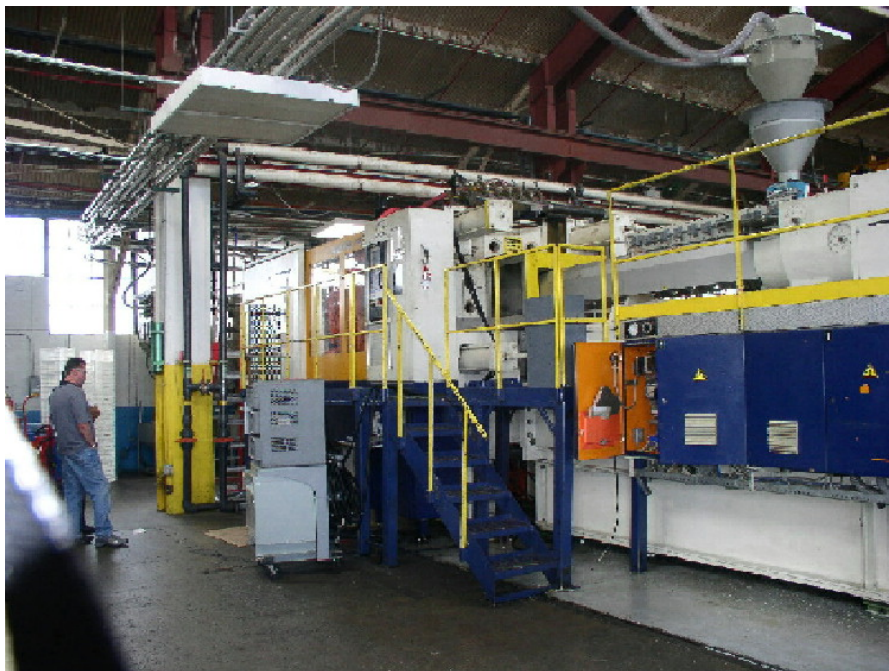
Exhibit #1

View of the front side of the plastic injector mold involved in this incident.

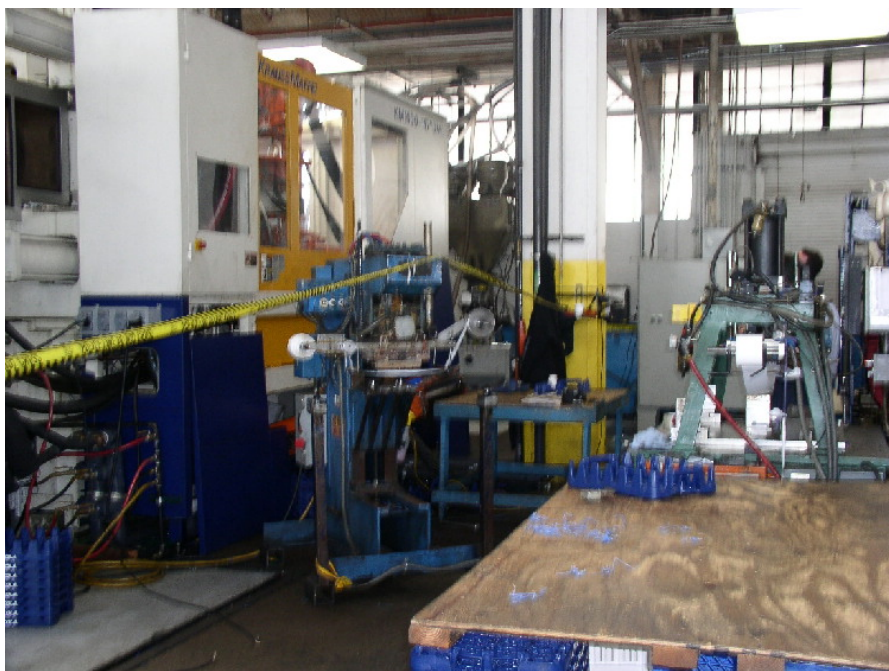
Exhibit #2

View of the back side of the plastic injector mold involved in this incident.

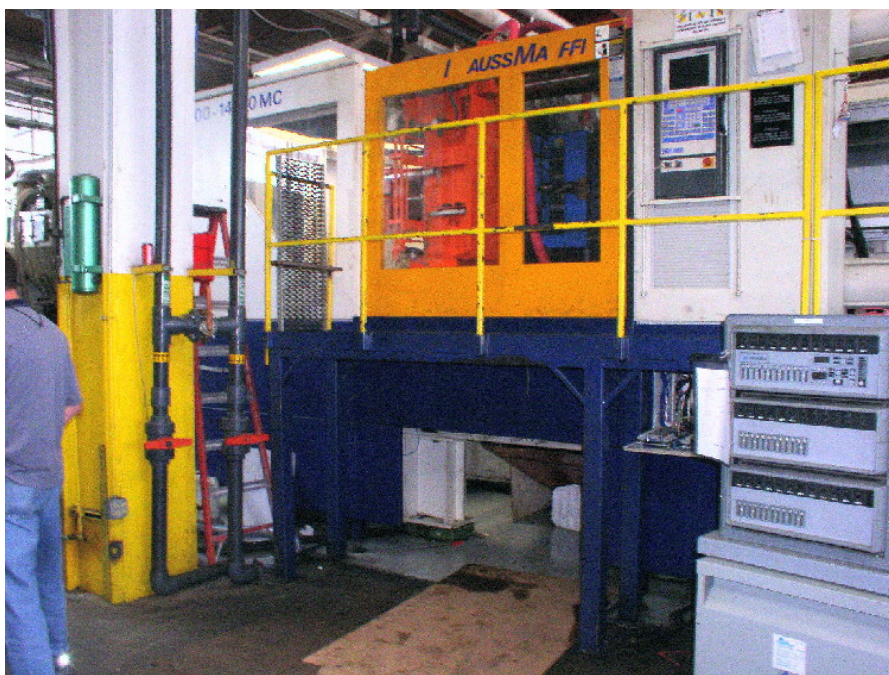
03CA006
Exhibit #3

View of the location where the victim entered inside the injector mold.

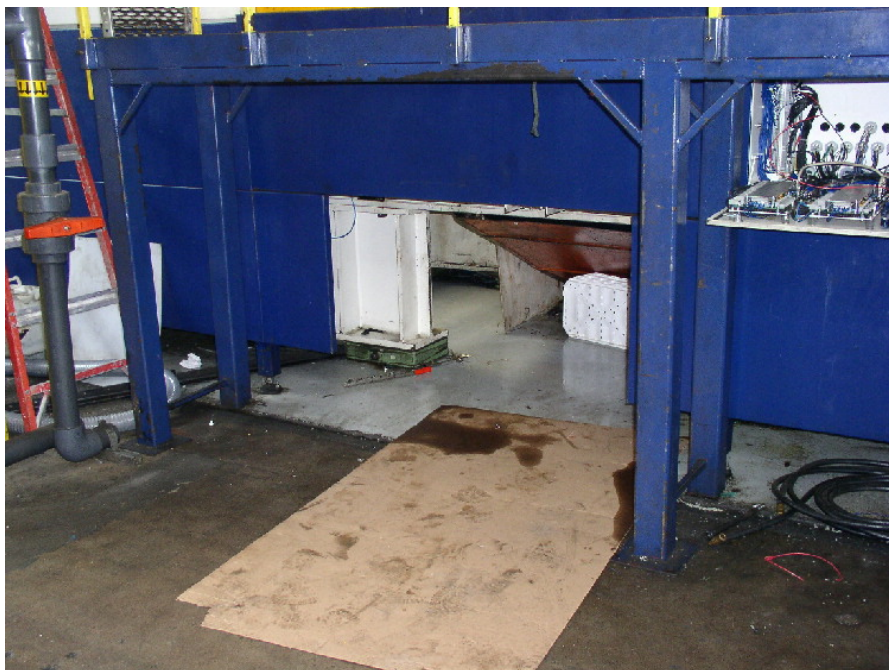
03CA006
Exhibit #4

Investigation of the incident site revealed the victim's tools lying next to the opening in the pedestal where the conveyor belt was located, and several pieces of the machine product laying scattered about the conveyor belt. The guard or shield on the side of the conveyor belt was unbolted on one side. These factors suggest that the victim crawled into the machine from the opening of the conveyor belt not being used. Once inside, he may have attempted to adjust the shield or guard to prevent the product from bouncing off the conveyor belt. Because the area he was in was extremely restrictive (approximately 51" long, 48" wide, and 58" high), he may have tried to stand up when the machine cycled, not realizing that the mobile portion of the mold would cycle backward again. When the machine cycled back, the victim may have been unable to move out of the way and his head got caught between the frame of the pedestal and the frame of the mold.

View of the area where the victim removed the conveyor belt to gain access to inside the injector mold.

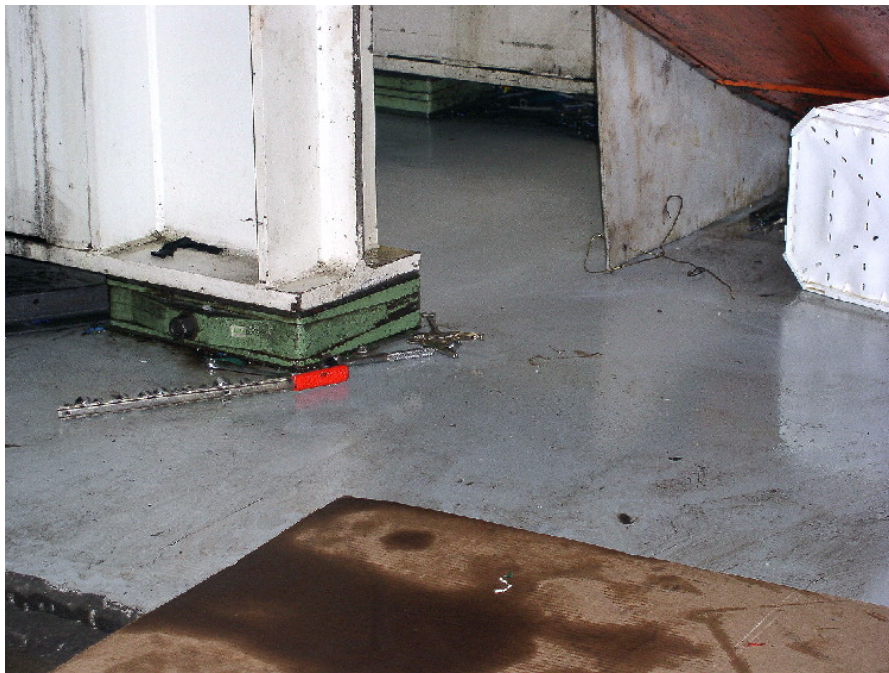
Exhibit #5

This is a picture of the victim's tools at the point of entry.

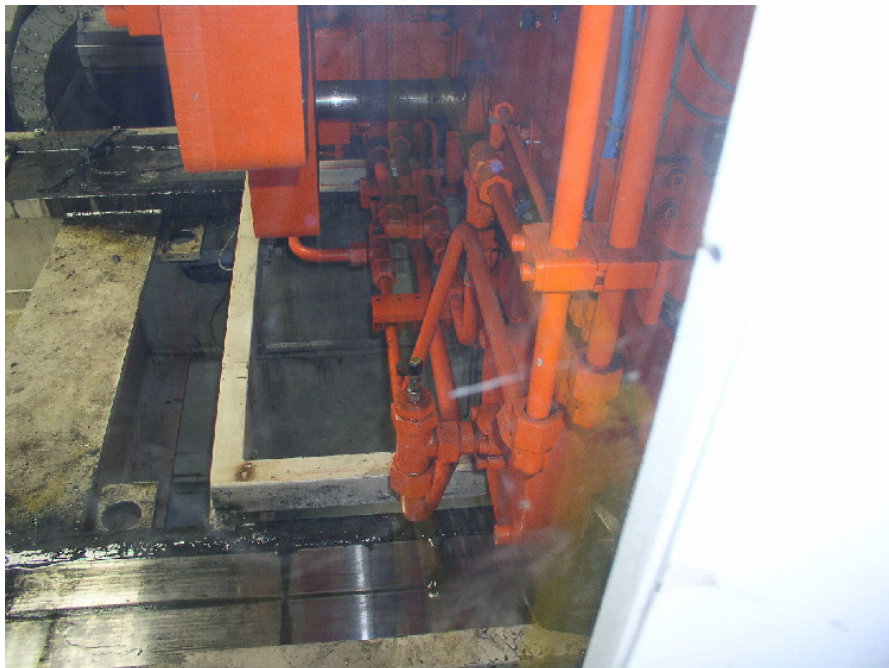
Exhibit #6

View of the area where the victim was caught looking from the top down.

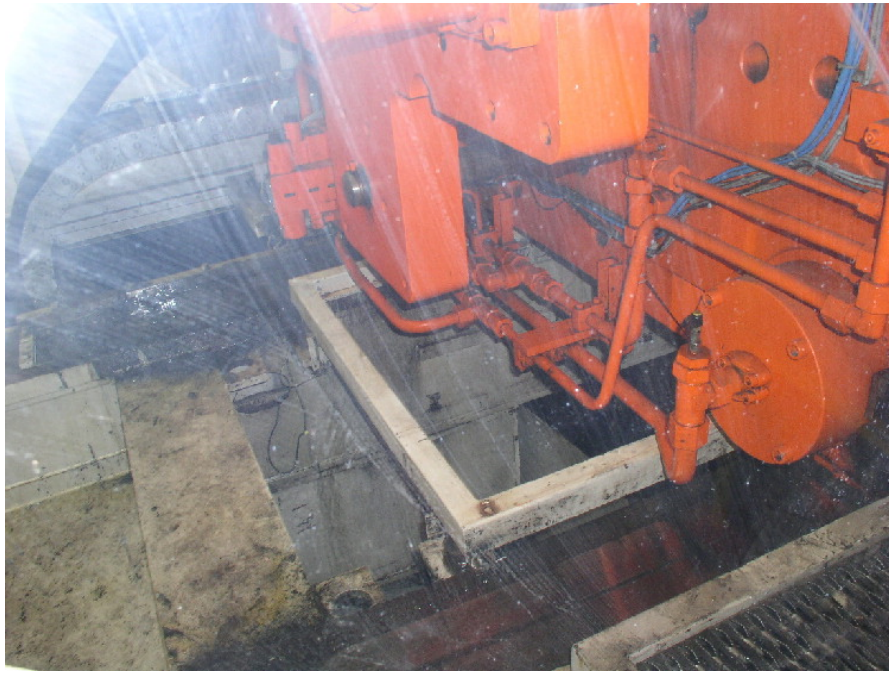
Exhibit #7

Another view of the area where the victim was caught looking from the top.

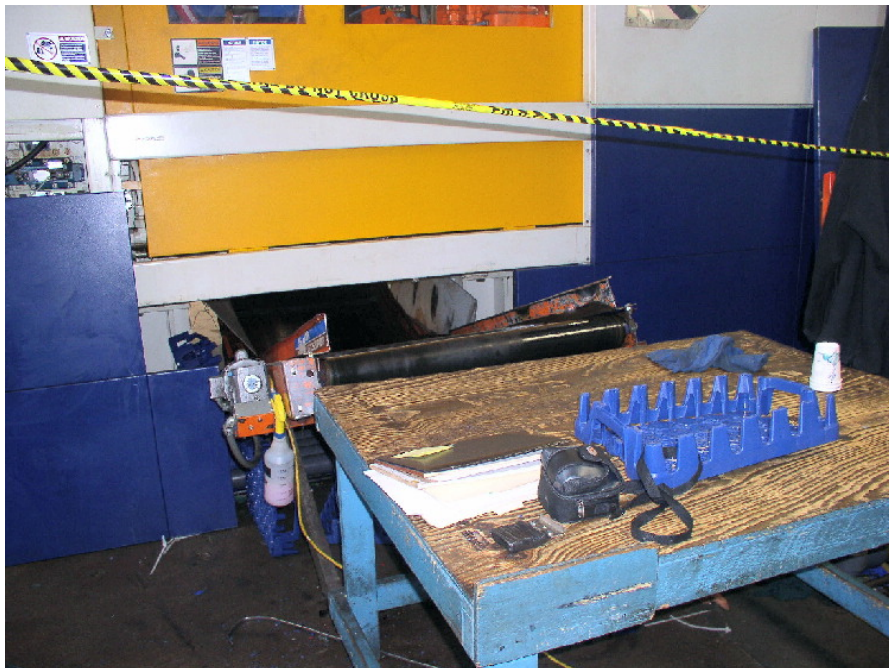
Exhibit #8

View of the victim's work area on the back side of the injector mold.

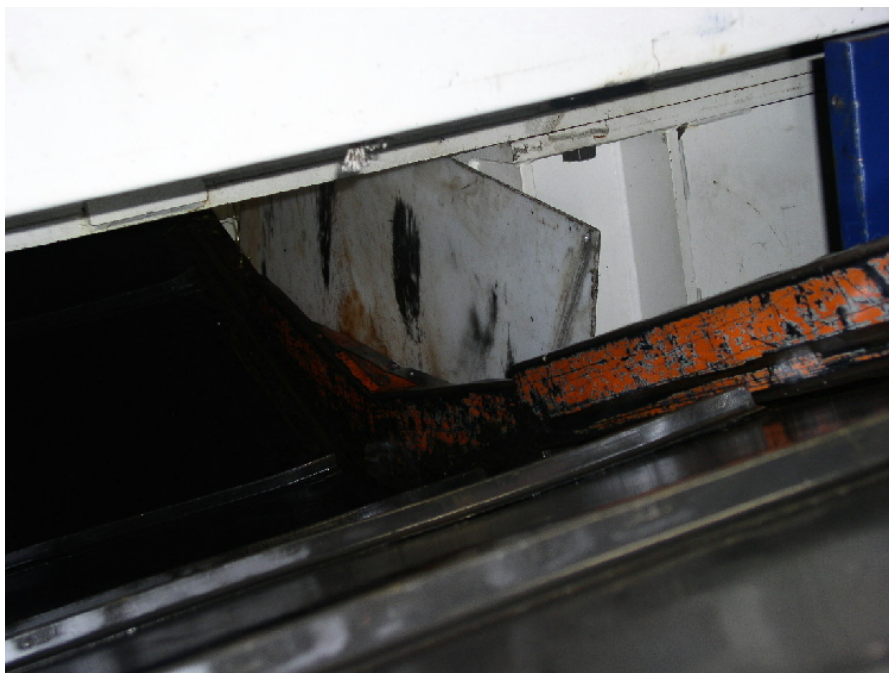
03CA006
Exhibit #9

View of the conveyor belt used to catch and transport freshly molded products.

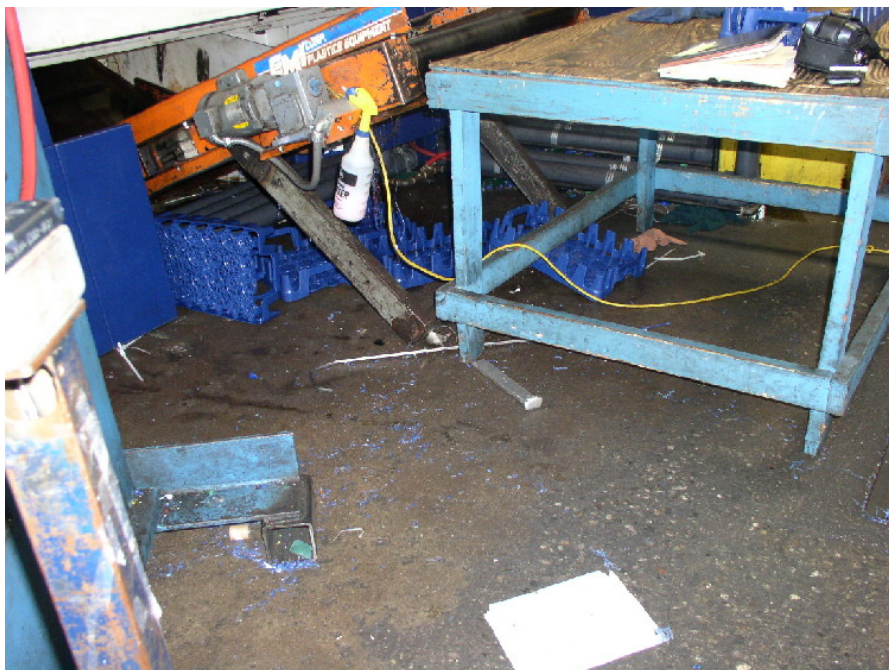
03CA006
Exhibit #10

View of the victim's work station with freshly molded products on floor.

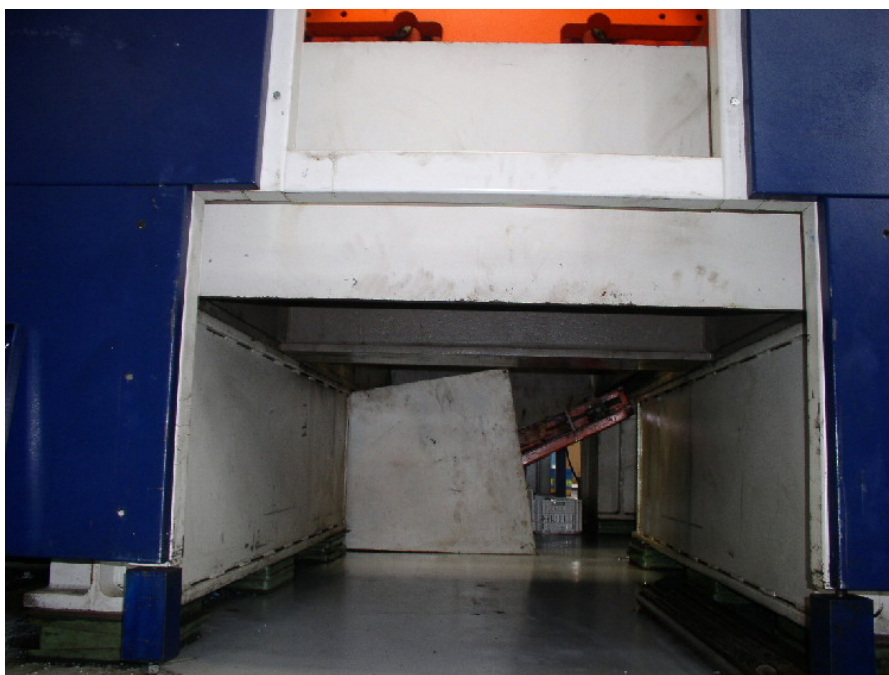
Exhibit #11

View of the left side of the injector mold with a panel removed
to show where the victim was caught.
