SUBJECT: A butcher died after getting his hand caught in a meat grinder.

SUMMARY
California FACE Report #03CA008

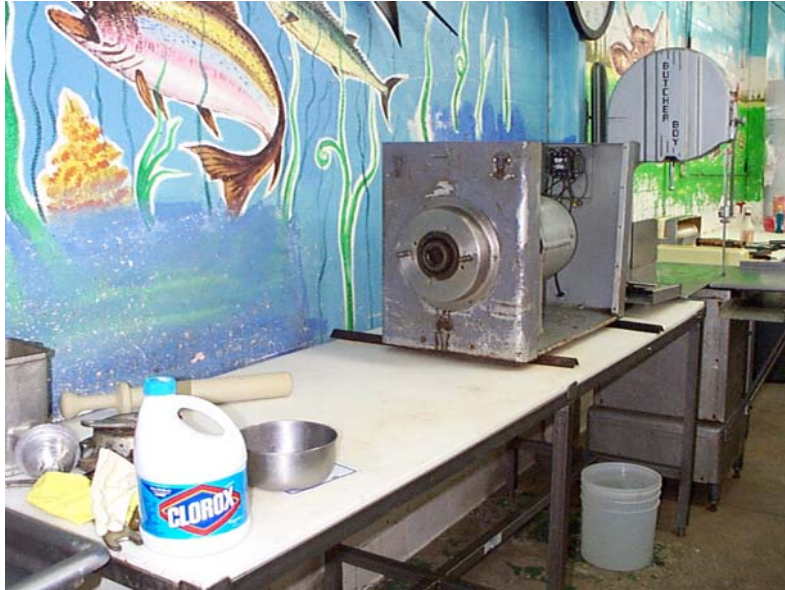
03CA008
Exhibit #1

The site of the incident was a small grocery and meat market that was privately owned. The machine involved in the incident was a screw type meat grinder (**Exhibit #1**). The meat grinder was discarded before this investigation took place. It is not known if the meat grinder had an interlock safety switch that shut off the power when the feed pan was removed, or if the switch was faulty, or if it had been by-passed.

On the day of the incident, the victim was grinding meat for sausages using the market's meat grinder. According to a market employee, the victim had finished grinding the meat and was cleaning the grinder. The victim removed the food tray and put his hand inside the bowl of the meat grinder to remove a piece of meat that was stuck inside. Two employees of the market, who heard the victim scream, responded to his aid and tried to remove the victim's hand from the meat grinder but were unsuccessful. The paramedics were called and had to disassemble the meat grinder and take part of it with the victim as they transported him to the hospital. The victim went immediately into surgery, but died the next day.

A picture of what was left of the meat grinder after the incident. The grinding mechanism was removed by the paramedics and transported to the hospital with the victim.

Recommendation #1: Ensure users of meat grinders disconnect or lockout and tagout the power source before starting the cleaning process.

Discussion: The cleaning of a meat grinder should always include the disconnection from its energy source to prevent any contact with moving parts. An energy control procedure would give specific safety instructions to those using the store's meat grinder on how to properly disconnect the power source before cleaning. This should be part of an employer's Injury and Illness Prevention Program (IIPP). Employers can ensure employees follow safe work practices through programs of training, supervision, rewards, and progressive disciplinary measures. Employers who allow others to use their equipment should develop a contractual agreement between the parties that includes an agreement that safety procedures are to be followed when using equipment, in this case safety procedures for using and cleaning a meat grinder.

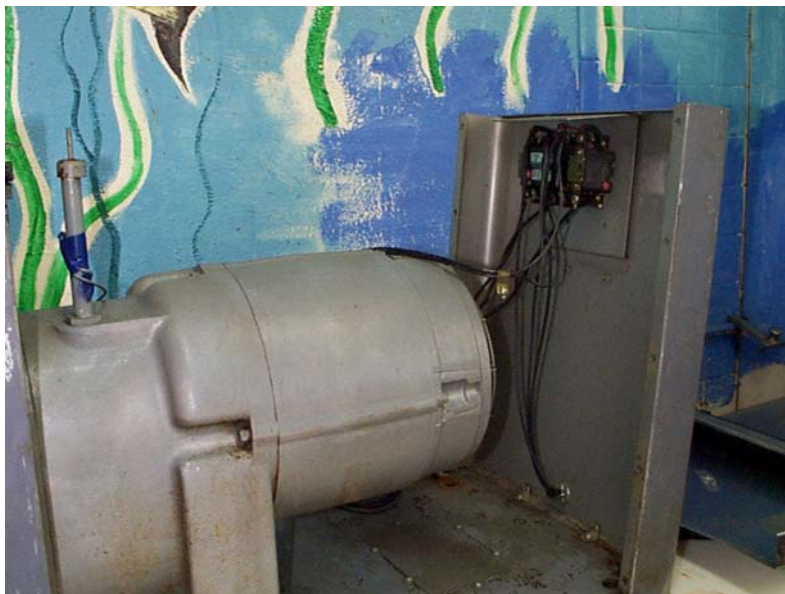
03CA008
Exhibit #2

A picture of the meat grinder's motor that was involved in the incident.
