SUBJECT: An automotive mechanic died when the vehicle he was working under slipped off a lift and fell on him.

SUMMARY
California FACE Report #03CA010

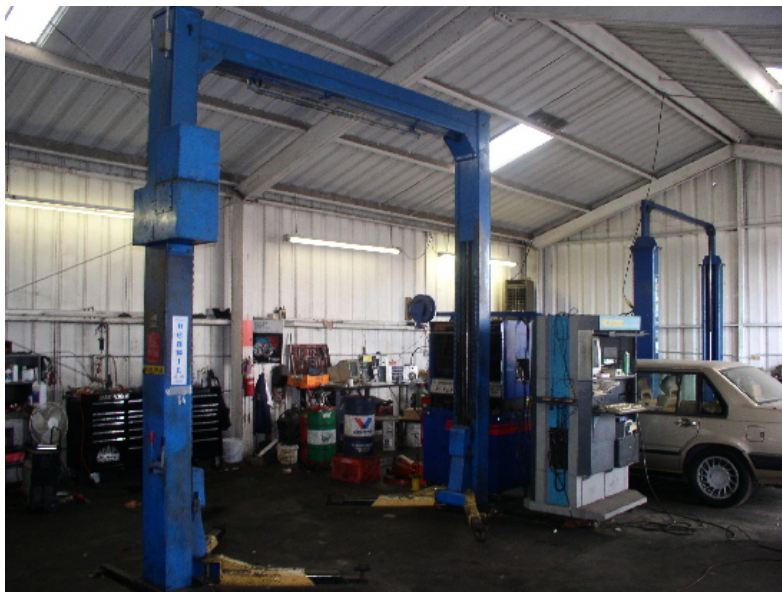
Exhibit #1

The site of the incident was an automotive repair shop which had eight bays and six lifts. The automotive lift involved in this incident was a 2-post, surface-mounted hydraulic lift with a capacity of 7,000 pounds that was manufactured around 1964 (**Exhibits #1, 2, & 3**). The vehicle involved in this incident weighed less than 7,000 pounds. The lifting arms on the lift were the outrigger type that were adjustable to accommodate the vehicle being lifted. The lifts were installed in the shop by the previous owner. The present owner had no manuals or books on the lift involved in this incident.

A picture of the automotive lift involved in this incident.

Recommendation #2: Ensure the automotive lifts used in the workplace are capable of raising the vehicle safely.

order to lift it equally and safely. If the arms cannot be placed in the proper position, then the vehicle should not be lifted. The lift involved in this incident was manufactured around 1964. When it was designed and manufactured, it could accommodate most vehicles on the road at that time. Today manufacturers engineer and design their vehicles to specifications quite different than 40 years ago. In this incident, the manufacturer of the lift was no longer in business. The employer had no manuals to determine what the manufacturer's recommendations were for operation and maintenance. There may have been additional restrictions in the way this lift should have been used which a manual would contain. Although the weight capacity was within limits, in this particular case, the vehicle was too long for the lift to accommodate. Had the victim used a different lift with a longer reach, this incident might have been prevented.

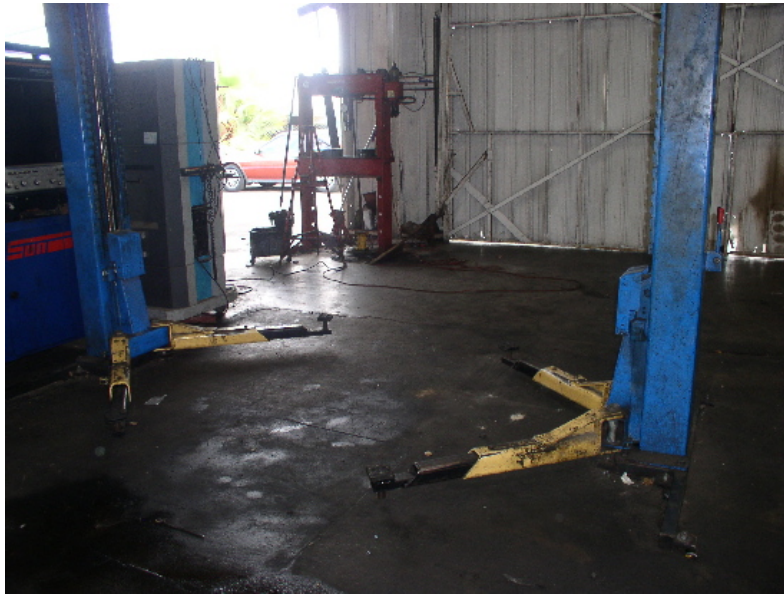
Exhibit #2

On the day of the incident, the victim was assigned to do repairs and maintenance on a crew cab pickup truck. The victim drove the vehicle into the bay and then adjusted the extension arms of the lift to accommodate the vehicle. The rear arms were unable to reach the spot where the vehicle manufacturer suggested they be placed in order to lift the vehicle safely. The victim placed the rear extension arms as far back as they could reach, then raised and lowered the vehicle many times throughout the work day depending on what procedure was being performed. As the victim raised the vehicle on the lift for the last time, the left-rear lift arm moved from its original position and was no longer positioned equally with the other arms to support the weight of the vehicle. The rear of the vehicle fell off the lift, and then the front of the vehicle came down, crushing the victim.

A picture of the automotive bay and lift with the adjustable lift arms.

Discussion: The adjustable arms and pads on most automotive lifts are to accommodate the different designs of the many vehicles that might require lifting. The operator of the lift must set the arm in the specific spot under the vehicle, recommended by the vehicle manufacturer, in

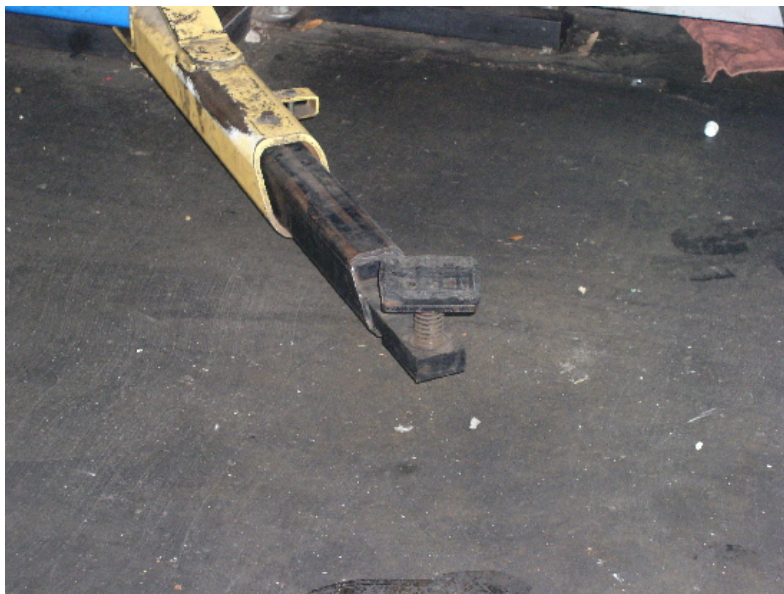
Exhibit #3

A picture of the automotive lift arm with the adjustable pad on the end.
