SUBJECT: A crane oiler dies when crushed between the counterweights and the rotating superstructure of a mobile crane.

SUMMARY
California FACE Report #04CA003

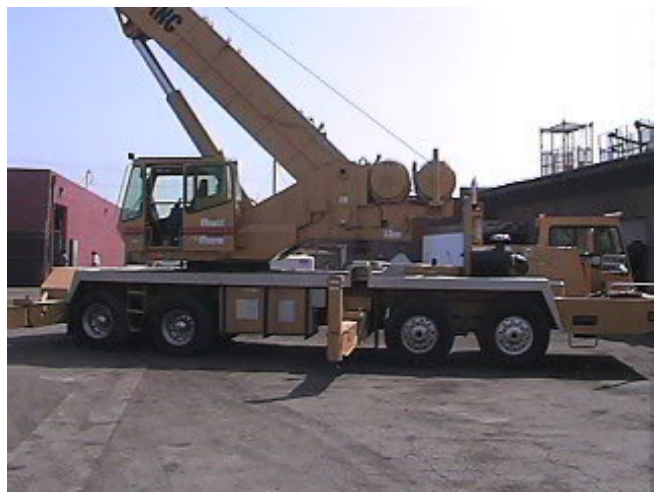
Exhibit 1. The mobile crane involved in the incident.

The site of the incident was a construction site of a commercial business. The machine involved in the incident was a mobile crane (**Exhibit 1**) that was hired to move concrete

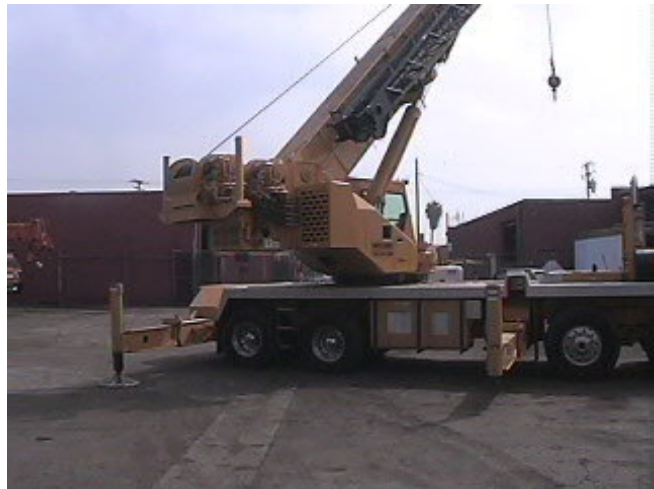
Exhibit 2. The truck-mounted crane rotating into position, depicting the blind spot for the operator.

Recommendation #3: Consider installing mirrors or other devices on the crane's cab to allow the operator to see any action to the rear of the superstructure when rotating.

Discussion: Most truck mounted cranes do not have mirrors on the crane's operating cab because the operator's attention is usually focused on the hook and boom which is always in front of or above the cab and never in the rear. However, when the focus of the operation is not on the hook and boom, then consideration should be given to where the operator's attention is focused. When rotating the crane for counterweight alignment, it might be beneficial to have mirrors or other devices that allow the operator to see the rear of the crane. This would allow the operator to take immediate evasive action when necessary.

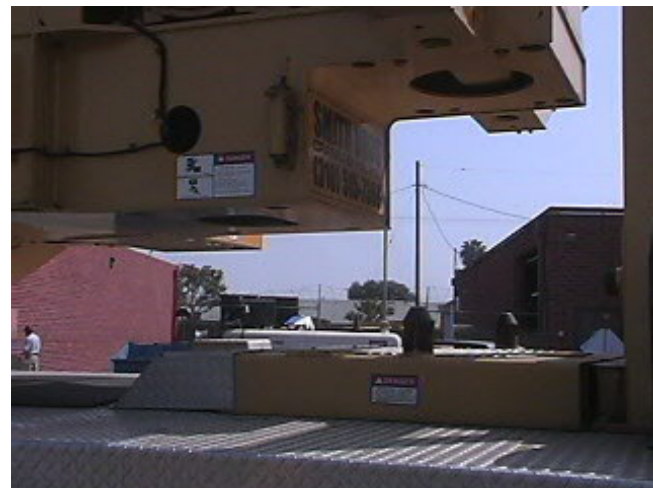
Exhibit 3. The base where counterweights are placed in order to be attached to the crane.

Paramedics were called and they transported the victim to the hospital where he died two days later as a result of his injuries sustained in this incident. Reconstruction of the incident suggested the victim climbed onto the crane to remove a shackle that was left on top of the counterweights. According to the crane operator the shackle would have interfered with the counterweights' connection to the superstructure.

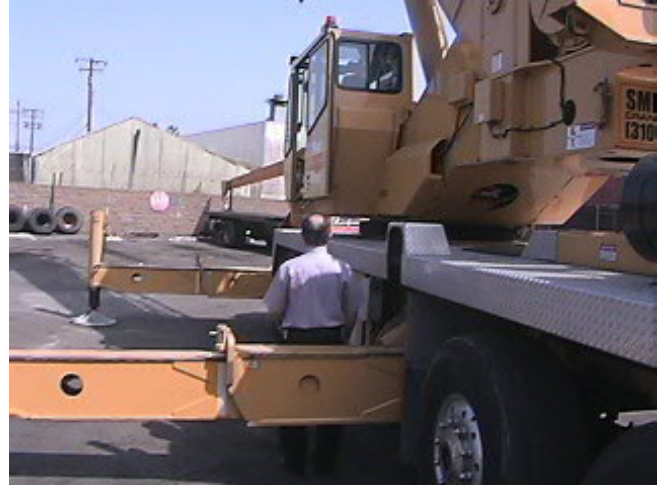
Discussion: The crane operator and victim had worked together for several years, and as a result of their working relationship they developed a habit of rotating the crane while the victim was not clear of the superstructure. As the crane rotates, the operator can not see all the action at the back of the crane because of the blind spots. The crane operator should not start rotating the crane without knowing all personnel are clear of the superstructure either by seeing or some other means. Employees also have a responsibility to stay clear of the crane while it is rotating. Safe work practices can be enhanced through programs of task-specific training, supervision, rewards, and progressive disciplinary measures.

Exhibit 4. A simulated picture depicting the victim's position while the crane rotated into position.

Recommendation #1: Ensure all personnel are clear from the counterweight and superstructure area before rotating the crane.

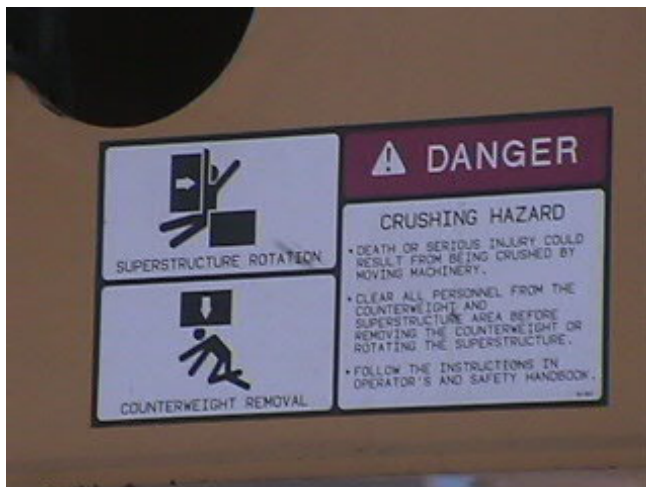
Exhibit 5. A picture of the safety placard on the crane.
