**SUBJECT:** Two heavy equipment mechanics electrocuted while working on a large earth moving piece of construction equipment called a scraper.

#### **California FACE Report #04CA004**

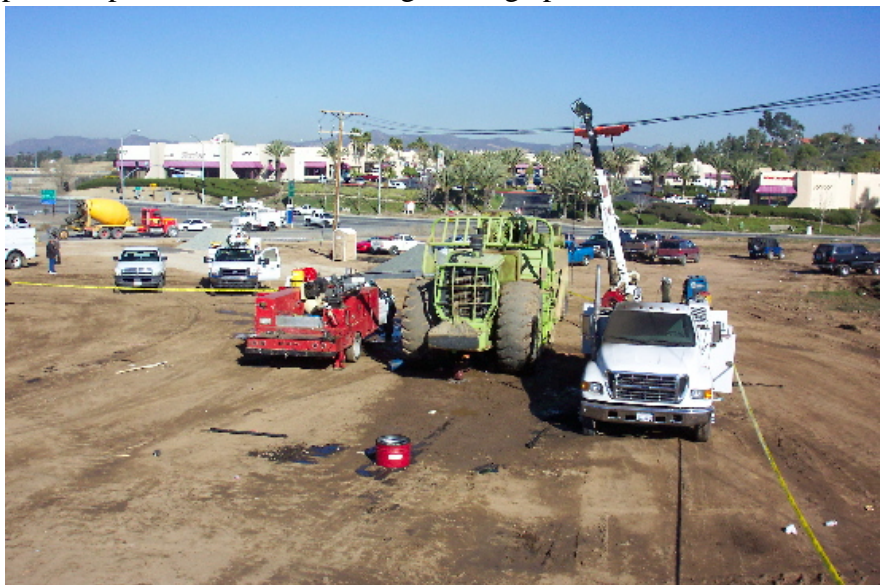
The site of the incident was a 45-acre construction site being graded for commercial development. On the day of the incident the victims were dispatched to the site to perform repairs on a scraper. The scraper was parked underneath a high voltage power line that

contained 12,000 volts of electricity (12 kv) and ran directly through the construction site. The victims arrived at the incident site and parked their trucks approximately four feet away on opposite sides of the scraper. The victims disconnected and removed the rear differential from the scraper using the truck-mounted crane on one of the trucks to lift it out of the scraper. The controls for the truck crane were portable and connected to the truck by an

Exhibit 1. A view of the construction site and equipment involved in this incident.

Discussion: Employers should conduct initial jobsite surveys to identify potential worker hazards. Once potential hazards have been identified, appropriate control measures can be implemented prior to the start of any work. Control measures in this incident could have included positioning the truck-mounted crane so the crane boom would not come within ten feet of the power line, or posting an observer to ensure the crane operator did not move the boom within ten feet of the power line. Other control measures could have included contacting the power company and having them de-energize the power line, or insulating ("sleeving") the power line phases with line hoses, or moving the scraper from underneath the power line.

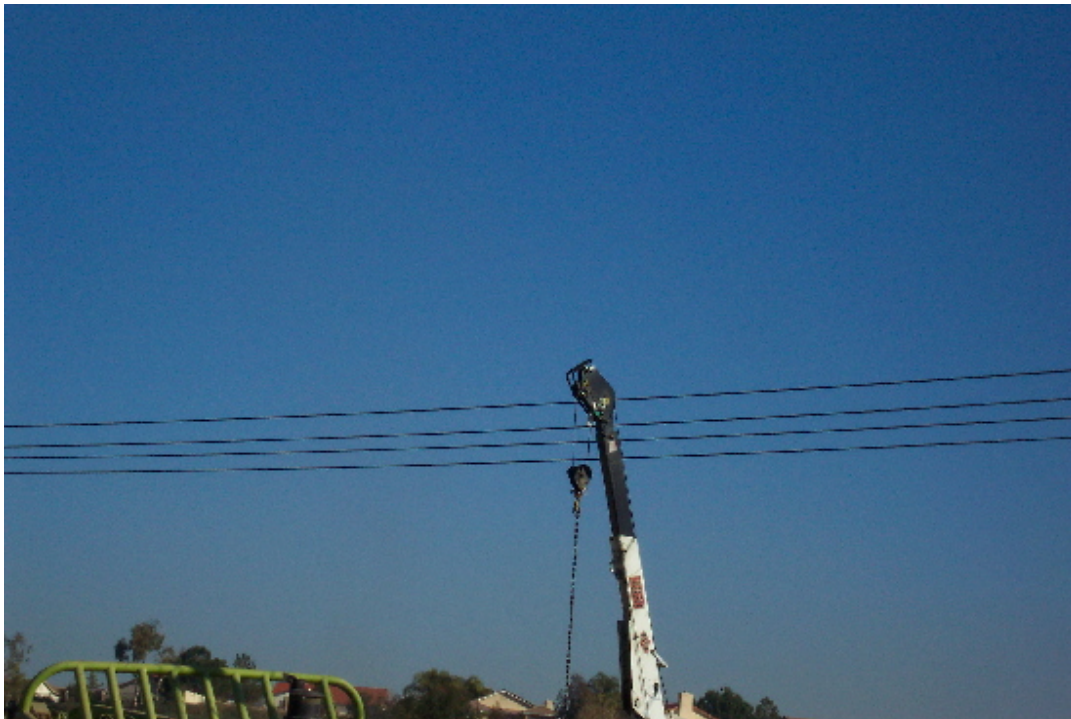
electrical cable. The 18-year-old victim was working the crane controls from inside the scraper apron, and the 40-year-old victim was on the bottom of the scraper where the dirt is first picked up. After installing the new rear differential in the scraper using the crane, the boom was being moved out of the way. It made contact with the overhead electrical line, sending electrical current down the boom, through the truck, into the boom control attached to the truck, and into the 18-year-old victim who was holding the control while inside the scraper apron. The chain attached to the hook of the crane cleared the scraper, so it was not an electrical path. The electrical current went into the scraper and into the 40-year-old victim who was also in contact with the scraper. Both victims were electrocuted and set on fire.

Exhibit 2. A picture of the incident scene with the crane boom still in contact with the high voltage electric lines.

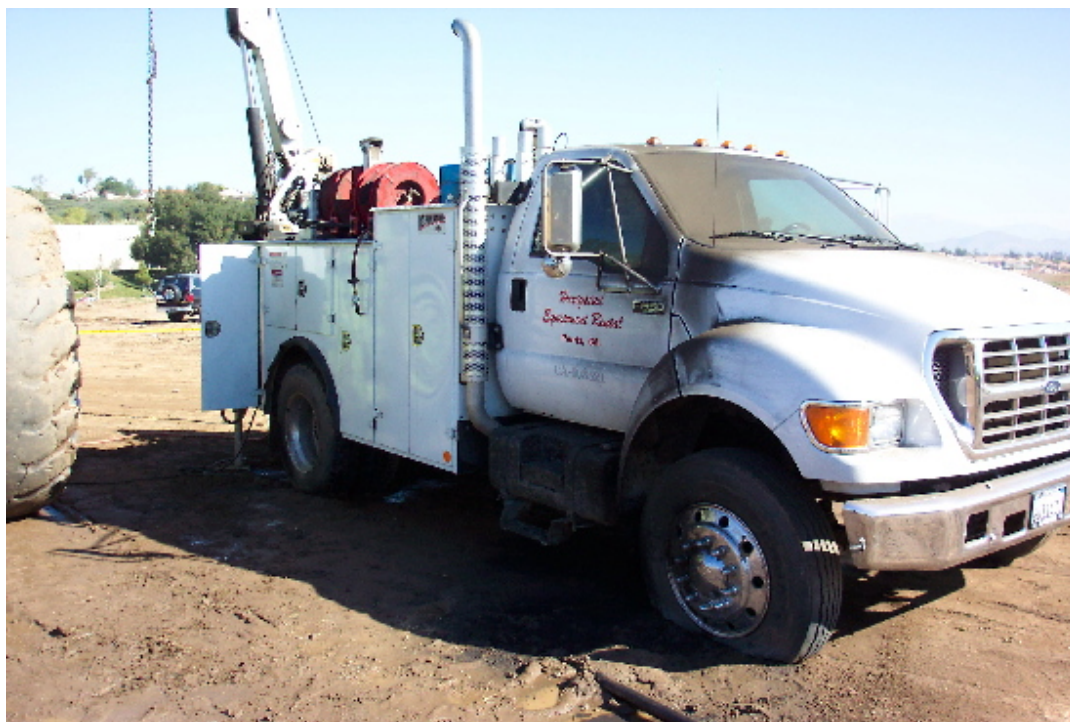
Discussion: The remote control system used on the truck-mounted crane was electrically connected to the crane. This system provided the "path to ground" which resulted in two fatalities. A remote control system which is electrically isolated from the crane would provide protection to a crane operator if contact with an energized overhead power line occurred. Electrical isolation could be accomplished by radio controls, fuse equipped control lines, fiber optic controls, insulated control boxes, etc. Manufacturers of crane systems should evaluate these options and incorporate an electrically isolated remote control system into the design of newly manufactured truck-mounted cranes. Manufacturers and their customers should cooperate in an effort to retrofit existing truck-mounted cranes with these systems, as well.

Exhibit 3. The victims' truck with the boom that made contact with the high voltage lines.
