SUBJECT: A construction laborer died when he was struck by a fast moving vehicle as he crossed the roadway in a street construction work zone

SUMMARY
California FACE Report #04CA008

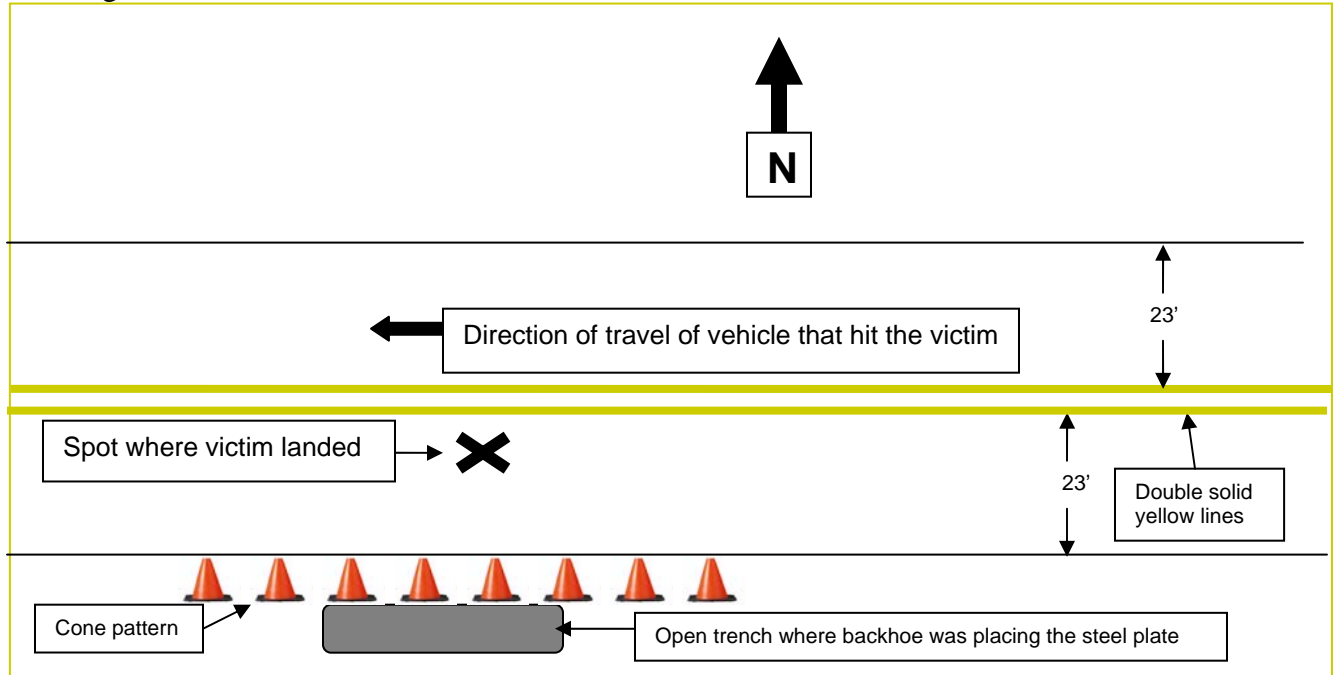
Drawing of Incident Scene

The site of the incident was an asphalt paved avenue that ran in an east-west direction. The company was contracted to replace a water line three feet deep that connected to a main water line. The water main lay on the south side of the avenue, and most of the work was done on the southern shoulder of the eastbound lane. On the day of the incident, sunset was at 5:50 p.m., and the weather was wet with a light rain falling all day. There were two streetlights on the north side of the avenue which were not operating. The avenue had one non-illuminated sign at each end of the work zone stating that there was a construction work zone ahead. It did not warn that traffic may come to a halt. It did not announce a reduced speed for the work zone. The posted speed for the area was 40 mph. There were traffic cones along the southern edge of the eastbound lane. A flag person stood at each end of the work zone to slow traffic, and to stop it when necessary.

The job had taken longer than anticipated and it was dusk by the time the crew began to finish up by placing steel plates over the open trench using a backhoe. The foreman on the job told the victim he was through for the day and that he could go home. The victim began to walk north across the avenue to get to his vehicle. He was entering the westbound lane within the still active work zone when he was struck by a westbound sports utility vehicle (SUV). The victim's co-worker, who was the flag person at the east end of the work zone, saw the SUV coming down the avenue from the east. He stated he waved the stop sign and whistled at the SUV but it did not stop. Another laborer working as a flag person on the west end of the avenue heard the yell and whistle and saw the SUV hit the victim. The backhoe operator, who was bringing a steel plate to the open trench, called 911. The foreman who was also on the west end of the job saw the incident occur and immediately drove his truck into the path of the SUV. He stopped the SUV approximately 200 feet west of the impact area. The police, fire department, and paramedics arrived within minutes and took control of the scene. The victim was transported to a local hospital. He was later transferred to a convalescent hospital where he died as a result of his injuries on August 2, 2004.
