**SUBJECT:** A machine operator died when he was caught between a conveyor belt and tension roller underneath an industrial machine

**SUMMARY**  
**California FACE Report #04CA011**

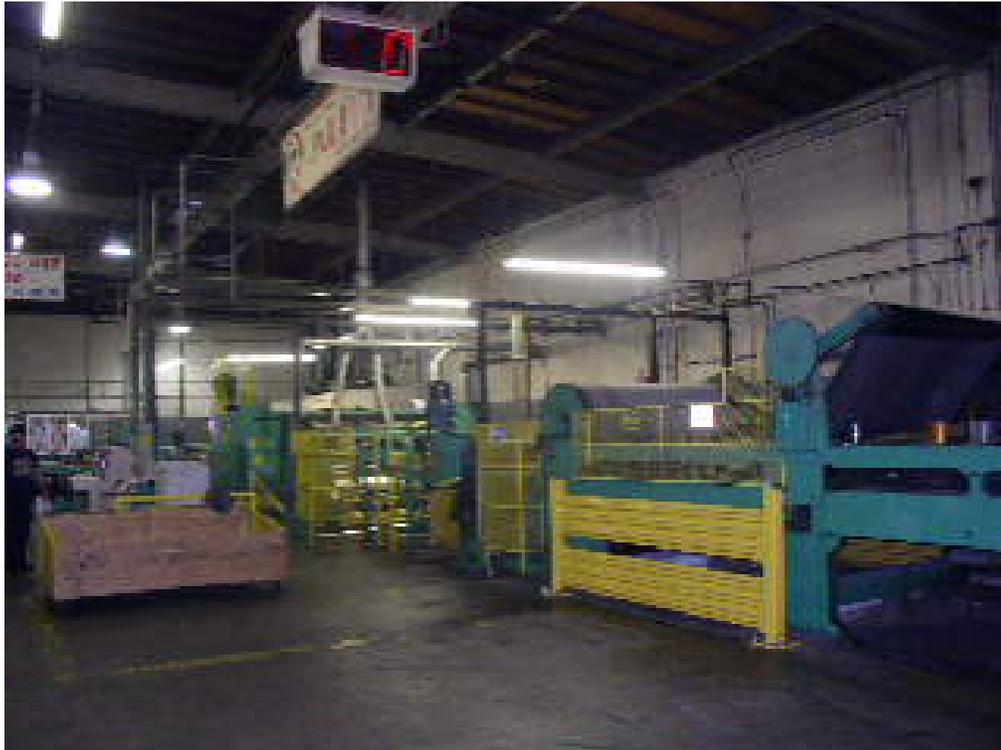
The site of the incident was a manufacturing plant of cardboard sheets and boxes. The machine involved in the incident was an industrial roller assembly used to make corrugated cardboard sheets. The assembly takes sheets of cardboard and, with the application of heat and an adhesive compound, compresses them together making different arrays of regular and specialty cardboard sheets.

**Exhibit 1. The machine involved in the incident.**

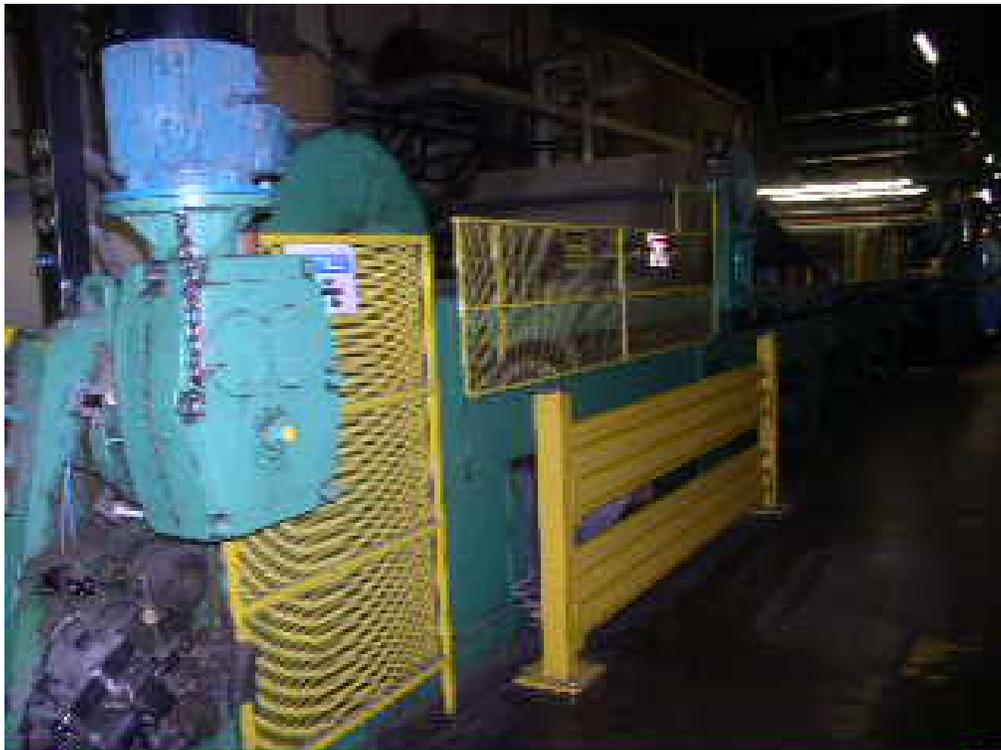
The supervisor immediately shut down the machine and found the victim underneath the machine, stuck between the conveyor belt and the roller. The supervisor and co-worker both stated that they did not see the victim go underneath the machine after he cleared it the first time. The company's lockout/tagout procedure was not being used at the time of the incident. The co-workers removed the victim from underneath the machine as the paramedics were called. The victim was treated at the scene and then transported to the hospital where his treatment continued until he expired later that morning.

Discussion: In this incident the victim was performing service on the conveyor system. During servicing, it is a frequent occurrence for guarding to be removed for access. This is permissible as long as the machine has been de-energized and lockout/tagout is used. When the machinery is to be restarted, the guarding must be replaced. If there had been guarding for this machine, and if it had been replaced after the cardboard had been removed from the conveyor system but before the system was restarted, the victim would not have been able to re-enter the incident site with the conveyor running.

**Exhibit 2. The location where the victim went underneath the machine with guards in place after the incident.**

**Recommendation #3: Ensure all machines are properly guarded to protect employees from moving parts.**
