SUBJECT: Two maintenance mechanics died when a suspended steel dock plate fell on them.

SUMMARY
California FACE Report #04CA013

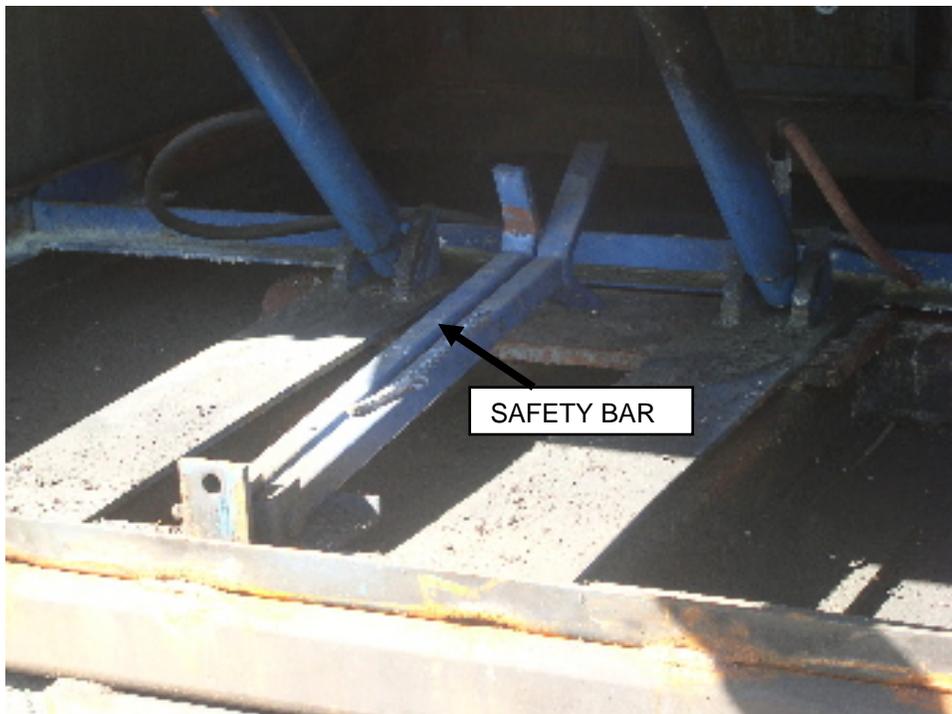
Exhibit 3

The safety bar used to hold the dock plate in the raised position when access is needed underneath.

Discussion: Employees should never place themselves under a suspended load without first securing the load to ensure it will not move or fall. The dock leveler had a safety bar that could have been used to support the dock plate in a raised position. Blocks, chocks, cribbing, and safety bars are all devices used to accomplish this goal. Had the victims used any one of these devices, this incident might have been prevented. Safe work practices can be enhanced through programs of task-specific training, supervision, rewards, and progressive disciplinary measures.

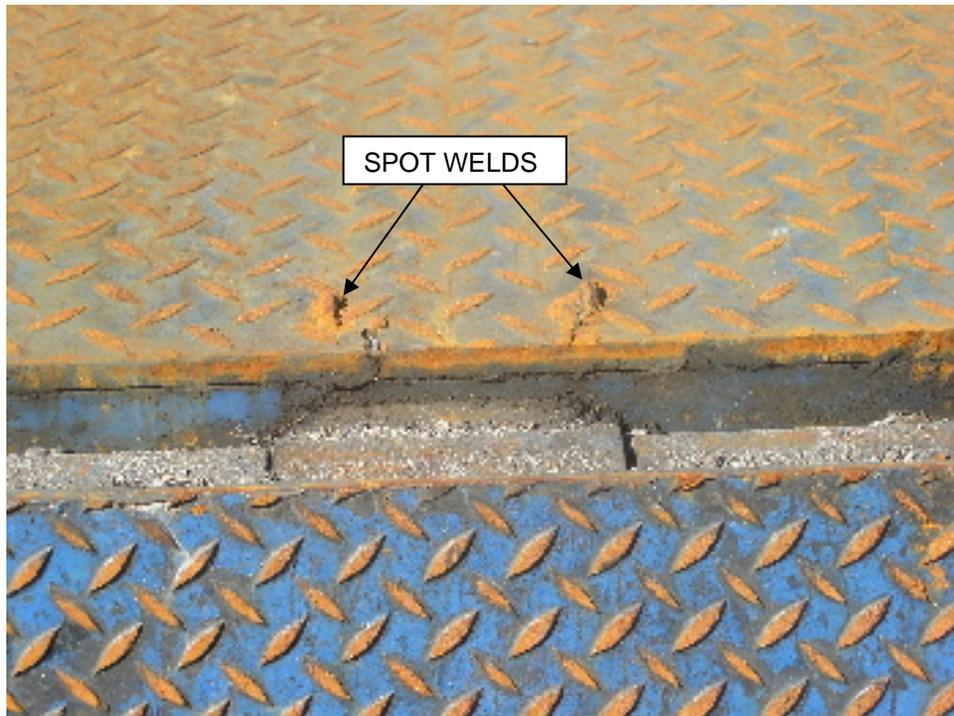
Exhibit 4

While the dock plate remained suspended, the victims moved under the dock plate and started connecting the hydraulic hoses without first engaging the safety bar or blocking the plate in the raised position. The weld that attached the pipe to the top of the dock plate broke and the dock plate fell, striking both victims in the back. One victim was struck but fell away from the dock plate while the other remained trapped underneath. Another employee working in the vicinity heard the loud noise and came over to investigate. The employee used a forklift to raise the dock plate off the trapped victim. The paramedics responded and administered CPR to both victims. One victim was transported to the hospital via ambulance in full cardiac arrest. The other victim was air lifted to the hospital. Both victims died as a result of their injuries.

The spot welds on top of the dock plate where the pipe was welded.
