**FROM:** California Fatality Assessment and Control Evaluation (CA/FACE) Program

**SUBJECT:** A car wash attendant dies when pulled into a side arm rotating brush in a car wash

**SUMMARY**  
**California FACE Report #05CA004**

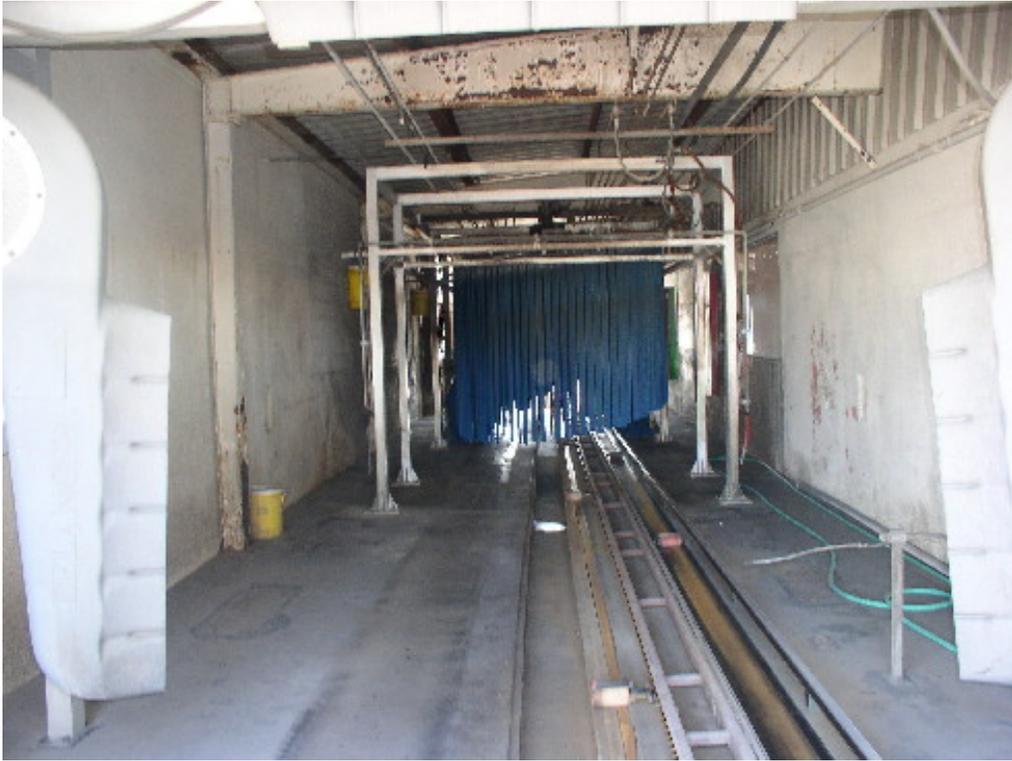
**Exhibit 1** The car wash tunnel looking from the tunnel exit.

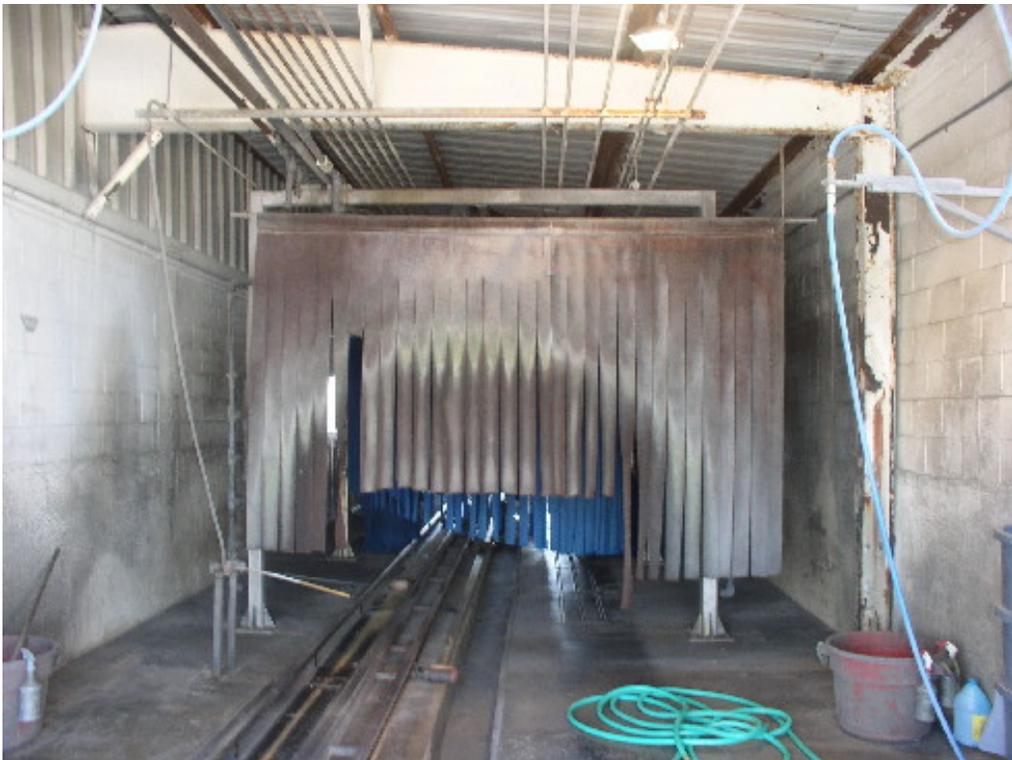
**Exhibit 2** The car wash tunnel looking from the tunnel entrance.

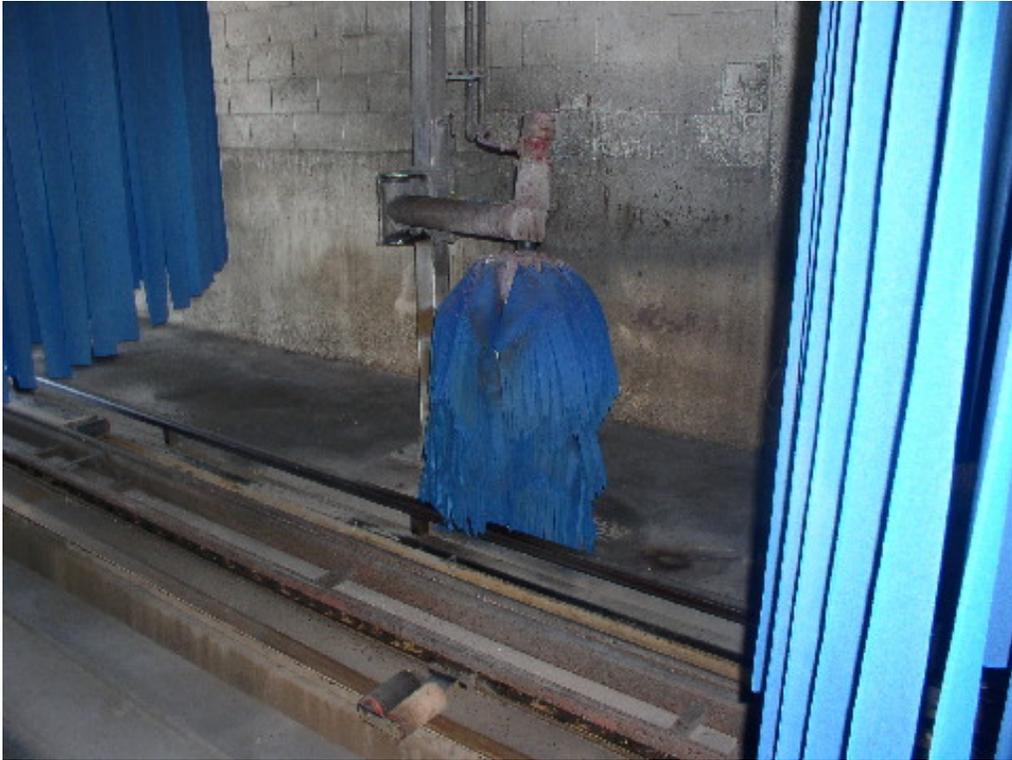
**Exhibit 3** The side arm brush involved in the incident.

**Recommendation #3: Owners of older car washes should consider modifying their systems with updated safety equipment.**

Discussion: The car wash system involved in this incident was approximately 30 years old. Since then, there have been significant improvements in the safety features of car washes. The system involved in this incident was hydraulically operated and was turned on and off by a single wall-mounted switch. Newer systems have safety features such as torque-limited brushes and vehicle-activated pressure plates. When owners of older car wash systems update their safety equipment, they significantly lessen the chances of an incident similar to this one from occurring.

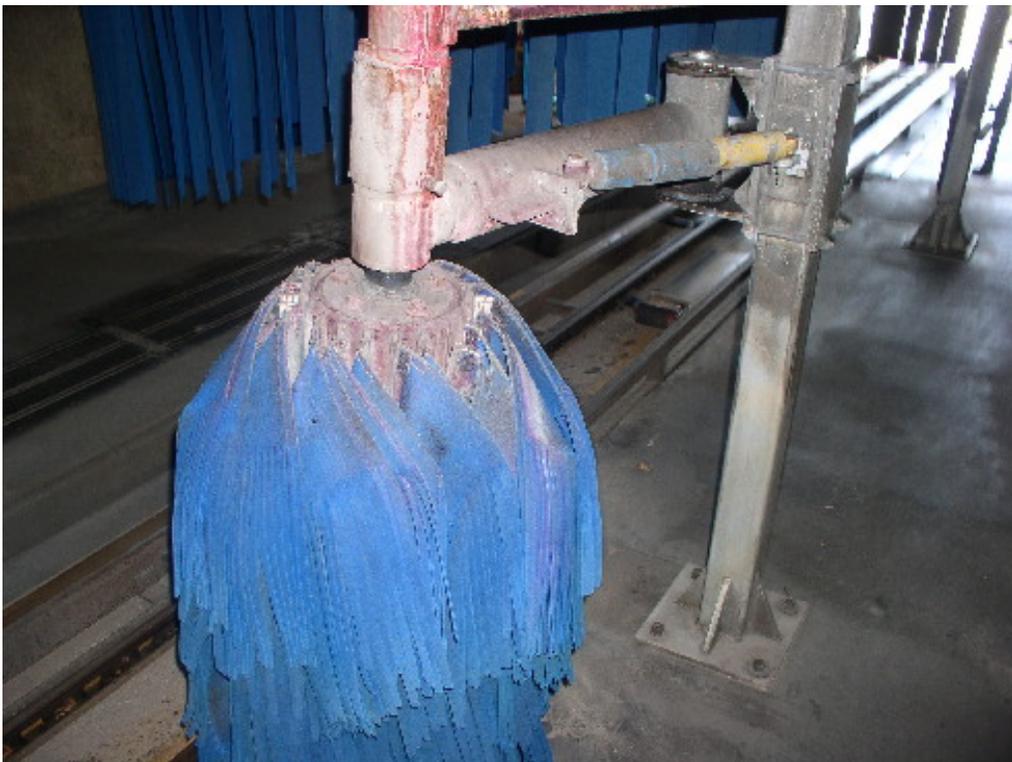
**Exhibit 4** A close-up view of the side arm brush.

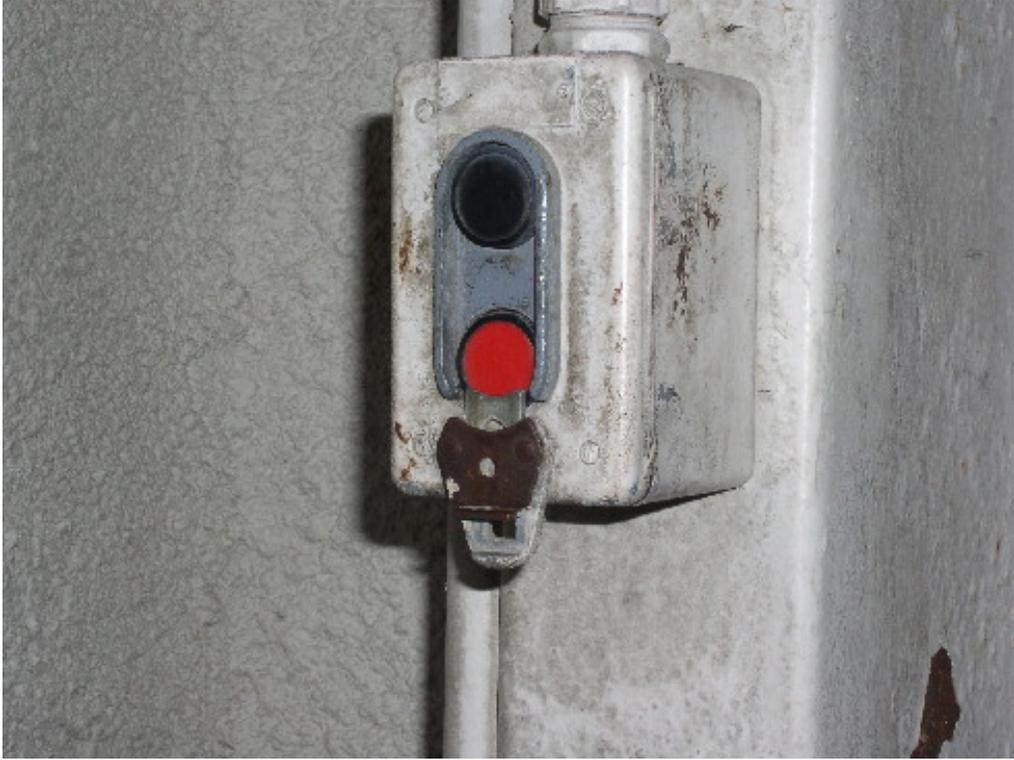
The site of the incident was a drive-through car wash. The car wash had a tunnel that cars and trucks were pulled through by a conveyor on the floor after the vehicle's interior was thoroughly vacuumed and the exterior was pretreated. The conveyor would pull the vehicle through a series of brushes that would wash the vehicle, and then a high volume water rinse was applied. The vehicle would go through a high-pressure air blower that would remove most of the water from its exterior, then be brought to the dry area where it would be towed dry and windows cleaned inside and out. The car wash equipment in the tunnel was turned on and off by a push button mounted on the wall of the entrance and the exit of the tunnel (Exhibits 5 and 6). All the equipment within the tunnel was connected to these switches.

**Exhibit 5** The equipment on/off switch at the exit of the tunnel.

### **Recommendation #2: Develop and implement a lockout/tagout program for the car wash.**

Discussion: The car wash did not have a lockout/tagout program. In this case a lockout/tagout program might have prevented the victim from being in the tunnel while the equipment was running. Lockout/tagout programs should address the following issues:

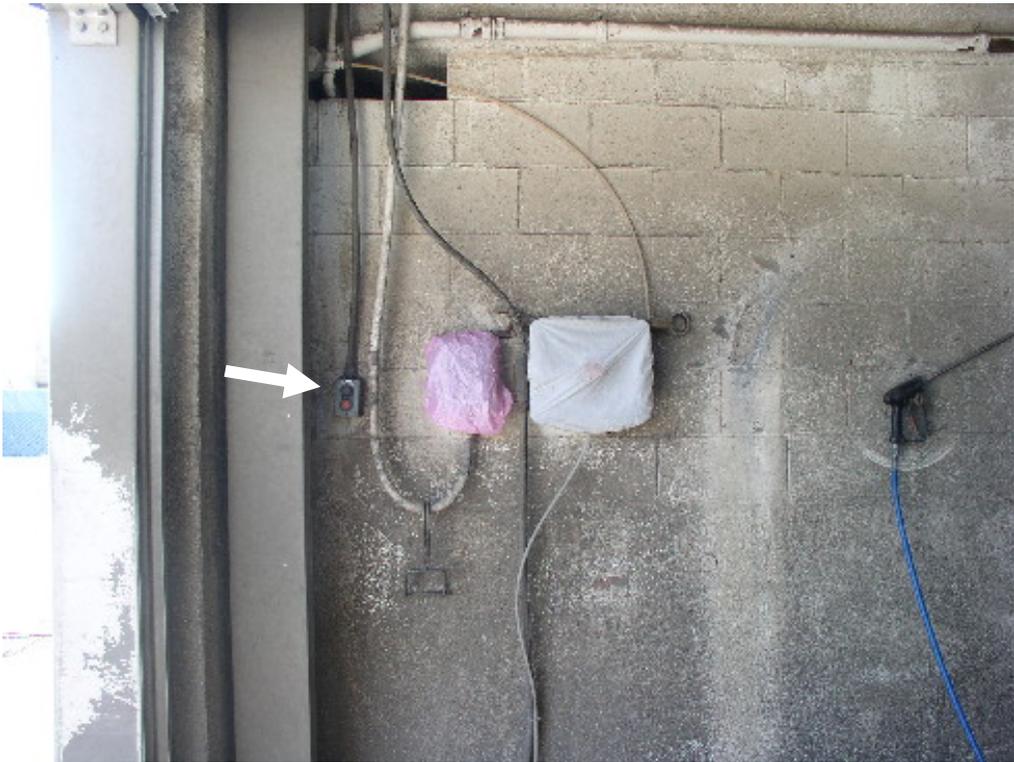
**Exhibit 6** A picture of the control switches at the entrance of the car wash tunnel.
