SUBJECT: An Apprentice Mechanic Died When the Truck Tire He Was Standing Over Exploded

SUMMARY
California FACE Report #05CA007

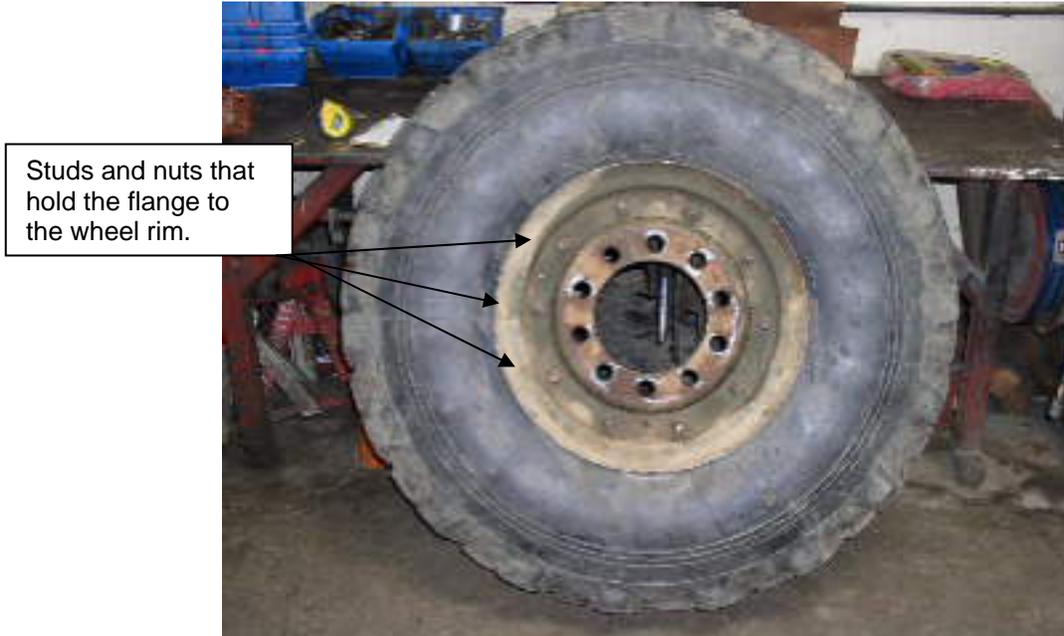
Exhibit 1: A front view of a truck tire mounted on a ten-bolt military wheel similar to the one involved in the incident.

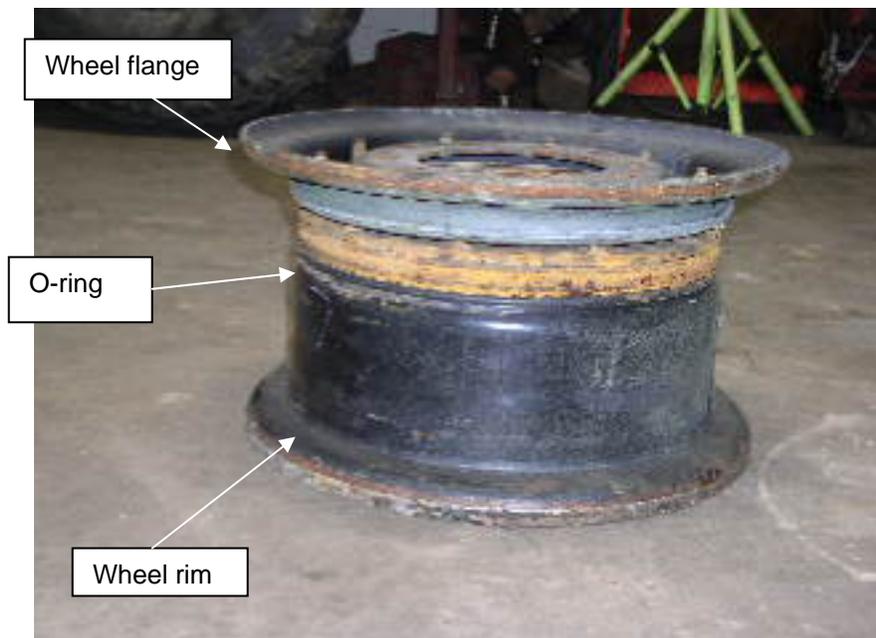
Exhibit 2: A picture of a military wheel showing the rim and flange and O-ring.

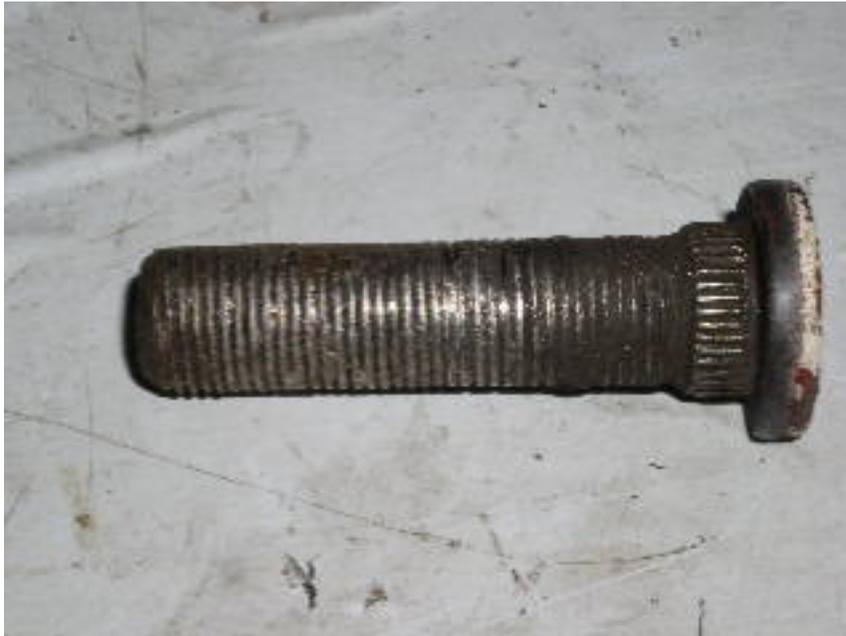
According to the employer of the victim and the lead mechanic, they believe that when the victim checked the air pressure in the tire, he detected an air leak around one of the studs holding the flange and rim together. The sound of the impact gun just before the explosion indicated that he probably was attempting to tighten or loosen one of the flange nuts. Inspection of the wheel studs showed all the threads were shredded off by the bolts when the tire exploded. Further investigation revealed that the wheels and their components were all bought at local auctions. It is not known whether or not the bolts and nuts

The safety factor built into most wheels is such that when one bolt should fail, the remaining bolts should be sufficiently strong to keep the wheel together. In this case that did not happen. Without having the original specifications available to ensure proper fit, there is no way to determine if the stocked bolts and nuts were appropriate for this type of wheel.

Exhibit 3: A picture of a wheel stud involved in the incident showing all the threads flattened by the explosion.

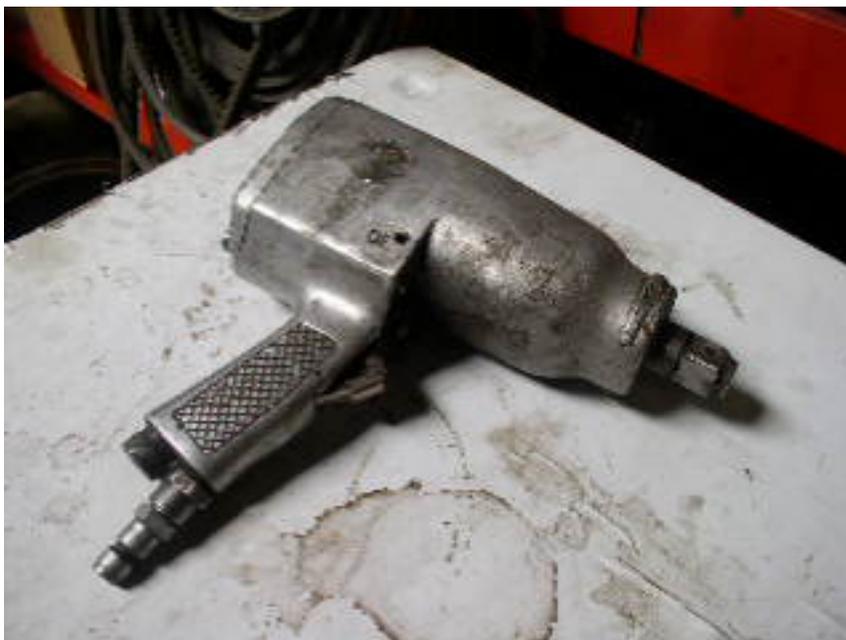
Exhibit 4: A picture of the impact wrench used by the victim.

Recommendation #1: Ensure employees never perform maintenance or repairs on an inflated tire.
