**SUBJECT:** A Hispanic laborer operating an overhead crane died when he was crushed between two steel frames when the rigging failed

**SUMMARY**  
**California FACE Report #06CA001**

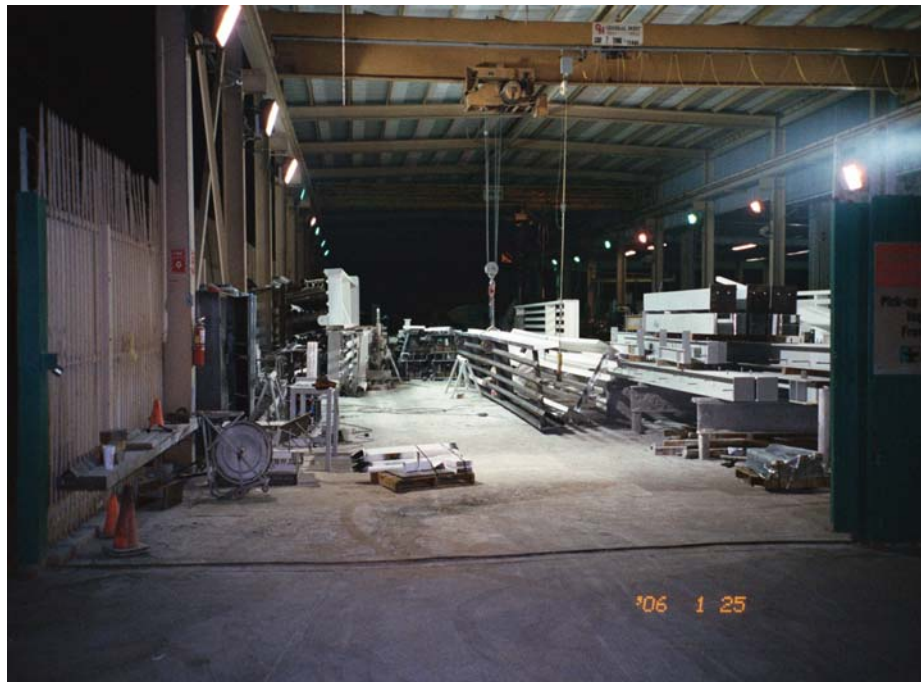
Exhibit 1. A picture of the work area where the incident took place.

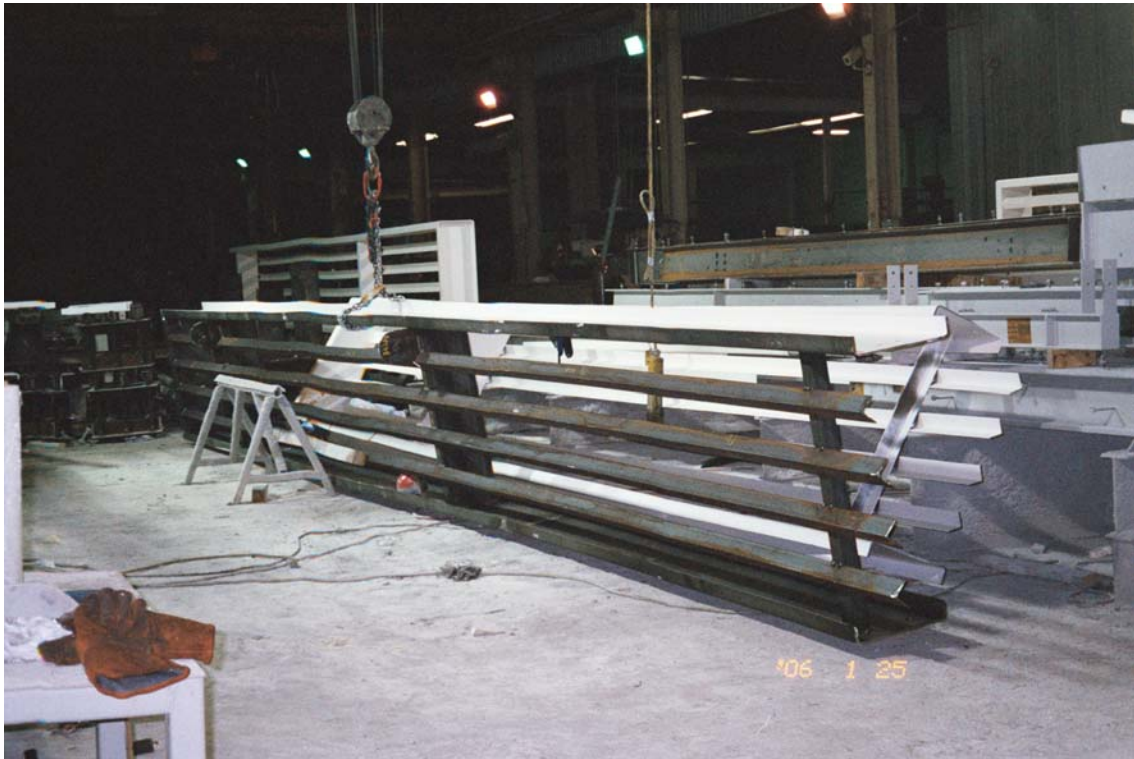
Exhibit 2. A picture of the steel frames that were involved in the incident.

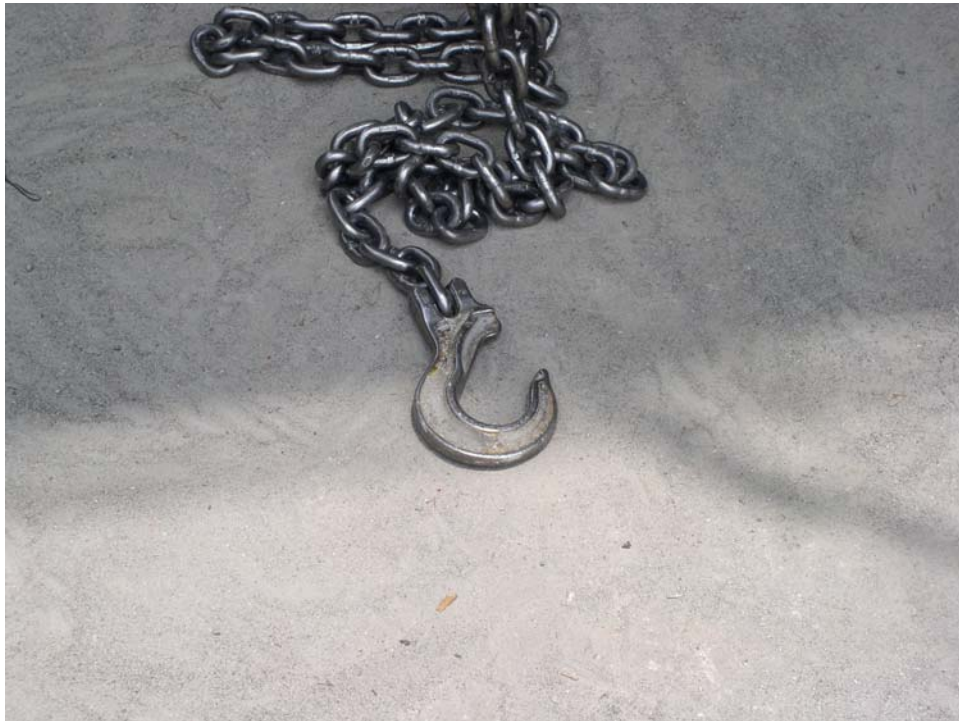
Discussion: The chain sling that the victim was using to move the steel frame was the standard sling he had used on numerous occasions. The safety latch attached to the hook had broken off at some point before the day of the incident, and had not been replaced. The latch was designed to prevent the hook from disengaging from the chain when properly rigged to lift material. Without the safety latch, there was nothing to prevent the hook from becoming disengaged from the chain when the tension was released from the sling. A thorough inspection of alloy steel chain slings performed by a qualified person designated by the employer should have discovered the missing safety latch as well as excessive wear, defective welds, deformation, and increase in link length.

Exhibit 3. A picture of the chain sling that was used to lift the steel frame from a horizontal position to a vertical position.

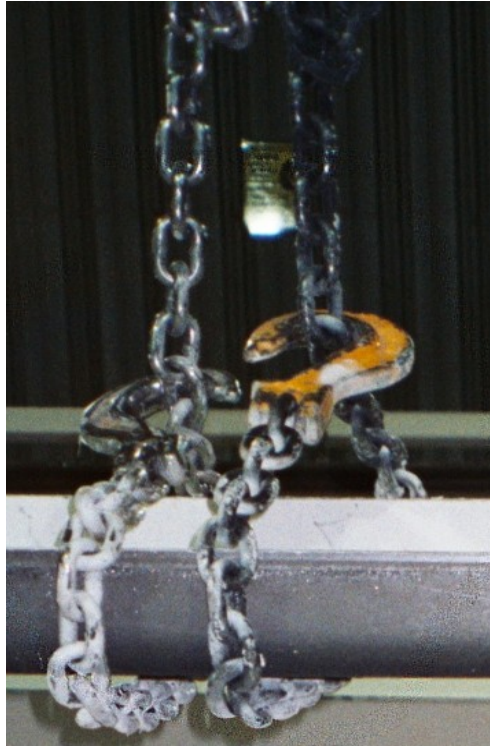
This released the tension on the chain because the steel frame remained on edge instead of lowering onto its side. Without any tension on the chain sling and no safety latch on the chain sling hook, the single choker hitch came undone. The wood beams, not strong enough to hold the full weight of the vertical steel frame, broke and the steel frame dropped to the ground. It fell forward toward the victim, crushing him between the two vertical pieces of steel. No one witnessed the incident. Two employees working in the same area heard the crash when the steel frame fell and called for help. They re-attached the chain sling to the steel frame and lifted it off the victim. Other employees dragged him from underneath the steel frame. The paramedics arrived at the incident scene and pronounced the victim dead.

Exhibit 4. A picture of a chain sling in a choker hitch position that was used to pick up the steel frame.

Discussion: In some workplaces, cranes are used to lift loads that never change in shape, size, or weight. In these types of work situations, a standard operating procedure can be developed that completely describes the actions and rigging that must be performed to safely accomplish any lift. Since the type of rigging and the actions surrounding the lift do not change from lift to lift, any worker performing the lift does not need specialized rigging knowledge. They can be trained to safely perform the lift through training in the standard operating procedure. In other workplaces, like the one in this incident, there is no standard load. Since the pieces being constructed are custom-made for each job, this implies that each lift will be different from the next. Properly rigging loads that vary in size, shape, and/or weight requires the specialized knowledge of workers who are certified riggers. If a workplace does not have workers who are certified in rigging, they can ensure that best practices are followed by implementing a training/testing program to assist their workers attain a rigging skill level equivalent to certification.

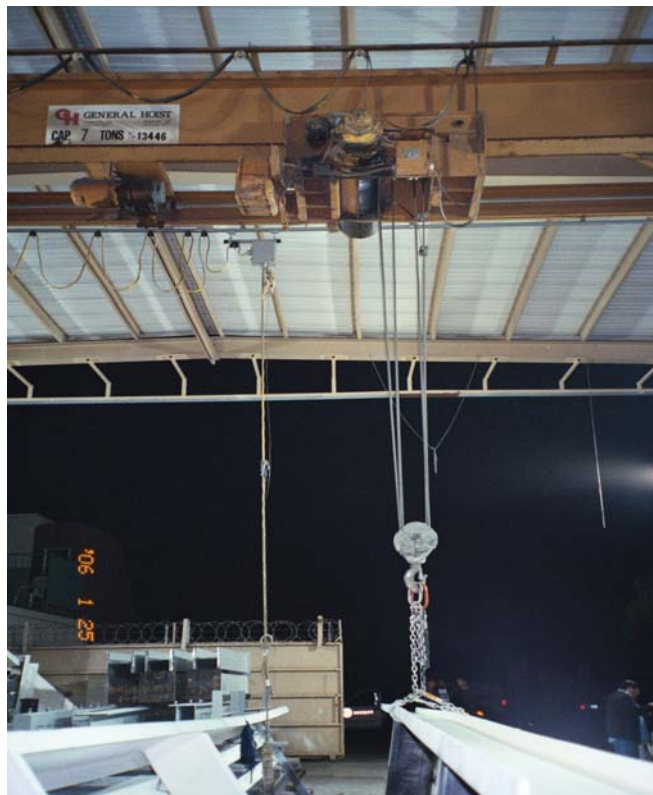
Exhibit 5. A picture of the overhead crane and controls involved the incident.

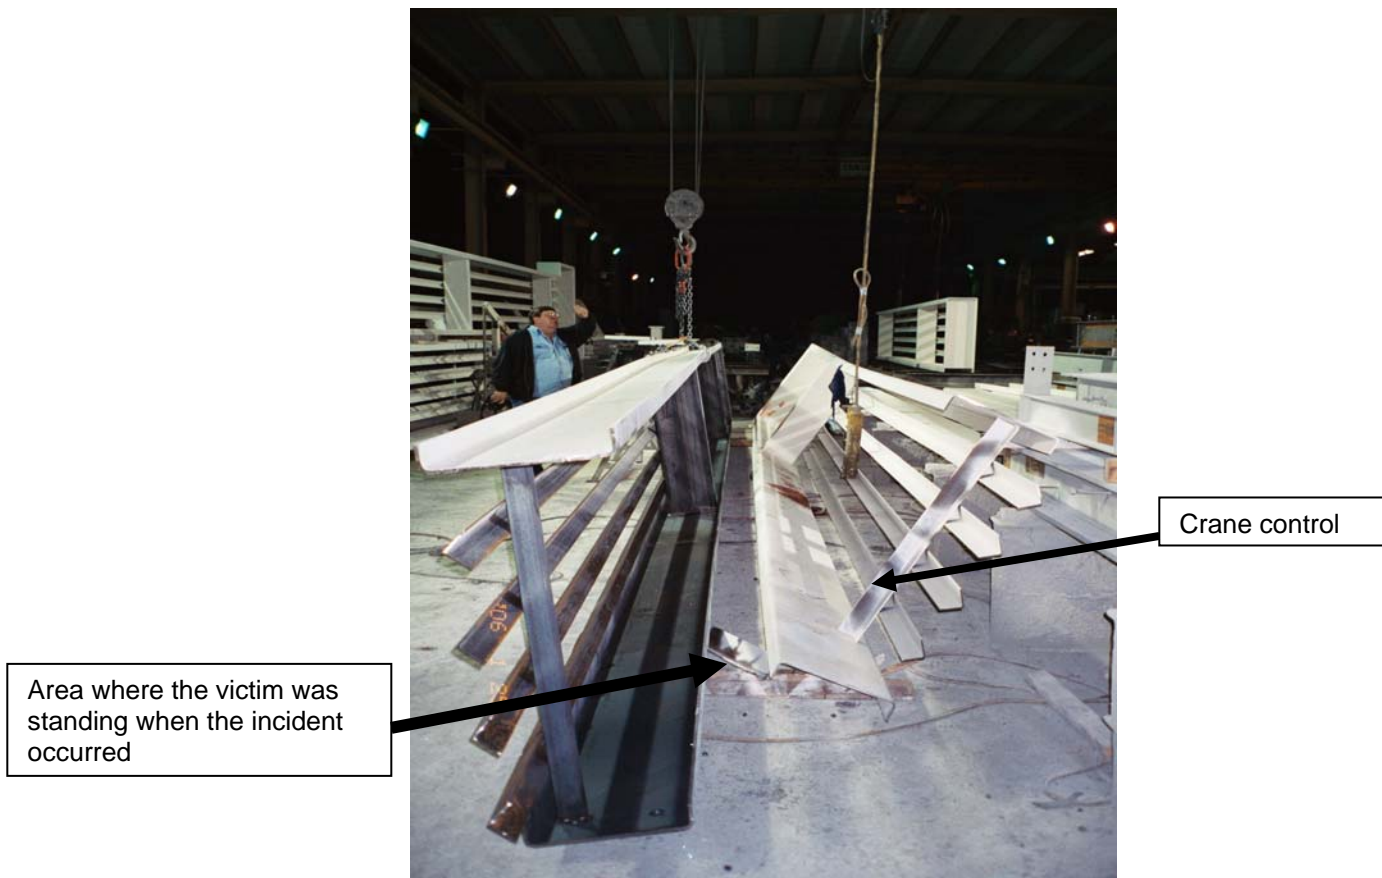
Discussion: In order to protect themselves and other employees, operators of overhead cranes must be constantly aware of their surroundings, and move their load in a controlled manner. In this particular case, the victim stood in an area where there was no exit should something go wrong. The victim should have avoided the areas directly under and close to the load. Employers can enhance worker compliance with safe work practices through programs of task-specific training, supervision, recognition, and progressive disciplinary measures.

Exhibit 6. A picture showing the area where the victim was standing and the crane control that the victim used to lift the steel frame.

**Recommendation #1: Ensure employees do not place any part of their bodies into areas where they might become trapped when operating an overhead crane.**

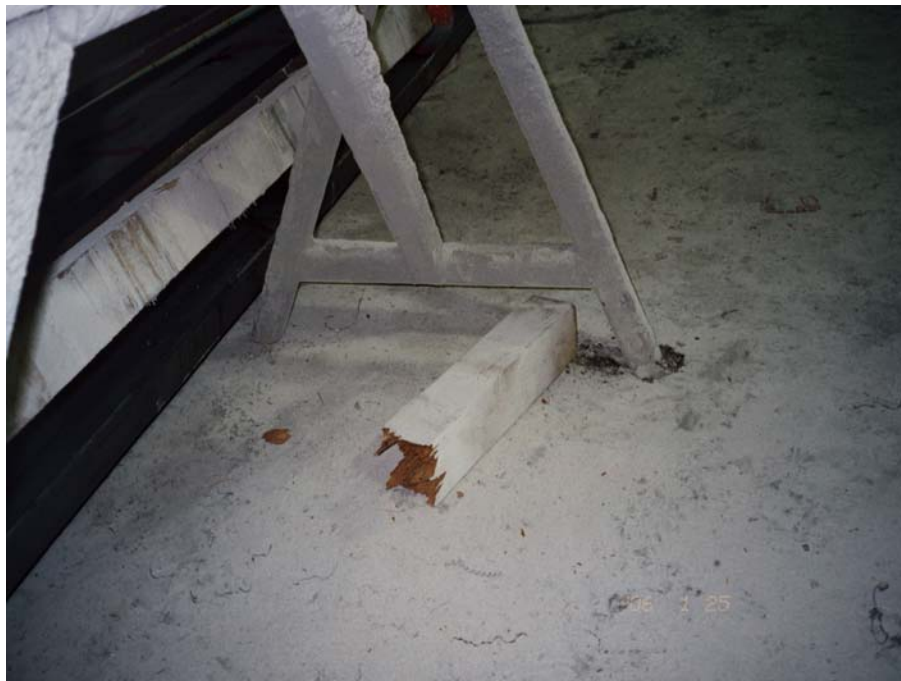
Exhibit 7. A picture of a piece of the wooden beam that broke under the weight of the steel frame.
