SUBJECT: A Packer in a Manufacturing Facility Dies When He is Struck by a Pipe that Rolled off a Storage Rack.

SUMMARY
California FACE Report #07CA003

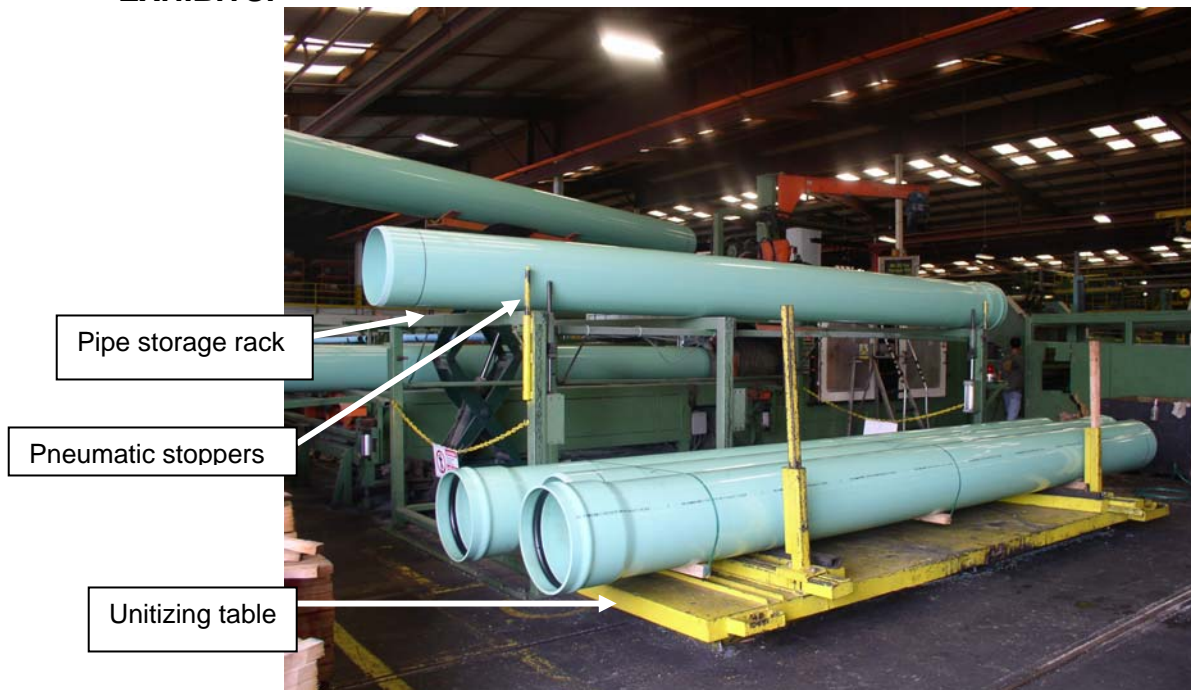
Exhibit1. The pipe storage rack and unitizing table.

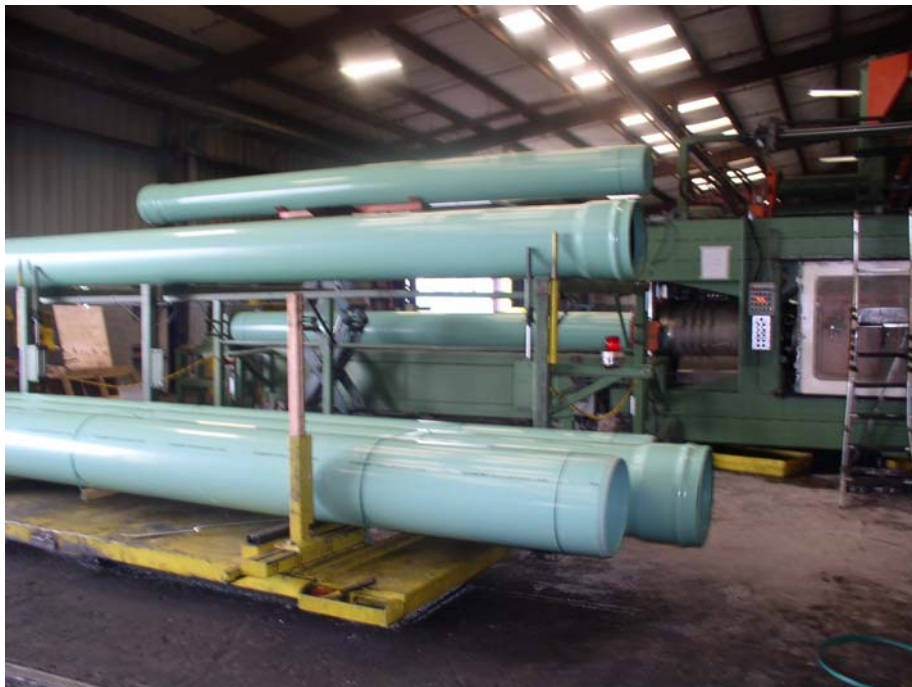
Exhibit 2. The pipe storage rack and unitizing table from a different angle.

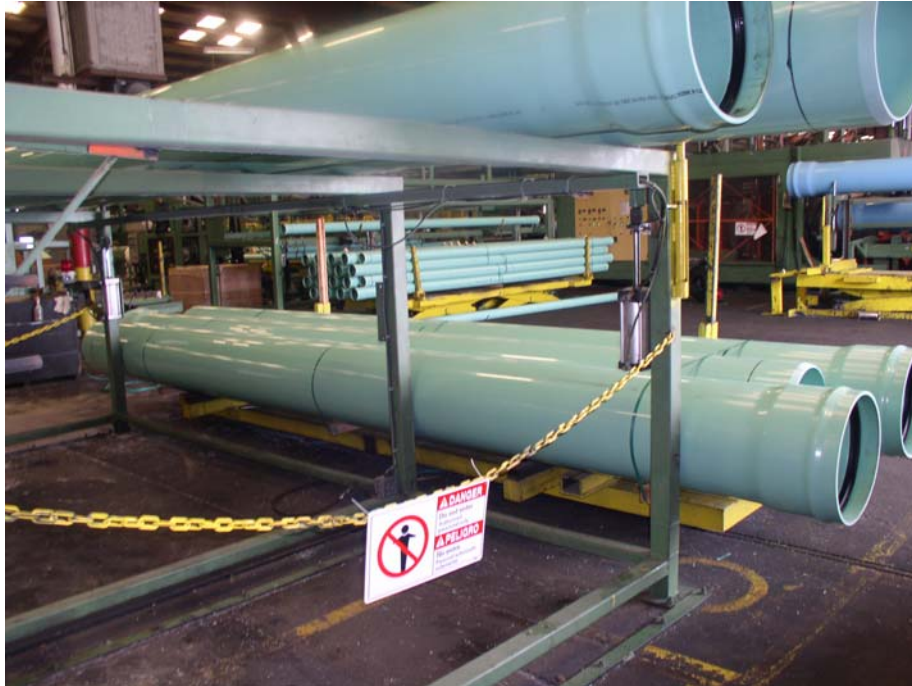
the same time, the automatic system behind him fed another pipe onto the storage rack. The pneumatic stoppers were not in an upright position to stop the pipe's movement, and it rolled off the storage rack, fell downward striking the victim in the back of the head, and then rolled onto the unitizing table. The surveillance video showed that approximately 35 minutes elapsed before the victim was discovered. Once the victim was discovered by co-workers, they rendered aid by checking for vital signs and placing a blanket over him, and called 911. The paramedics and fire department arrived and pronounced the victim dead at the scene.

Exhibit 3. The area under the pipe storage rack where the victim was leaning over the pipe when the incident occurred.

Recommendation 2: Develop, implement, and enforce a written hazardous energy control program for the area under the pipe storage rack.

Discussion: In this particular case, the employees were working with a hazardous energy that was not properly identified, i.e., the rolling pipes on the pipe storage rack. Employers who have employees that work with hazardous energy should develop and implement a written hazardous energy control program that identifies and labels all hazardous energy sources, and de-energizes, isolates, blocks, and/or dissipates all forms of hazardous energy before work begins. The employer should identify the activities that place the workers in hazardous situations and go through a stepwise program to first try to eliminate the hazard entirely. If that is not possible, the employer needs to implement engineering or administrative controls that will abate the hazard.

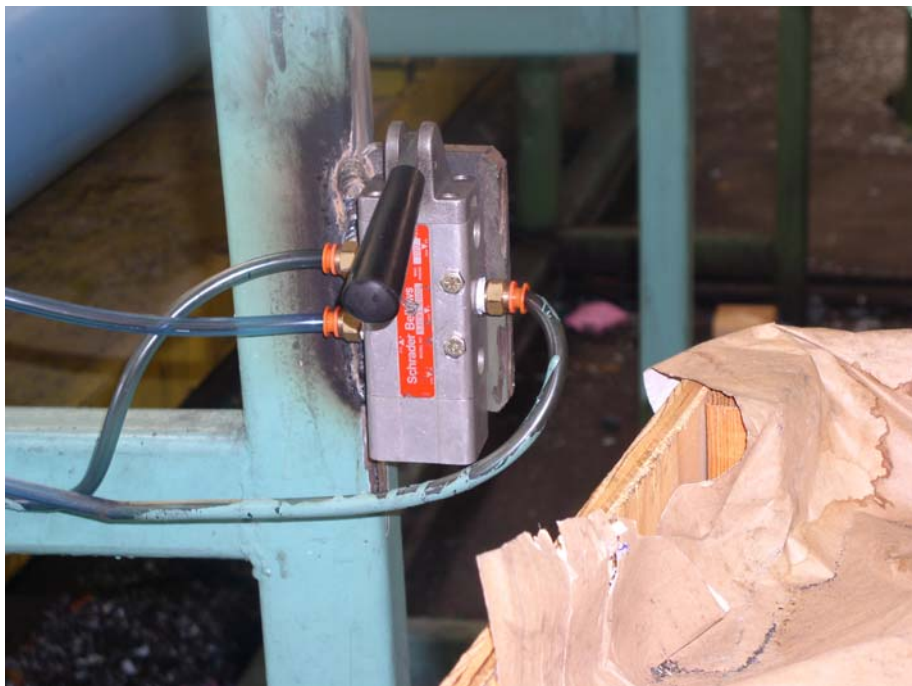
Exhibit 4. The switch used to activate the pipe storage rack stoppers.

Recommendation #1: Ensure that safety measures are in place to prevent pipes from rolling off a storage rack to a bundling table prior to anyone entering the area.

Discussion: The pipe was gravity fed onto the pipe storage rack. Therefore, a stopping device was necessary to prevent the pipes from rolling off the other end. In this particular case, the storage rack was equipped with pneumatic stoppers. Video surveillance showed that pipes would occasionally roll off the rack and onto the bundling table because the stoppers were jammed or stuck in the down position. Daily or pre-shift testing of the system to ensure that the stoppers are operating properly, would be a safety measure that could be taken to ensure employee safety. Additional safety devices, such as a sensor system that alerts the operator whenever the stoppers fail to activate and shuts down the turntable feed system so pipe are not fed onto the pipe storage rack, would also ensure employee safety. Changing out the old pneumatic valves that operate the stoppers to a push button type that is spring loaded to the open position would also help ensure the stoppers are in the correct position. Manually installed stoppers are also an alternate safety measure that will stop pipes from rolling off the rack.
