SUBJECT: An Ironworker Dies When He Falls 50 Feet Through a Floor Opening.

SUMMARY
California FACE Report #07CA009

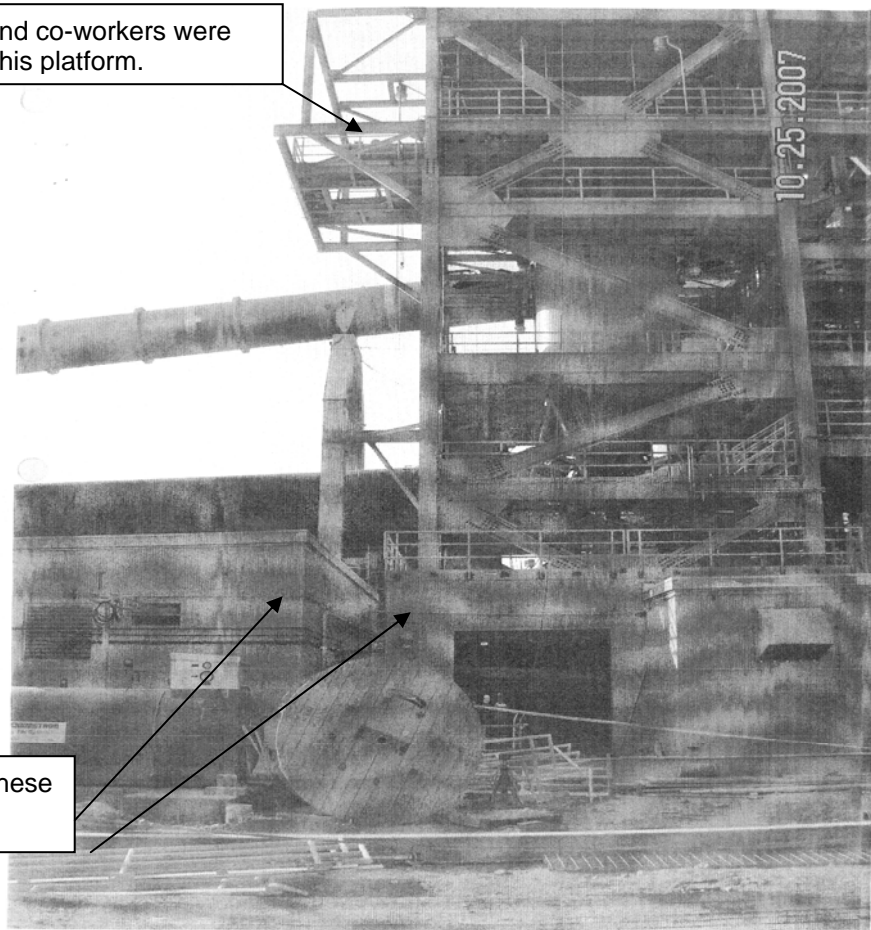
Exhibit 1. The structure involved in the incident.

The victim and co-workers were working on this platform.

The victim landed between these two buildings when he fell.

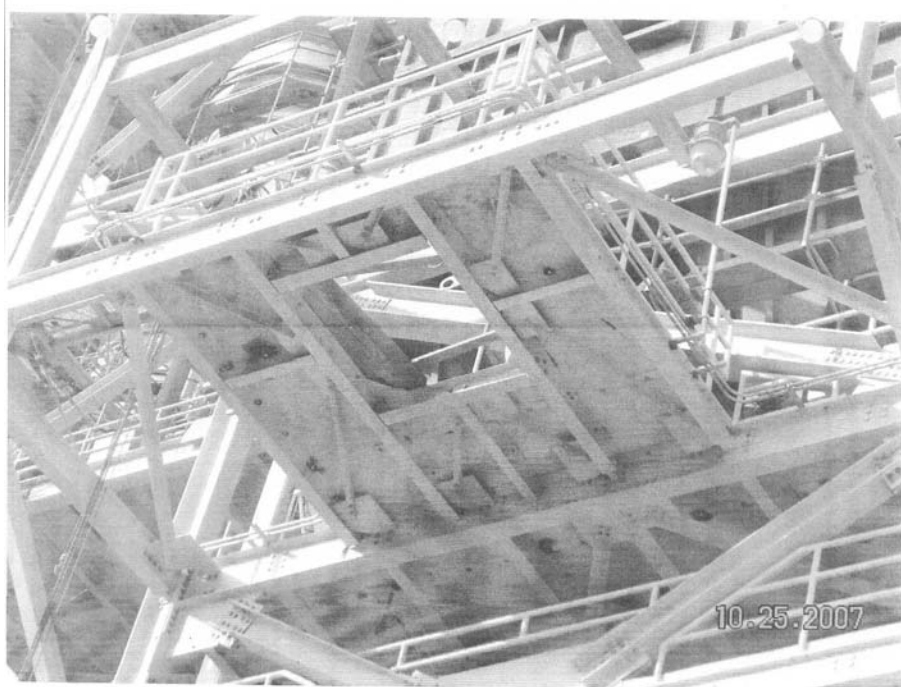
Exhibit 2. View looking up at the floor opening on the platform through which the victim fell.

Discussion: When employees work around an elevated floor opening, proper procedures must be followed in order to provide a safe and healthy work environment. The floor opening must be covered to prevent workers from falling through it. The covers should be capable of safely supporting whichever is greatest: 400 pounds, or twice the weight of the employees, equipment, and materials that may be imposed on any one square foot area. The cover must be secured in place to prevent accidental removal or displacement. Additionally, it should be clearly marked with letters not less than one inch high and in a language the workers can understand, stating: "Opening-- Do Not Remove." In this case, the hole was covered but not marked, and the evidence

suggests that the victim and co-workers either removed the cover of the opening in order to accomplish their task, or the cover had already been removed prior to their entering the balcony. In either case, personal fall protection equipment should be used properly to prevent falls through unguarded floor openings. The victim and co-workers had safety harnesses on with lanyards but they did not tie off when they were working around the floor opening. Employers can enhance worker compliance with safe work practices through programs of task specific training, supervision, recognition, and progressive disciplinary measures.

Recommendation #1: Ensure that proper procedures are followed when employees are working around elevated floor openings.
