**FROM:** California Fatality Assessment and Control Evaluation (CA/FACE) Program

**SUBJECT:** Maintenance Worker Dies When He Falls Off the Roof of an Apartment Building.

**SUMMARY**  
**California FACE Report #08CA001**

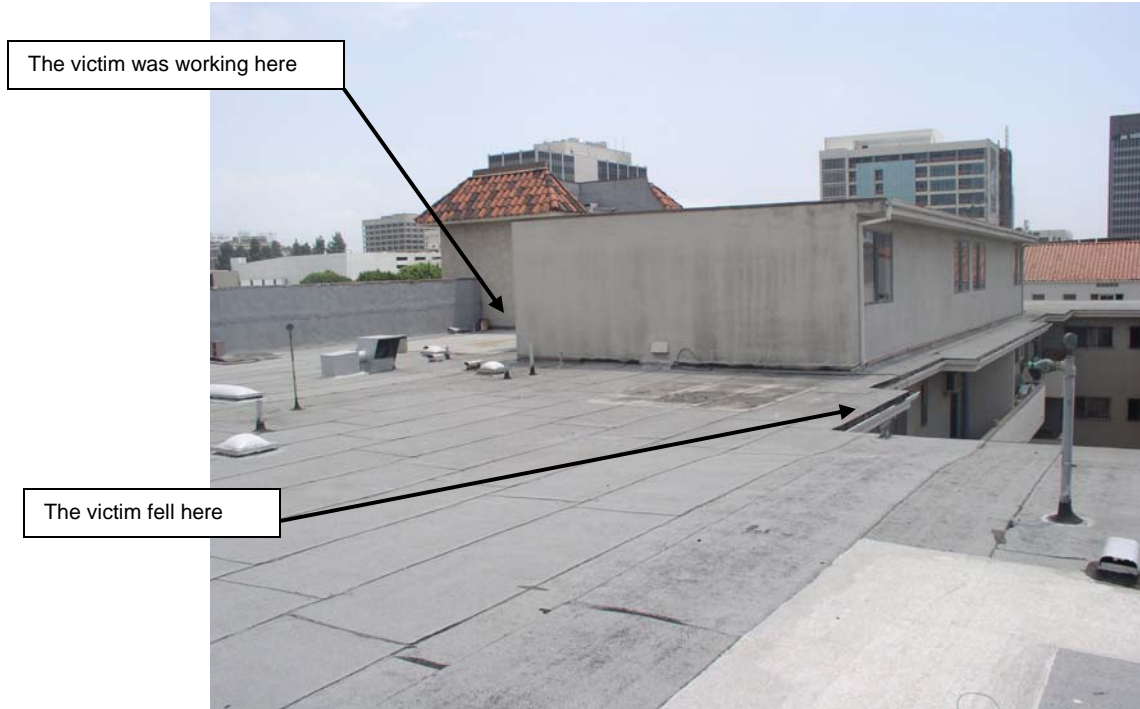
The site of the incident was the flat roof of a three-story apartment building (see Exhibits 1 through 5). The roof was rectangular in shape with a central opening for the building's patio below. There were no guardrails or warning lines on the roof perimeter or the perimeter of the central opening. The area of the roof that was leaking was in the northeast portion of the roof. The leaking roof area was surrounded by a five-foot high parapet wall on the north and the exterior walls of a penthouse on the east and south.

**Exhibit 1. The roof where the incident took place.**

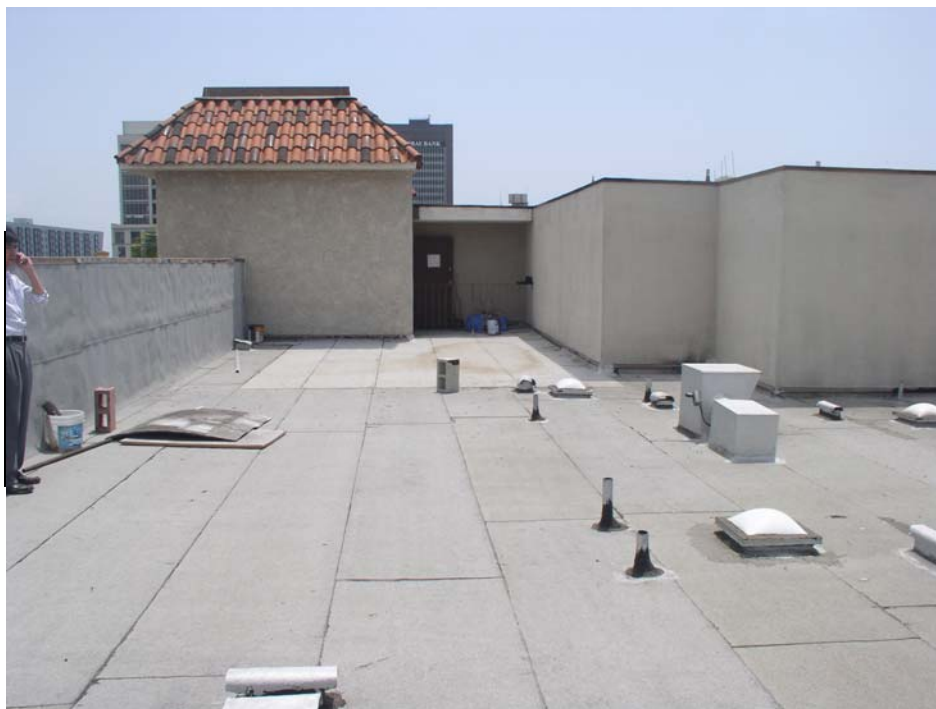
**Exhibit 2. A picture of the north/east corner of the roof where the victim was repairing a leak.**

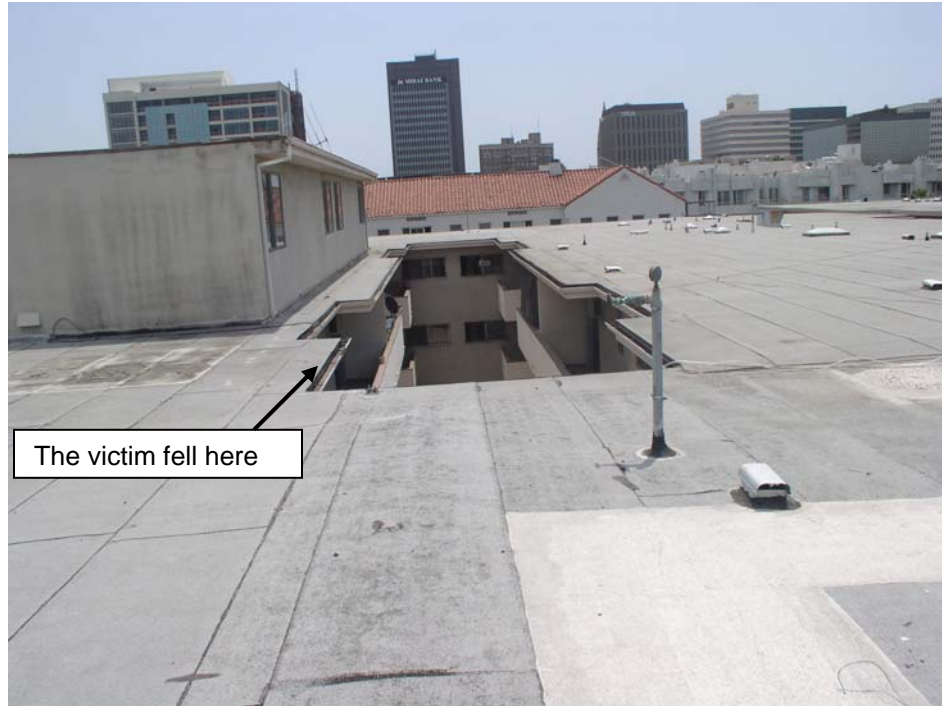
**Exhibit 3. The roof opening where the victim fell.**

**Recommendation #3: Building owners should consider the installation of permanent guardrails around the unprotected edges of flat roofs wherever feasible.**

Discussion: Flat-roofed buildings are different from angled-roof buildings because heating, ventilation, and air conditioning (HVAC) systems and other types of equipment are more likely to be placed on the roof of flat-top buildings. This means that a flat-top roof is commonly accessed by workers to maintain and repair roof-top equipment as well as to maintain and repair the roofing surface. Since many of these workers are employed by companies other than the building's owner, the building owner does not control the level or uniformity of fall protection training and skills these workers possess. A way to insure the safety of all these workers over the entire rooftop, even to the edge of the building, is to install a guardrail around all unprotected edges. In this case that would include guardrails around the entire building's perimeter and the central roof opening for the building's patio.

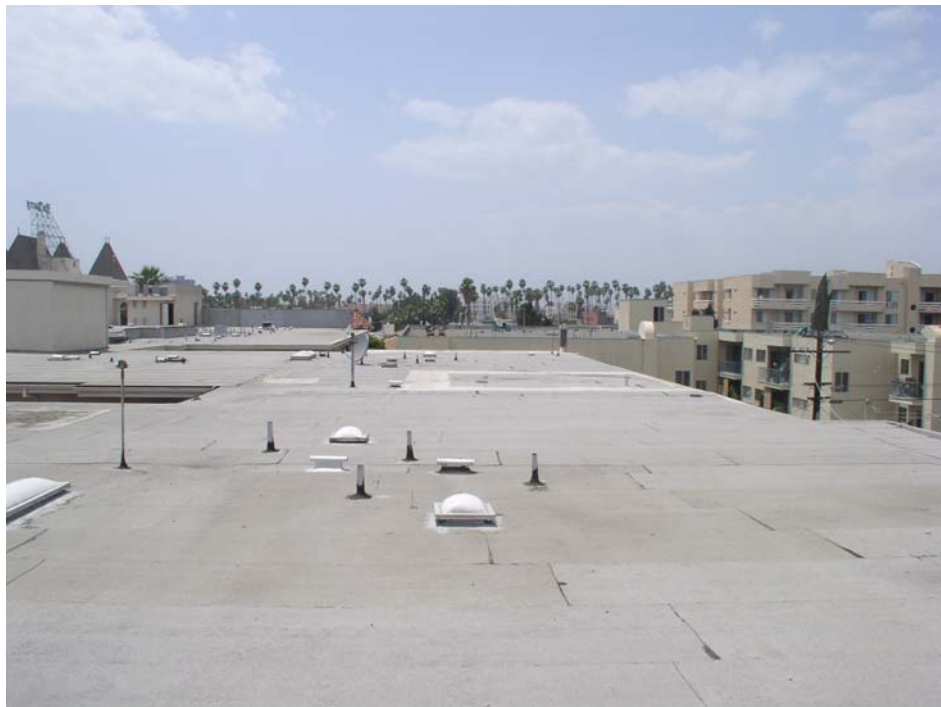
**Exhibit 4. A picture of the roof looking south.**

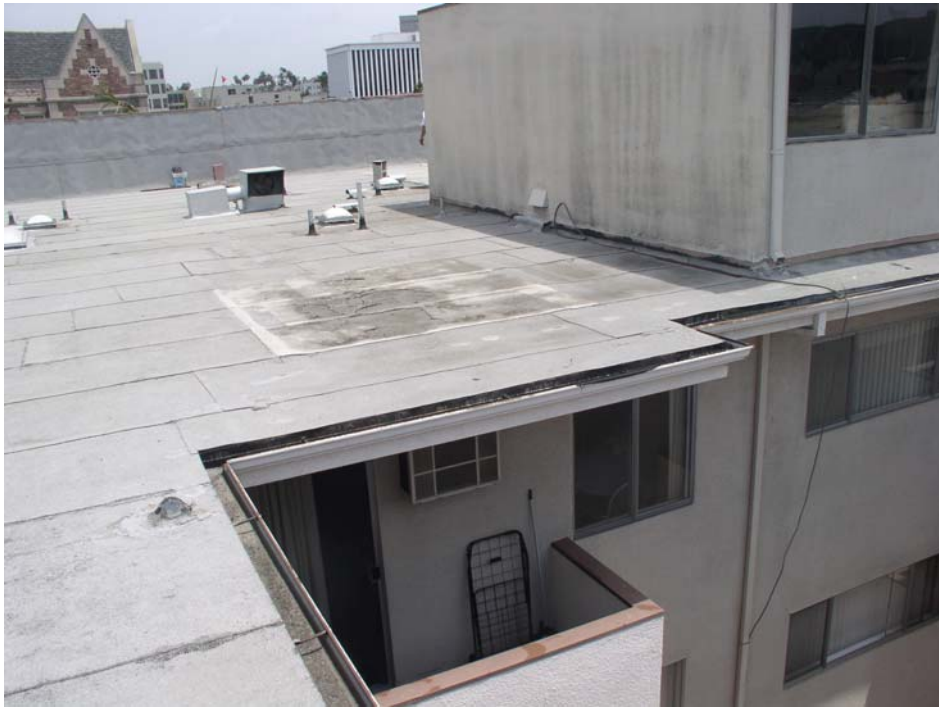
**Exhibit 5. The spot on the roof where the victim fell.**

**Recommendation #1: Ensure fall protection is used for workers performing roof repairs.**

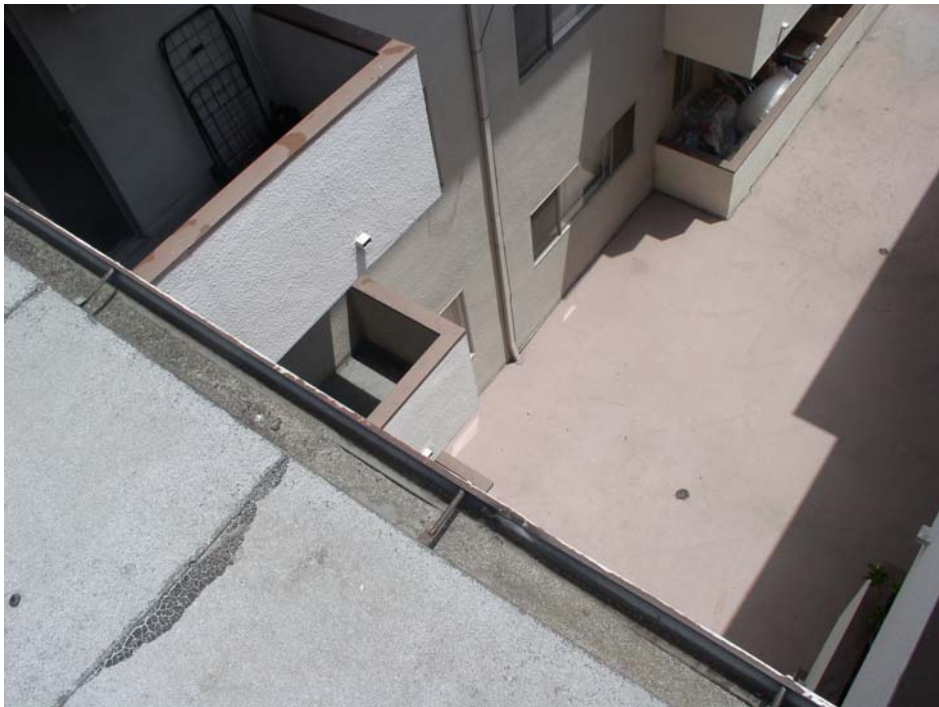
**Exhibit 6. A picture of the patio area where the victim landed after his fall.**
