**SUBJECT:** Tree Trimmer Dies When He is Pulled into a Wood Chipper

**SUMMARY**  
**California FACE Report #08CA005**

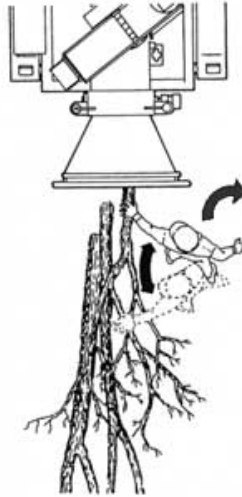
*(Courtesy of Michigan Occupational Safety and Health Administration, Pub OSC-6125).*

Discussion: In this particular case, a witness observed the victim standing directly behind the feed table in front of the chute as he fed tree branches into the wood chipper. The feed table provides an important measure of safety by increasing the distance between the feed rollers and the operator. The wood chipper was equipped with a safety stop and reversing feed control bar located across the top and down each side of the feed chute. The operator could easily activate this safety device while standing at the side of the feed table. However, if standing directly in front of the feed table, the operator is out of reach of this safety device. Also, if an operator should place any part of his/her body on the feed table, the risk of getting snagged or dragged into the chipper blades is greatly increased and a worker caught by the hands could not activate the quick stop device. The correct and safe feeding pathway is from the side, and the operator should walk away immediately following feeding as depicted in the following illustration.

**Recommendation #2: Ensure that all employees stand to the side of the feed table when feeding trimmings into the brush chipper.**

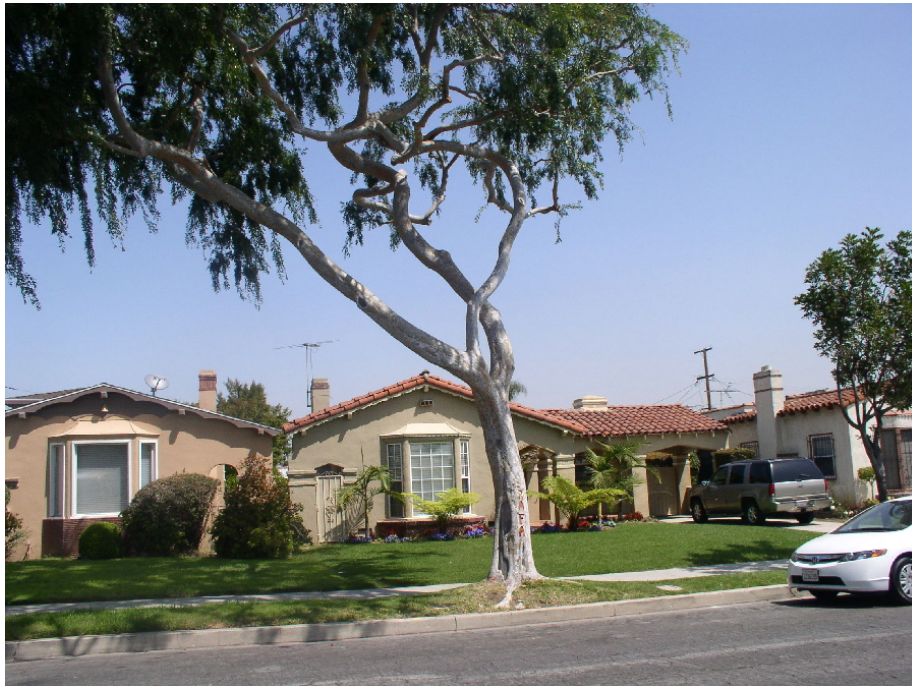
**Exhibit 1. The street where the incident occurred and the tree that was being trimmed.**

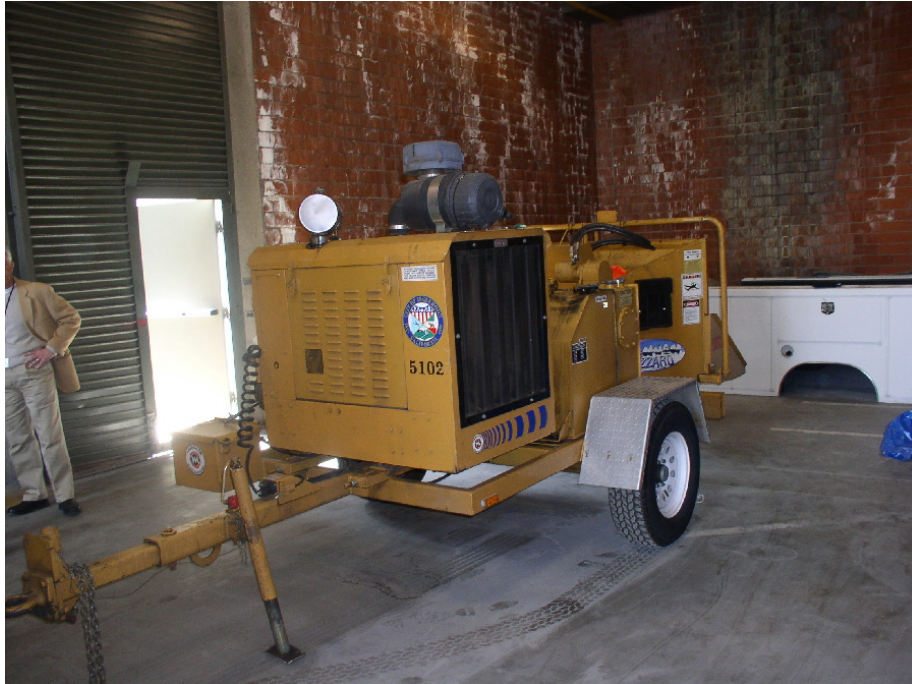
**Exhibit 2. The brush chipper involved in the incident.**

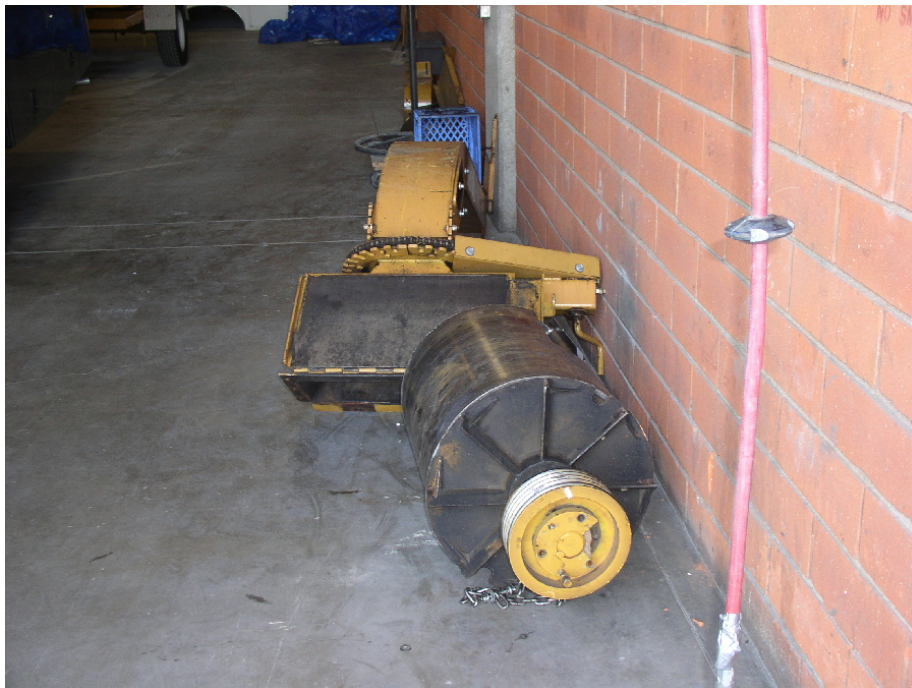
**Exhibit 3. The discharge chute and drum that were removed from the brush chipper during the initial investigation.**

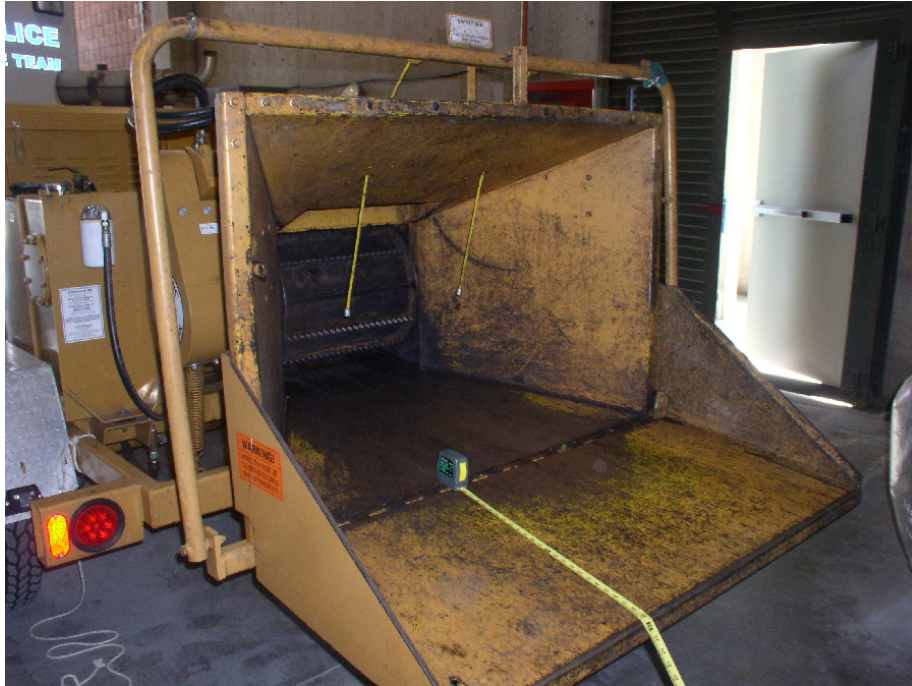
**Exhibit 4. The in-feed chute and shroud that feeds the tree limbs into the feed wheel.**

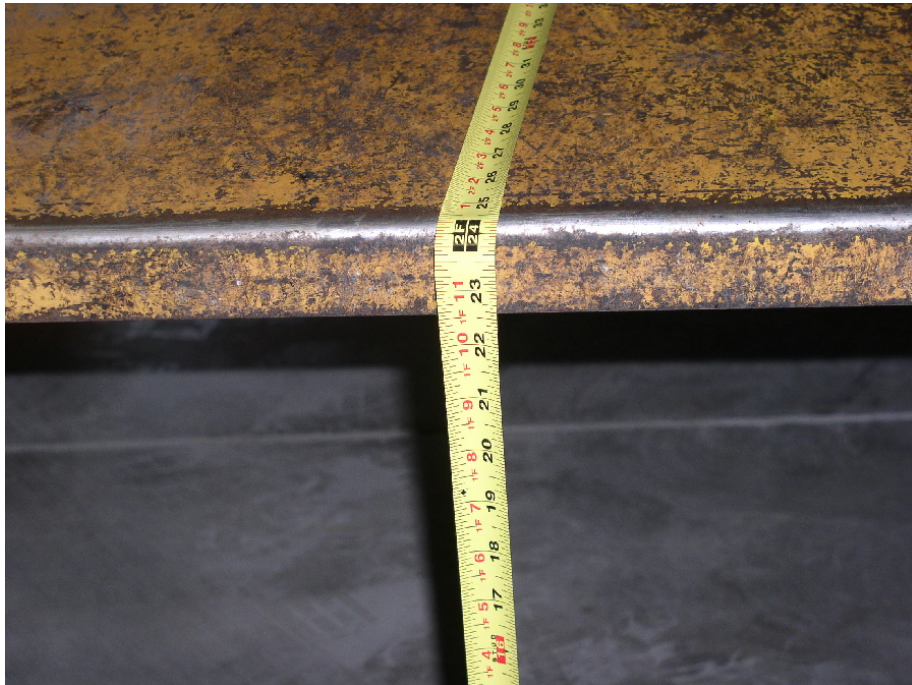
**Exhibit 5. The measurement of the in-feed table in relation to the ground.**

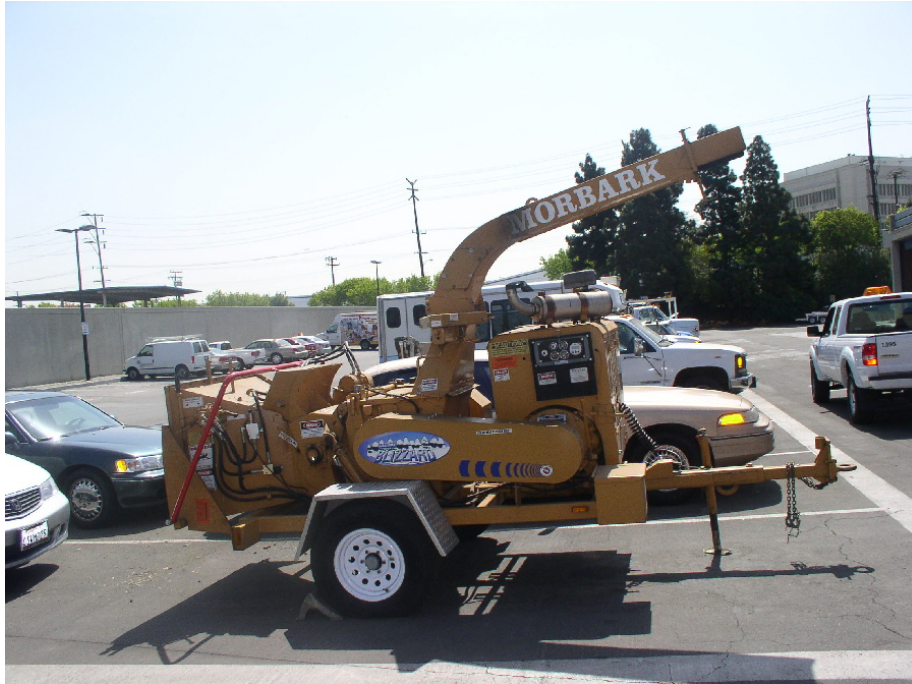
**Exhibit 6. A fully assembled brush chipper similar to the one involved in the incident.**
