SUBJECT: A Diesel Mechanic Dies When he is Crushed Between the Tire and the Cab of a Fire Truck.

SUMMARY
California FACE Report #08CA009

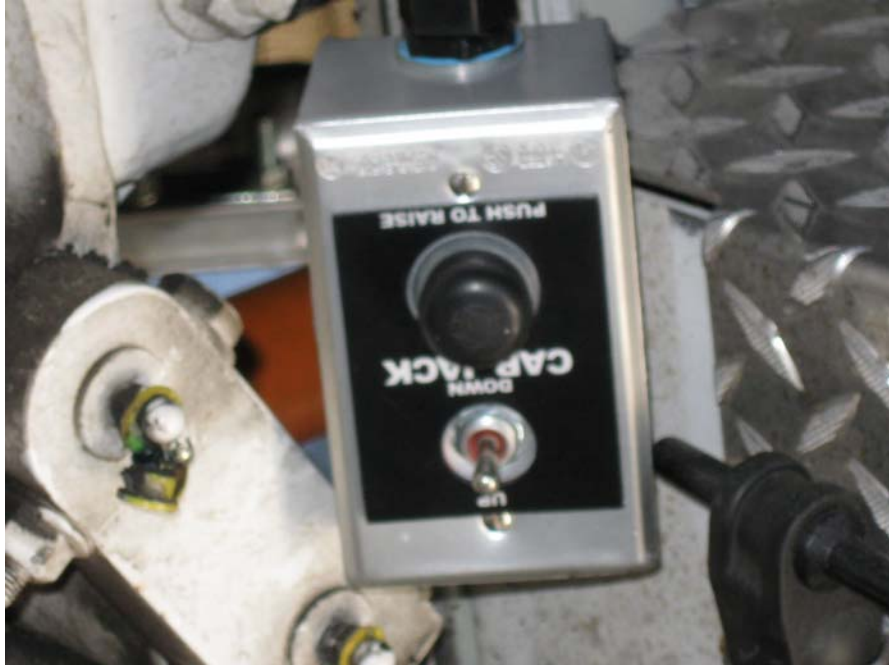
Discussion: In this incident, the push button in the control box had to be held down continuously as the cab was being raised, but not when being lowered. In this design, the operator does not have control of the downward cab movement because it continues moving downward even if the control box should become separated from the operator. Having a “dead man” switch incorporated into the down position would allow the operator to have continuous control over the cab movement up and down, particularly if the control box should become physically separated from the operator. Had a dead man switch been part of the down position on the control box, this incident might have been prevented.

Exhibit 1. The control box used to raise and lower the cab.

Recommendation #2: Truck manufacturers should design a control box “dead man” switch to use when lowering cabs.

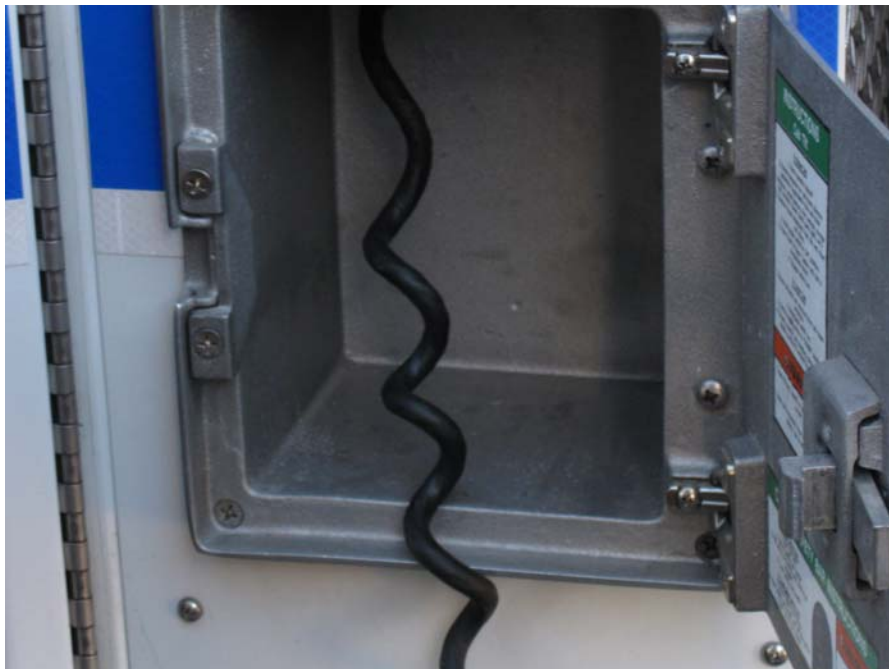
Exhibit 2. The storage area for the control box showing the spiral cord that attaches to the control box.

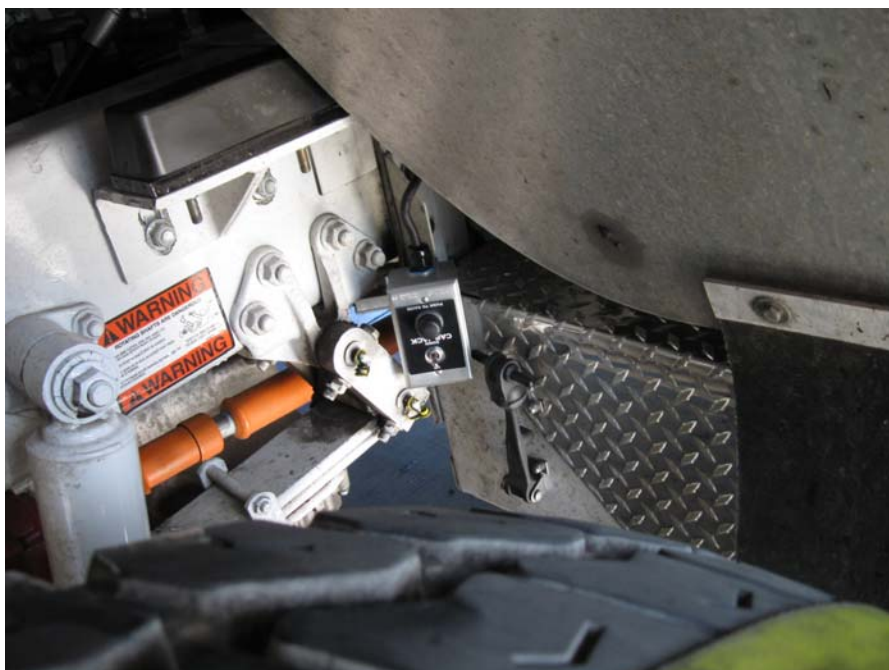
Exhibit 3. The location of the control box - next to the tire wheel well.

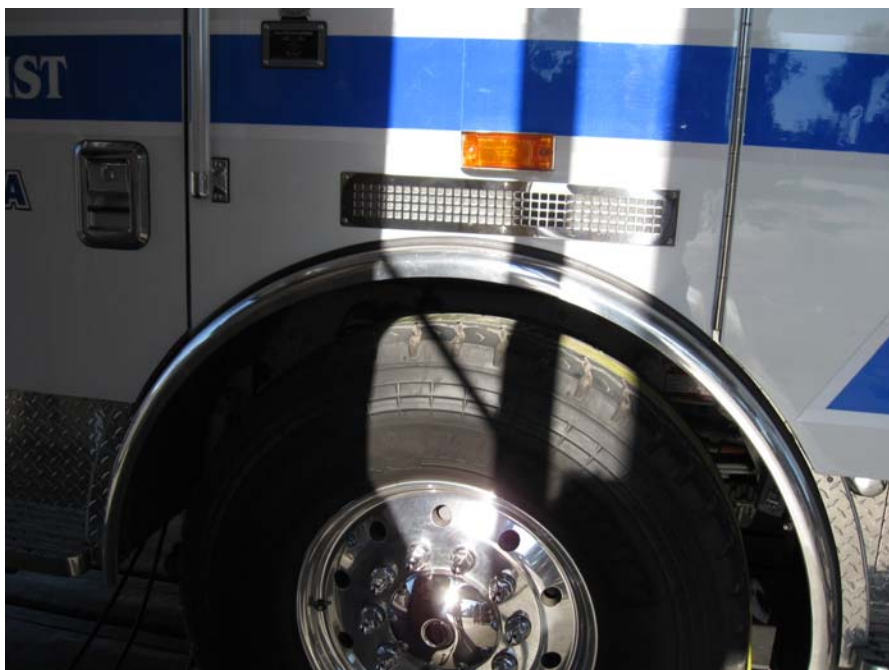
Discussion: The victim was crushed between the fire engine cab and tire. It is not known exactly what the victim was doing at the time of the incident. Evidence suggests the victim might have been trying to prevent the sensor cables from becoming entangled by the lowering cab, or he was trying to retrieve the control box that might have slipped out of his hand as he was lowering the cab prior to performing the dynamometer testing. If sensor cables become entangled while the cab is lowering, the cab should be stopped, and then raised and locked into place before attempting to reroute the cables. If the control box slips or is dropped from the mechanic's hand, the mechanic should stand clear and allow the cab to lower regardless of damage that may occur. In this incident, the fatality may have been prevented had the victim stood clear of the cab while it was lowering.

Exhibit 4. The tire and fender of the cab where the victim was pinned.

Recommendation #1: Employers should ensure that diesel mechanics always stand clear of lowering cabs.

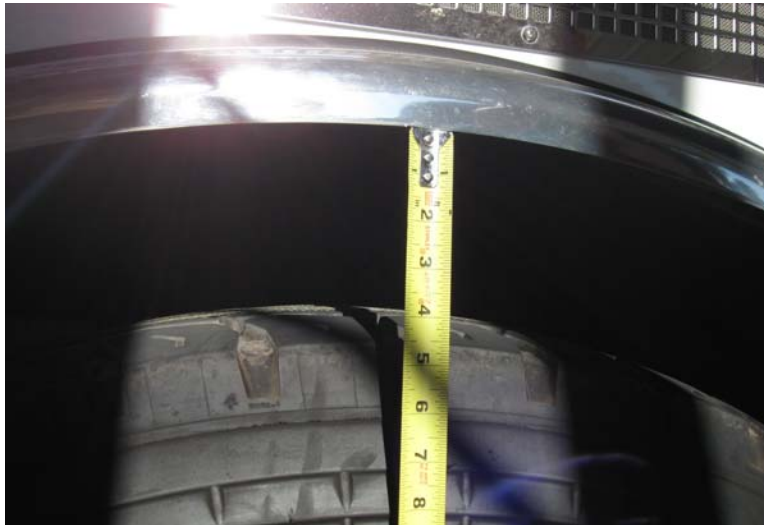
Exhibit #5. The distance between the tire and fender of the cab was approximately 4.5 inches.
