**FROM:** California Fatality Assessment and Control Evaluation (CA/FACE) Program

**SUBJECT:** Janitor Dies When He Falls into a Baling Machine that Bales Cardboard for Recycling

**SUMMARY**  
**California FACE Report #09CA009**

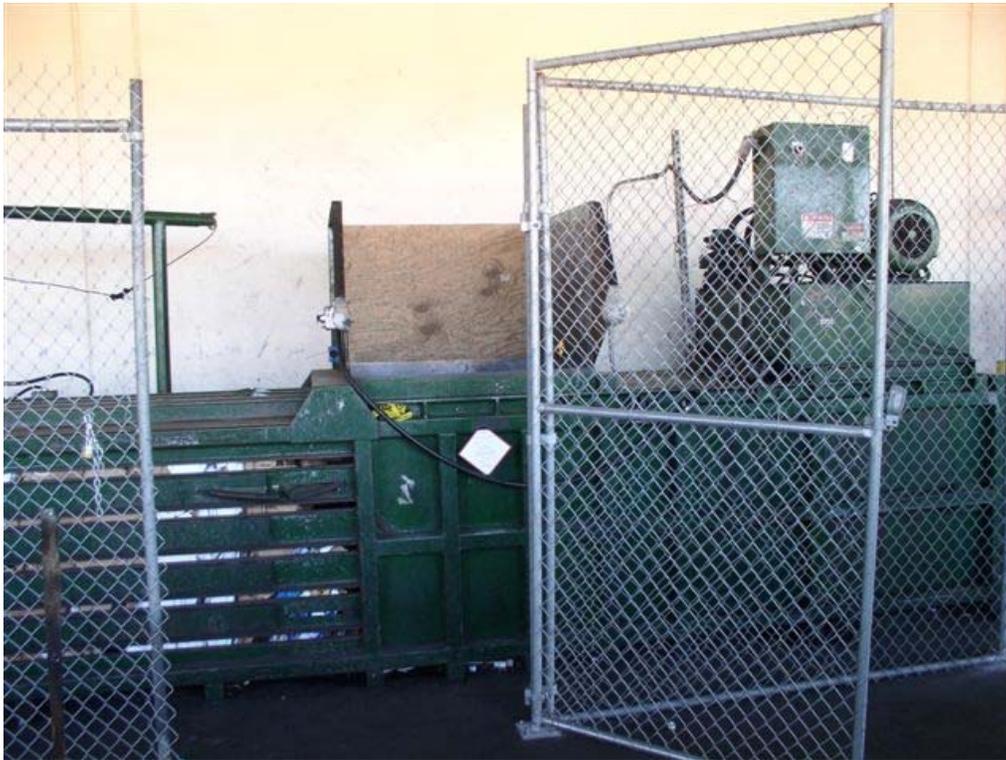
**Exhibit 1. The front view of the cardboard baling machine involved in the incident.**

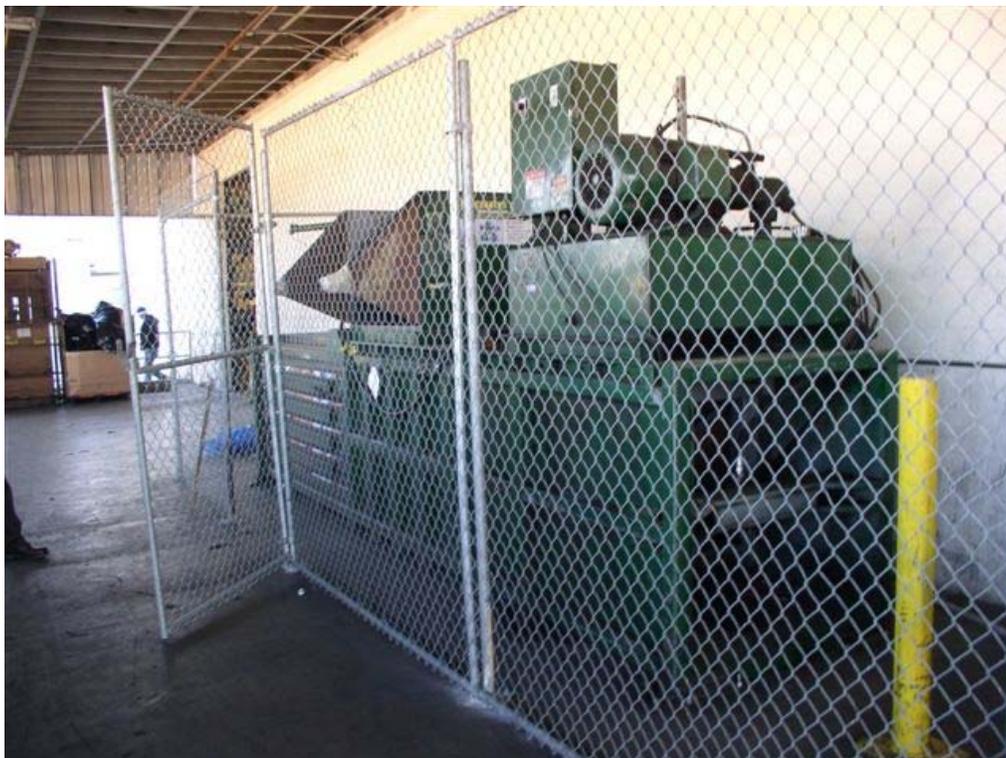
**Exhibit 2. Side view of the cardboard baling machine.**

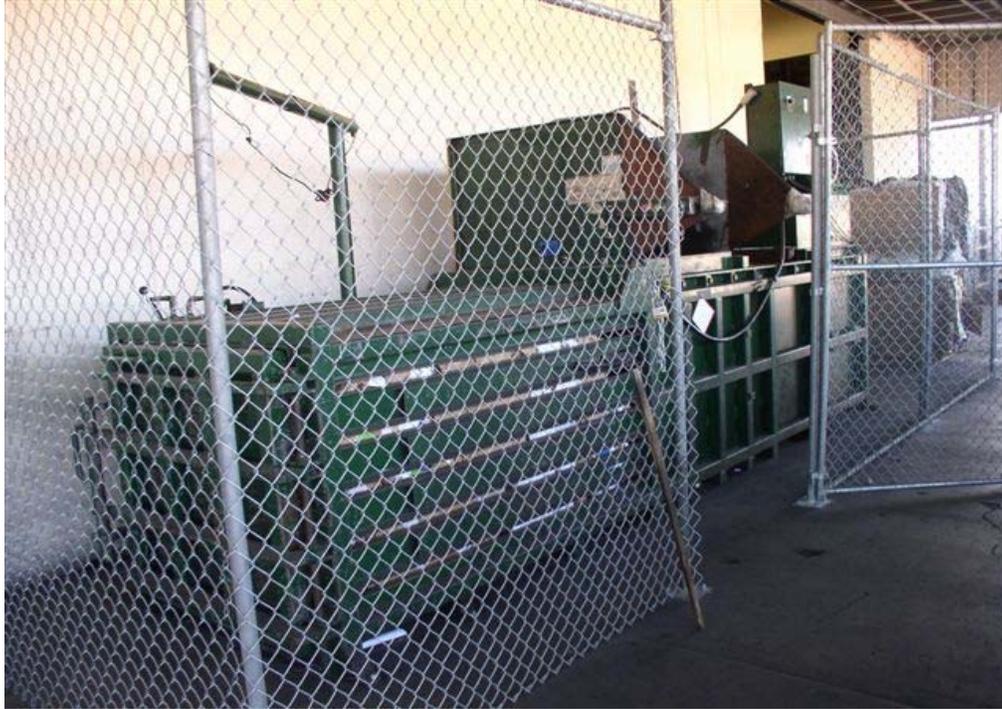
**Exhibit 3. Alternate side view showing the baling chamber.**

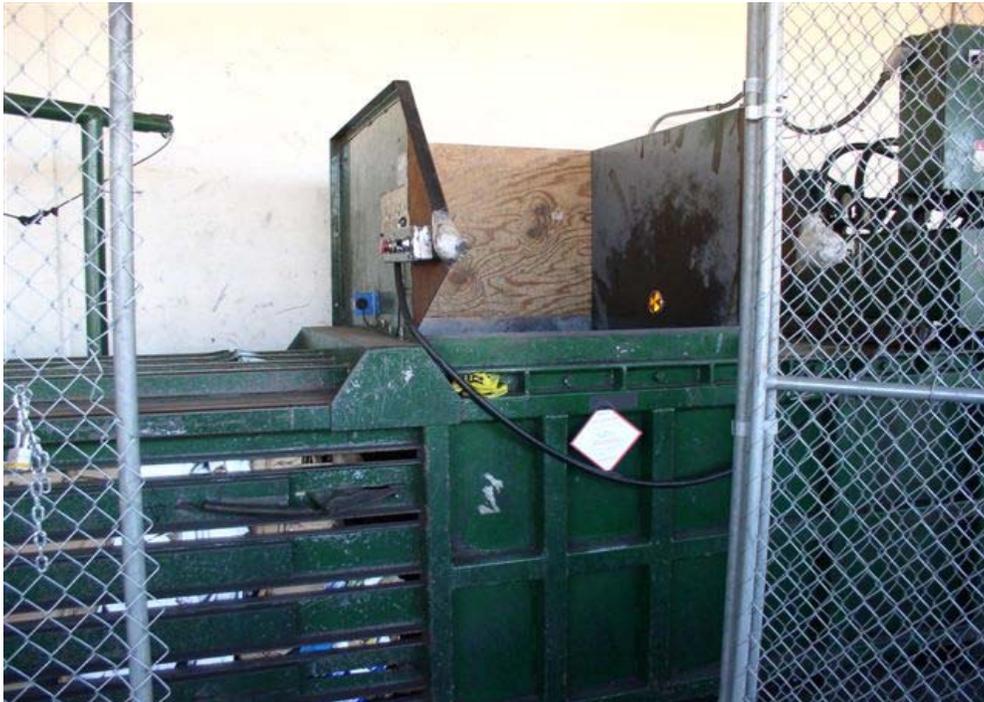
Discussion: In this incident, the victim was able to gain access to the point of operation of the machine through the opening on the open side of the hopper. It is not known exactly why the victim was standing in the compaction chamber. When he entered the compaction chamber, his body broke the sensor beam and activated the ram that crushed him. Guards around the machine's point of operation are necessary to prevent entry of hands, fingers, or any part of the body into the point of operation. Had this guard been in place, the victim would not have been able to climb into the machine and this incident might have been prevented.

**Exhibit 4. The feed hopper and compaction chamber.**

**Recommendation #1: The area around the machine's point of operation is guarded by barriers or interlocked safety gates.**

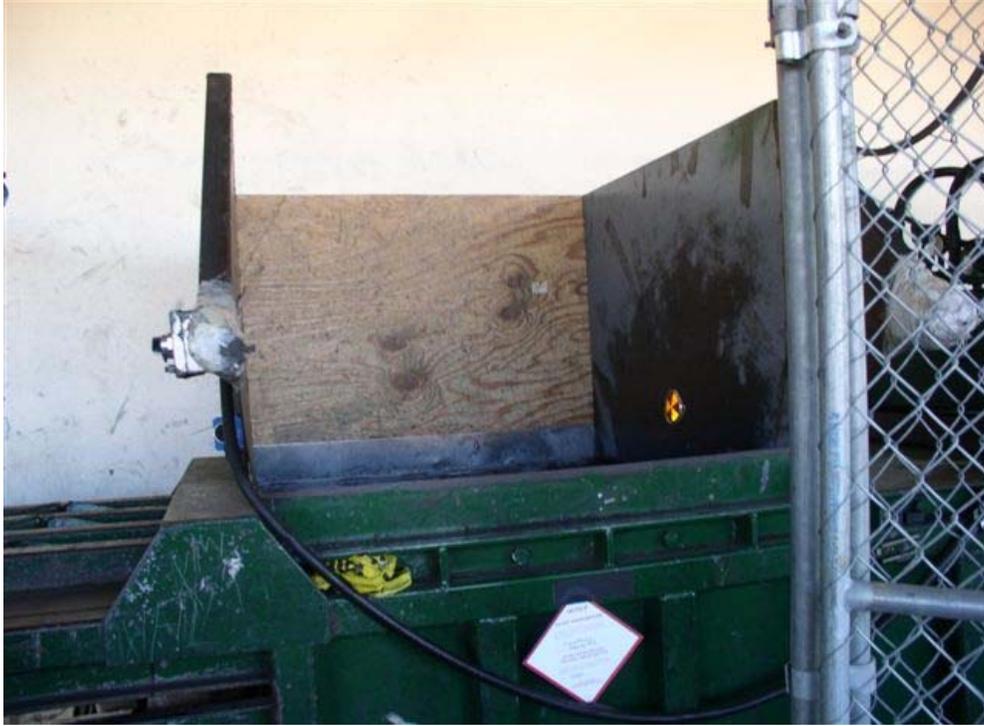
**Exhibit 5. Closer view of the feed hopper.**

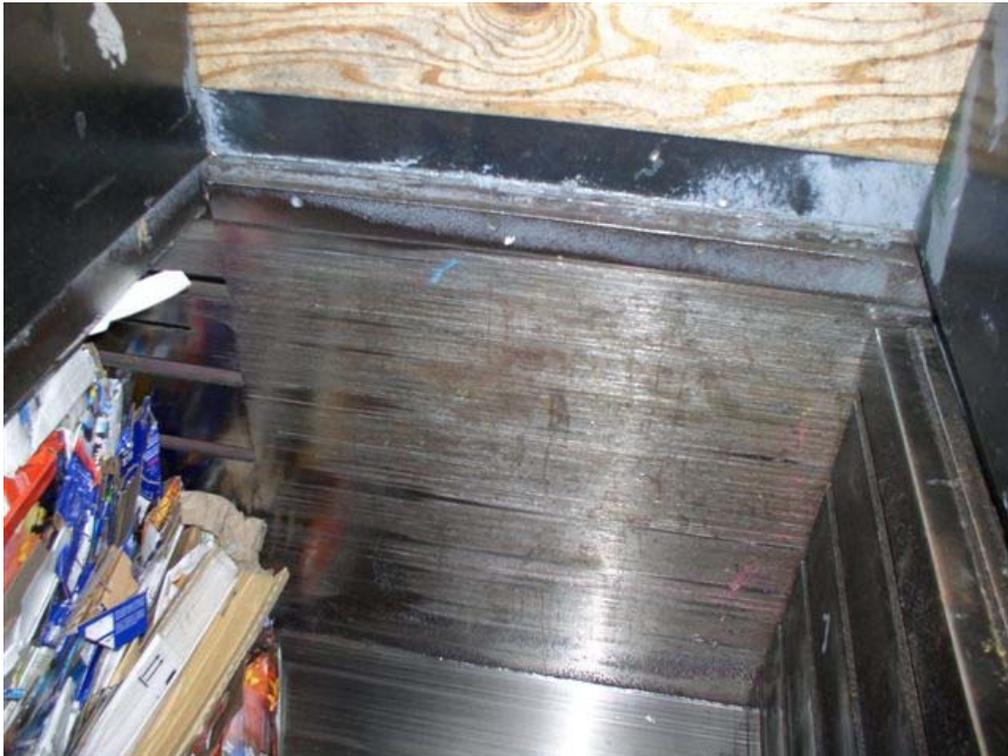
**Exhibit 6. Inside view of the compaction chamber.**

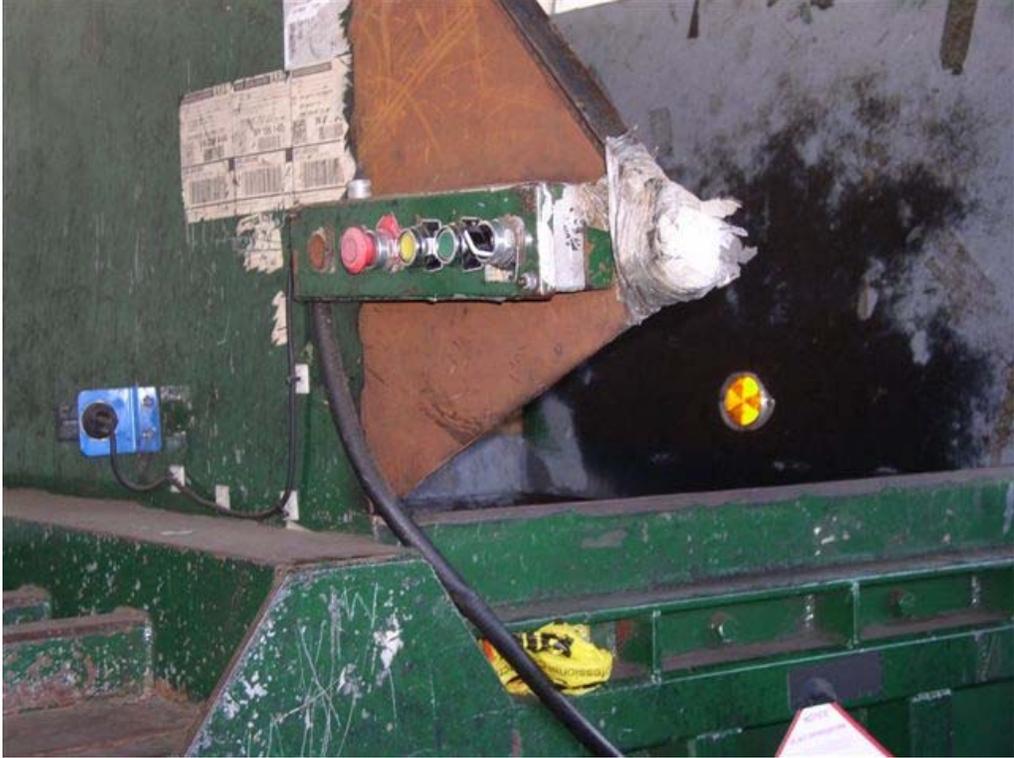
**Exhibit 7. The controls and electronic sensor.**

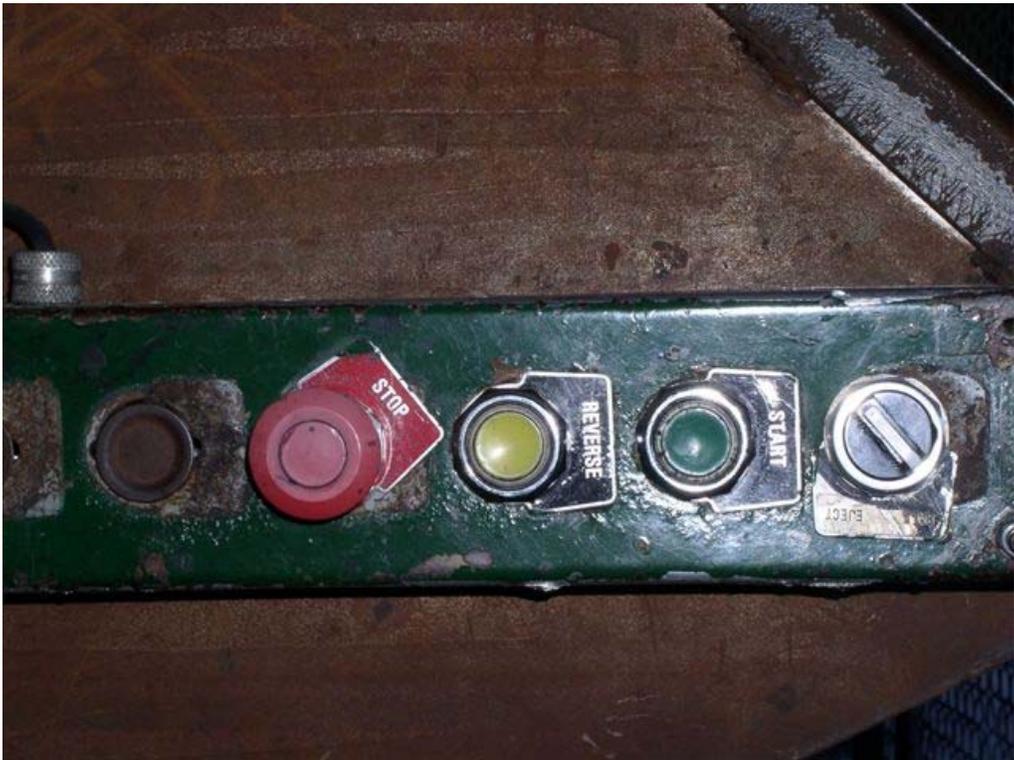
**Exhibit 8. Close-up of the controls.**
