**FROM:** California Fatality Assessment and Control Evaluation (CA/FACE) Program

**SUBJECT:** A Laborer Dies When He is Crushed by an Industrial Washing Machine

**SUMMARY**  
**California FACE Report #11CA007**

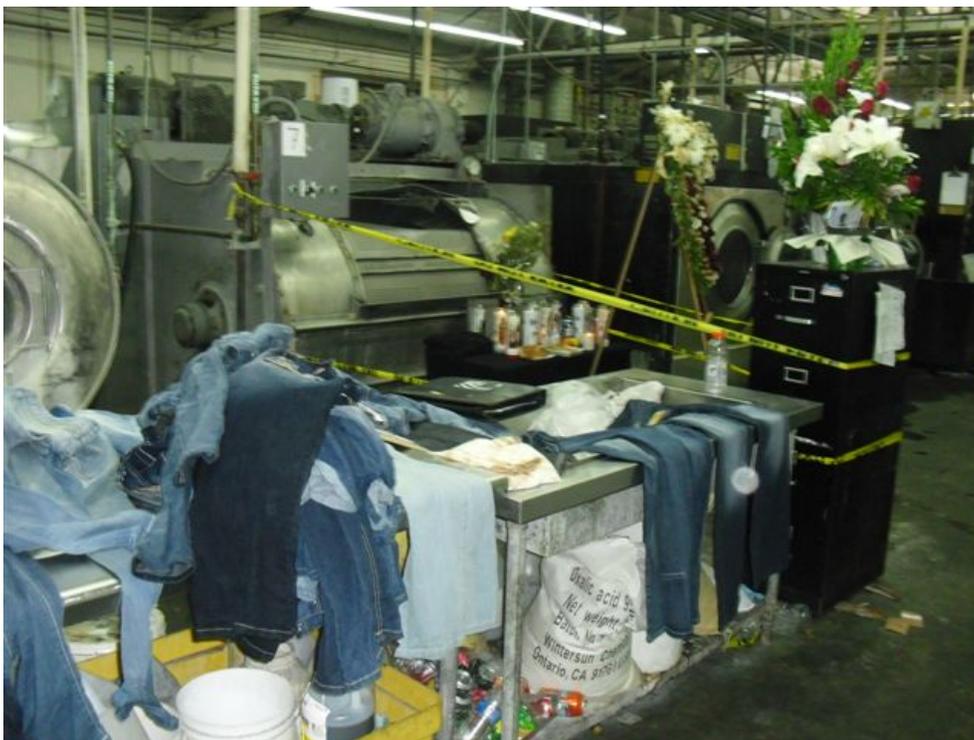
**Exhibit 1. The work area where the incident occurred.**

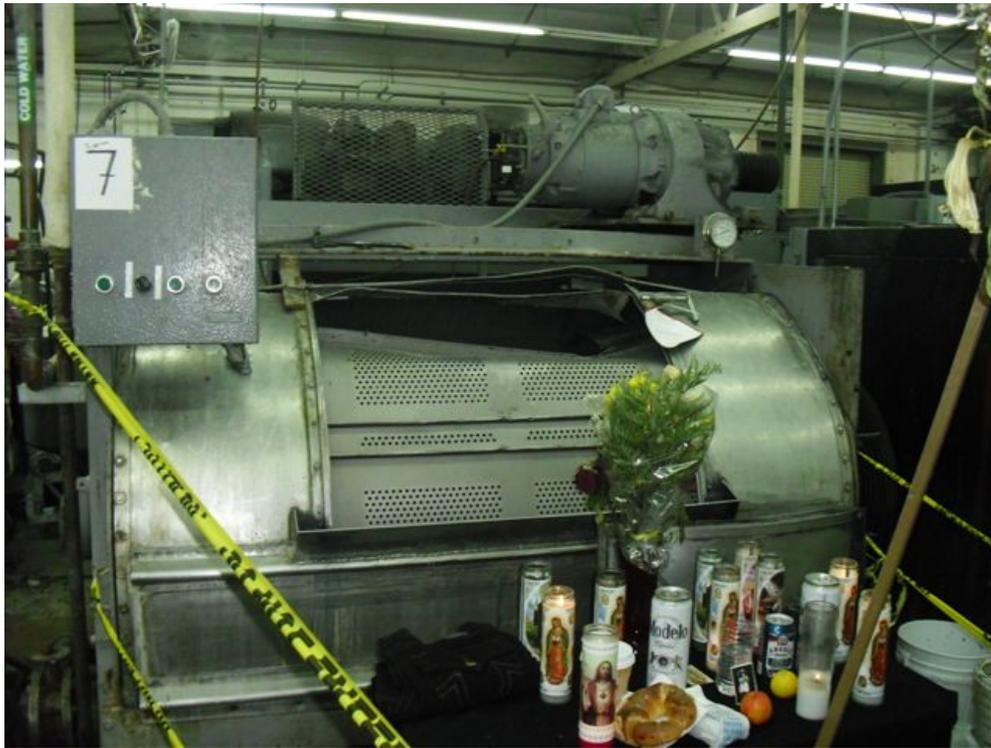
According to the victim's supervisor, the washing machine involved in this incident had been out of service for about a six-month period approximately a year prior to the incident. One of the brackets that held the horizontal drum was broken, the drum wasn't aligned properly within the machine structure, and the machine leaked water every time it was used. The employer would only use this machine when the work load demanded it. The supervisor stated that the employer was aware that the safety interlock wasn't working properly.

Discussion: In this incident, the washing machine was poorly maintained and the safety interlock on the washing machine door was disconnected. There was no documentation of a repair request or work completion on the washing machines. Operators would simply tell the mechanic that something was wrong with a machine

**Exhibit 2. The industrial washing machine involved in the incident.**

and wait for him to perform the repair or maintenance. If documentation for the manufacturer's specifications is not available, then any repair or maintenance should be directed by an engineer with knowledge and experience in the operation of that machine. Had the safety interlock on this washing machine been in proper operating condition, the machine would not have started when the supervisor turned the cycle switch, and this incident might have been prevented.

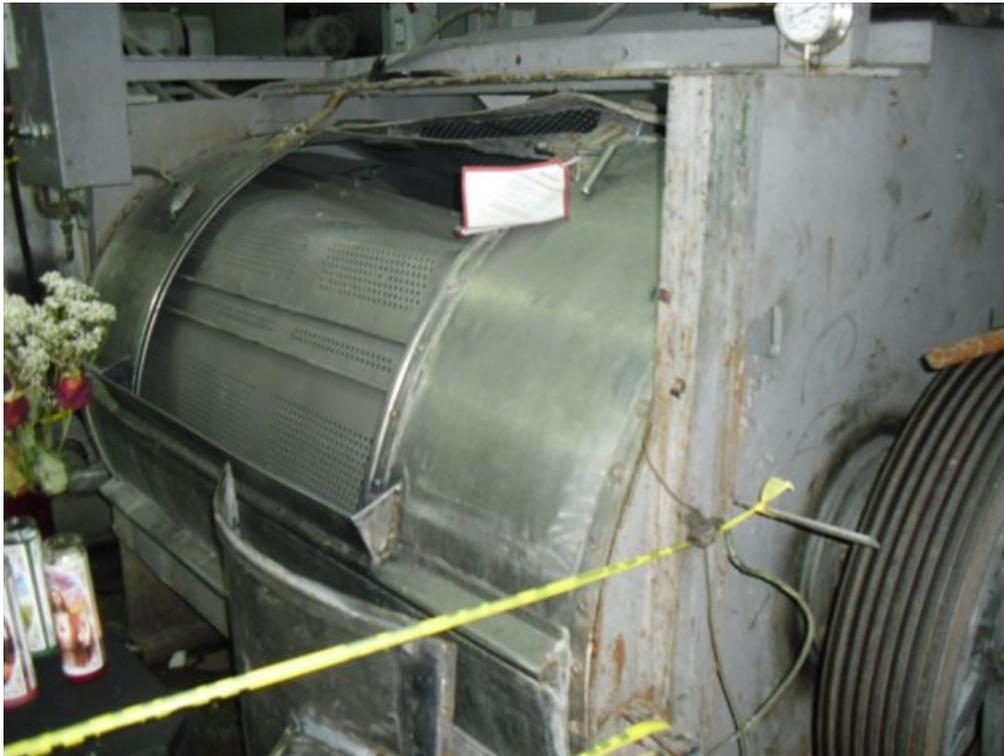
The washing machine had two doors to gain access to the horizontal drum. The outside door, which slid upward, was located on the outside frame of the machine. The inside door was located in the center of the drum. It opened upward after it was aligned with the outside door. The process to align both doors required the horizontal barrel to be "jogged" either upward or downward by manipulating the buttons on the control panel. The washing machine also had a safety interlock which was designed to disconnect the electrical power to the motor during wash cycles when the doors were open so that workers could not enter the machine while the machine was running. The safety interlock was inoperable at the time of the incident.

**Exhibit 3. The industrial washing machine with the sliding door open, exposing the inner rotating barrel.**

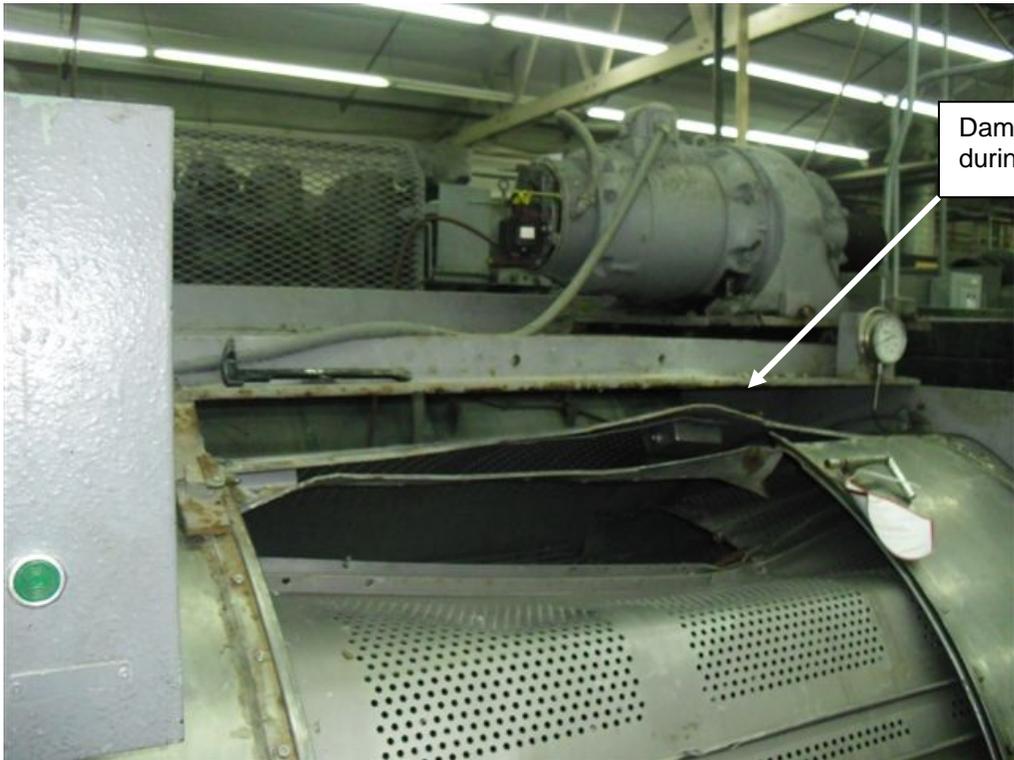
**Exhibit 4. The industrial washing machine opening.**

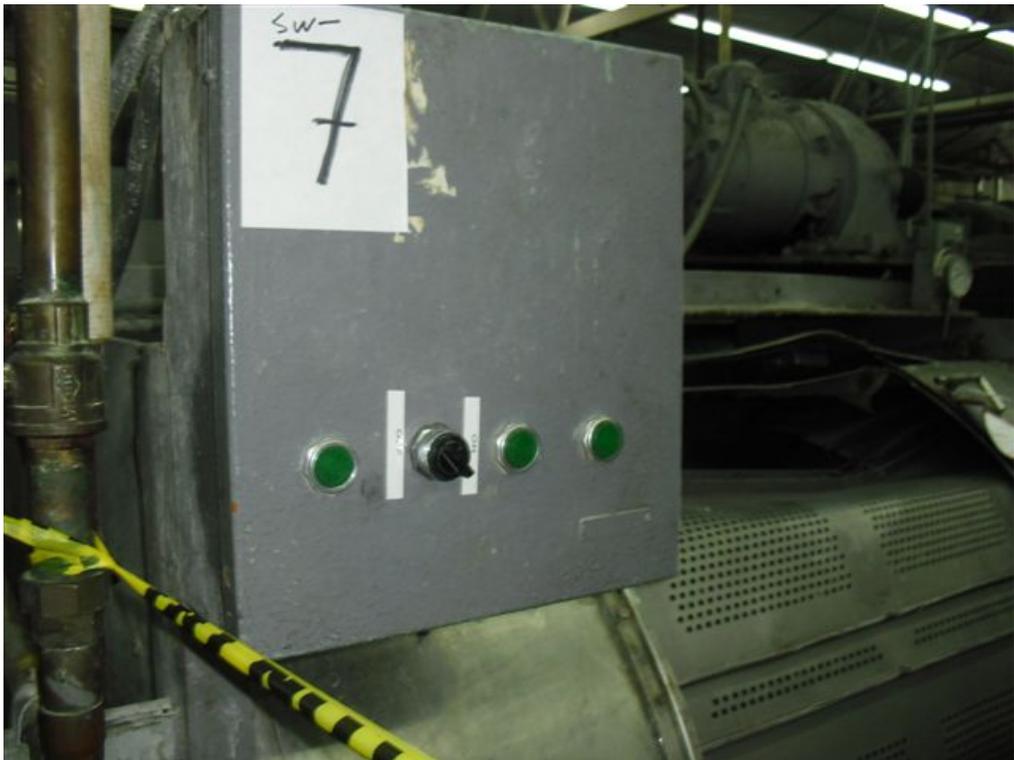
The control panel, mounted just to the left of the machine consisted of an on/off switch and three push buttons (Exhibits 5 & 6). The on/off switch did not de-energize the machine, it simply controlled the wash cycle. The buttons were used to align the inner and outer doors.

**Exhibit 5. The control panel for the industrial washing machine.**

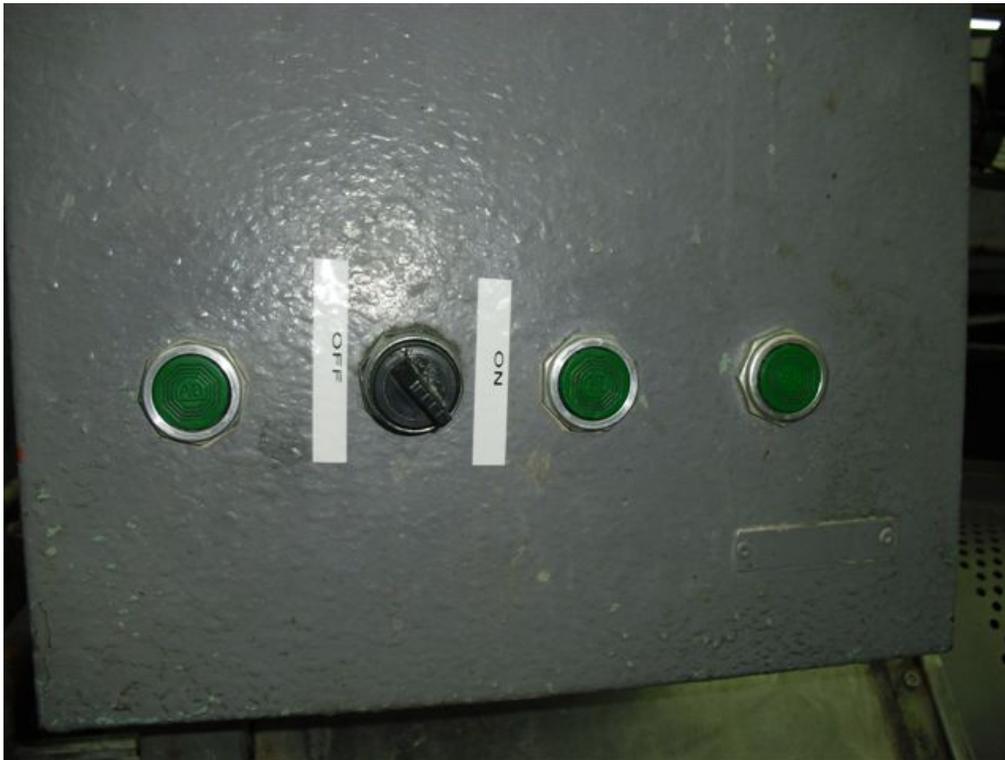
**Exhibit 6. The buttons on the control panel.**
