**California Department of Public Health  
Occupational Health Branch**

**FATALITY ASSESSMENT AND CONTROL EVALUATION PROGRAM  
(CA/FACE)**

**Two Tree Trimmers Die When They Are Electrocuted  
While Pollinating Date Palm Trees  
Case Report: 16CA003**

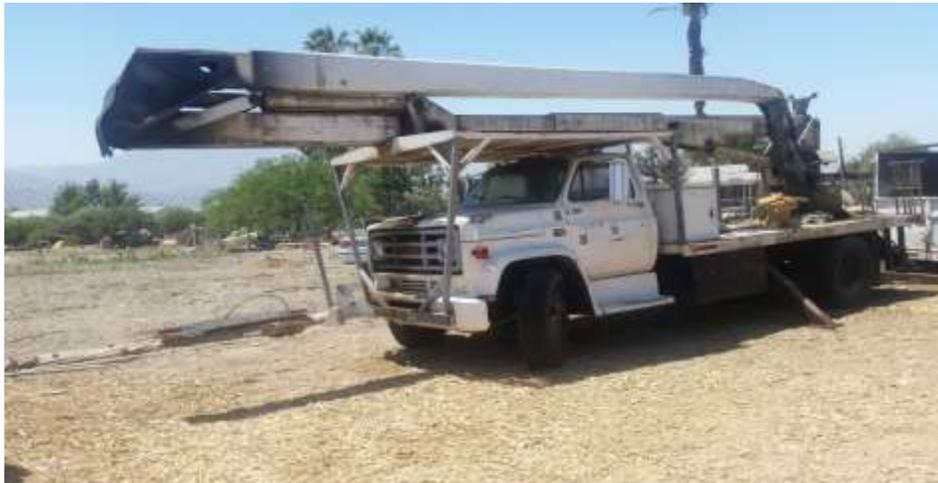
Exhibit 1. The vehicle involved in the incident.

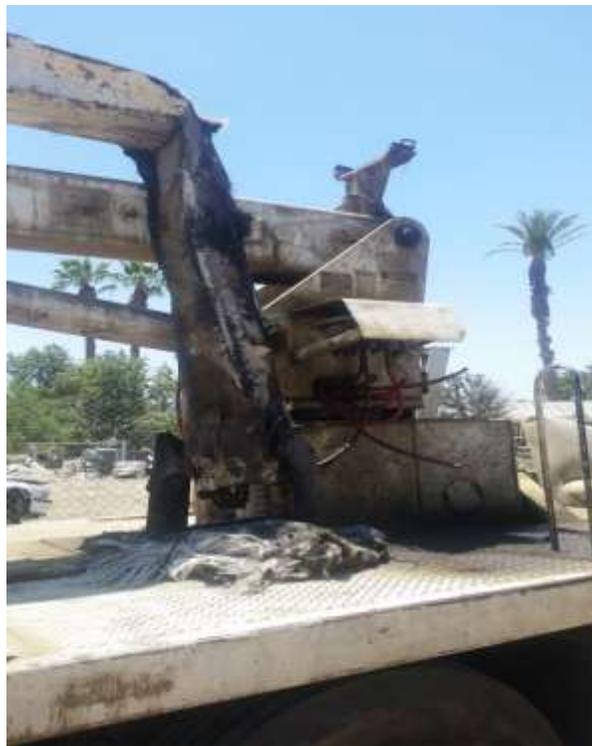
Both victims entered the bucket of the aerial lift. Using the controls inside the bucket, they raised it up directly under the high voltage lines and made contact. Victim #1 reached out to move the line and when he made contact it produced a huge electrical arc and both victims were electrocuted. The arc started a fire in the bucket and the victim #2 fell out of the bucket to the ground below.

Exhibit 2. The melted bucket that held the victims when they made contact with the high voltage electrical line.

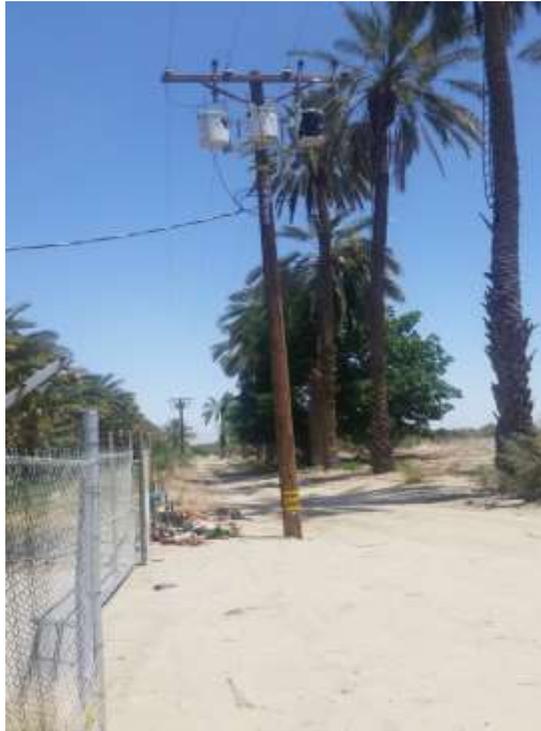
On the day of the incident, the two tree trimmers (victims #1 and #2) were continuing their work which they started five days earlier. Their assignment was to continue pollinating the date palm trees in a large orchard. They arrived at the company yard at approximately 10:30 a.m. and checked in with the owner who gave them the keys to the aerial lift truck. When they arrived at the orchard, they parked the aerial lift truck under high voltage power lines.

Exhibit 3. Location of truck (adjacent to power lines).

**Recommendation #2: Ensure there is a minimum of ten feet between the aerial lift bucket and the high voltage power lines.**

Discussion: In this incident, the work was not performed at a minimum recommended distance from high voltage power lines. To pollinate the palm trees, the two victims positioned the bucket truck in close proximity to the high voltage power lines. The victims raised the bucket and it made contact with the lines. When any boom-type lifting or hoisting equipment is operated in close proximity to high voltage power lines, a minimum clearance from the high voltage lines needs to be maintained. In this case, the minimum distance was ten feet. If the victims had positioned the bucket truck appropriately, the bucket would not have made contact and this incident would have been prevented.

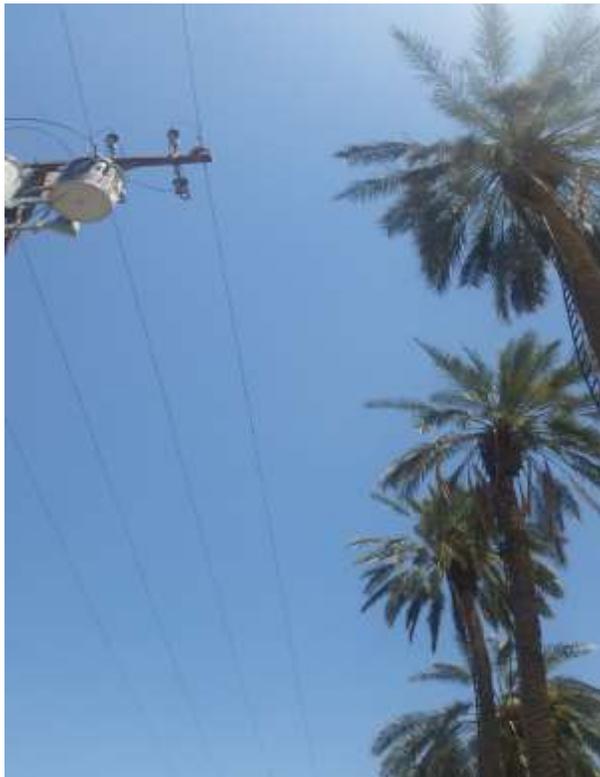
Discussion: In this incident, a high voltage power line was located about 15 feet from the top of the palm trees being pollinated, and the aerial truck was parked under the high voltage power lines. However, in raising the boom lift to access the date palms, it was foreseeable that it could contact the high voltage line. A daily job hazard analysis would have identified this risk, and safe work procedures could have been implemented to prevent this incident. For example, the aerial boom truck could have been parked on the other side of the palm trees, thereby creating a safer distance from the high voltage power lines.

Exhibit 4. The proximity of the power lines to the palm trees.

**Recommendation #1: Ensure that a daily job hazard analysis of the work area is conducted, including any electrical hazards from high voltage power lines.**

**Recommendation #4: Employers should always inform the electric company whenever working in close proximity to their high voltage power lines.**

The utility company and the employer should discuss the options for protecting workers, such as de-energizing and grounding the power lines or covering them with insulating hoses or blankets. Had the electric company been notified before the start of this job and the power de-energized, the victims' death could have been prevented.
