**FATALITY ASSESSMENT AND CONTROL EVALUATION PROGRAM  
(CA/FACE)**

**A Heating, Ventilation, and Air Conditioning (HVAC) Contractor  
Dies When He Falls Through a Skylight  
Case Report: 16CA005**

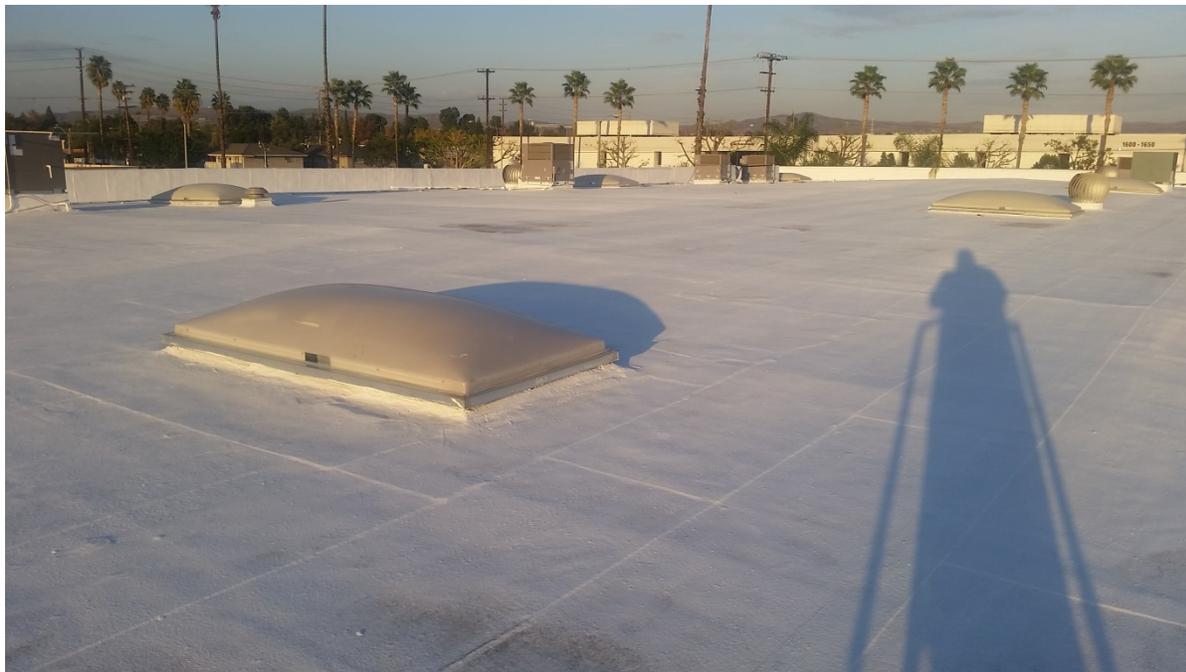
The scene of the incident was a converted warehouse that was being used as a dance and martial arts studio. The warehouse was constructed in 1972 and was approximately 130 feet long by 60 feet wide. There were six skylights on the roof. The AC equipment was located approximately five feet from the adjacent skylight. In order to encourage more enrollments, the owner of the dance studio decided to expand within the warehouse, adding theme rooms for different age groups. The construction of the theme rooms was almost complete. The owner of the dance studio asked the victim for an estimate to install additional air ducts from the air conditioning unit on the roof to each room below.

Exhibit 1. The flat roof of the warehouse showing the skylights and AC units.

**Recommendation #2: Ensure that building owners install safety nets, screens, covers, or guardrails around skylights within six feet of HVAC equipment.**

Discussion: In this incident, the skylight in close proximity to the AC unit created a serious safety hazard. Although the job was of short duration, the victim was still at risk in the event he fell onto the skylight cover. The skylight's plexiglass fixture can and should be designed to serve the function of providing ambient outdoor light into a building, while having sufficient strength to support at least twice the weight of employees, equipment, and materials that may be imposed on the cover at any one time. Architects, engineers, and employers should work together to ensure that skylight fixtures specified in the building plan meet this strength requirement. These skylight fixtures should be permanent and of sufficient strength to protect workers who access the roof from inadvertently falling through them. Until adequate design requirements are in place and skylights installed to protect workers from falling through them, HVAC contractors may not know if the skylights in their work area can support their weight. Therefore, HVAC contractors need to ensure that safety nets, screens, covers, or guardrails are in place around skylights in the immediate work area. Had the building owner installed these protective barriers around the skylights, this incident could have been prevented.

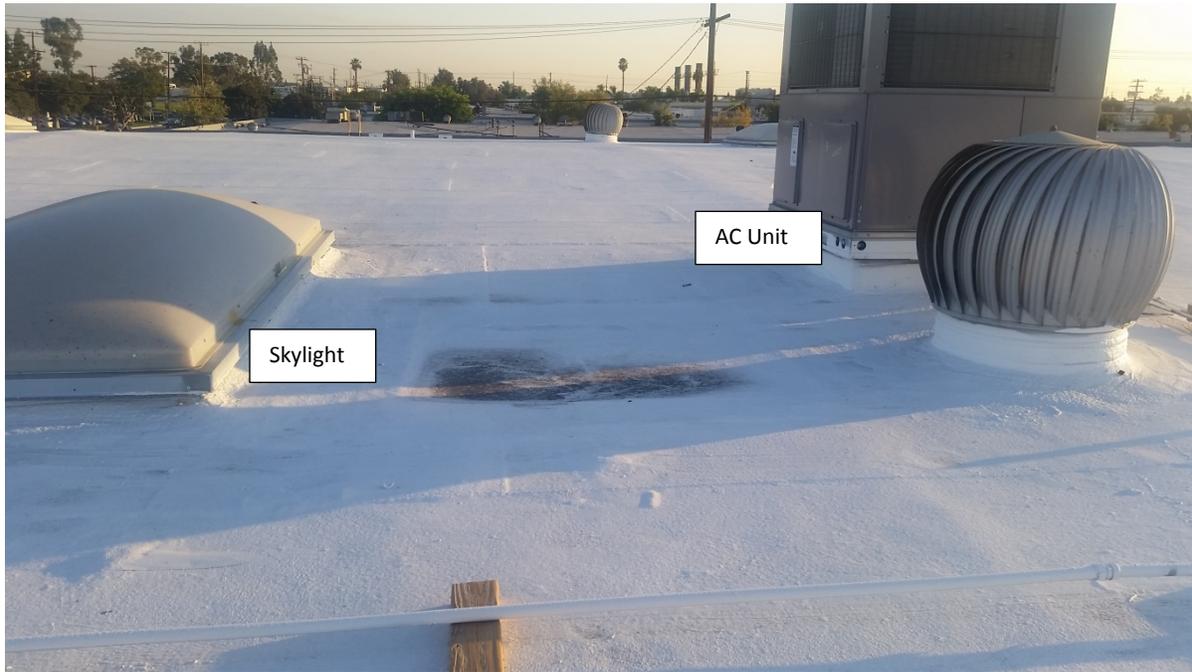
After completing a survey of the electrical panel, the victim climbed up a fixed exterior ladder on the back side of the warehouse to gain access to the flat roof of the building. He then traversed over to one of the AC units to inspect the components to determine whether additional duct work was possible. Another contractor was working below (inside the warehouse), completing the finishing touches on the theme rooms. He stated that all of a sudden he heard a scream and a crashing noise that came from one of the other theme rooms. He hurried over to the room and found the victim lying on the concrete floor underneath the broken skylight. He then went to the front office to inform the owner and called 911. Both the owner and contractor stayed with the victim until emergency medical services arrived. The victim was transferred to a local hospital where he succumbed to his injuries 19 days later.

- A daily job hazard analysis of the work place was not performed.
- Working in close proximity to an unprotected skylight.
- The skylight was not designed to support the weight of a worker.

Exhibit 2. The incident scene.

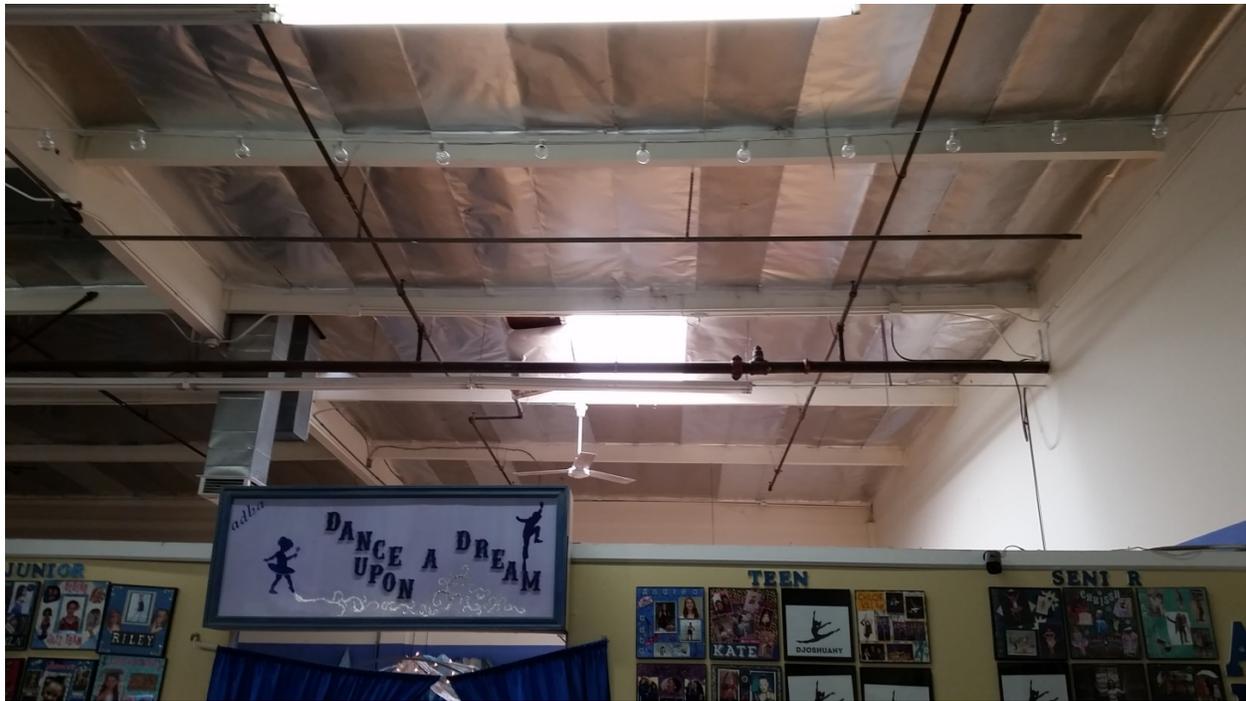
Exhibit 3. The dance studio theme room skylight opening involved in this incident.
