**FATALITY ASSESSMENT AND CONTROL EVALUATION
PROGRAM (CA/FACE)**

**A Tree Feller Dies When Struck By a Tree Limb
While Felling a Fire-Damaged Tree
Case Report: 17CA004**

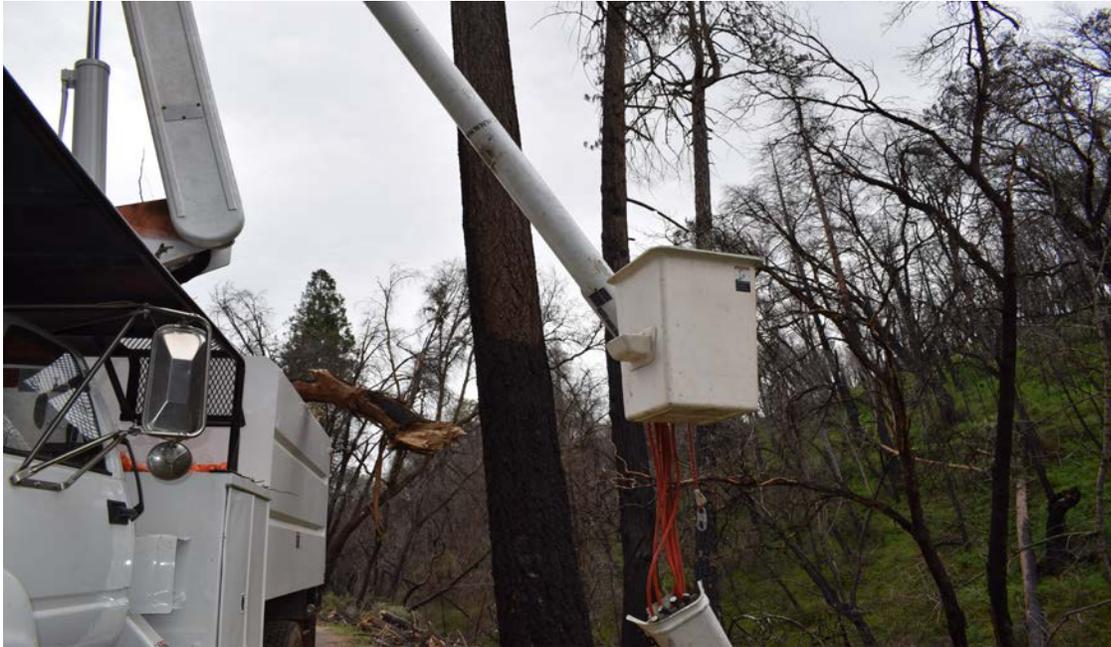
This time, as the excavator pulled, the spar initially moved as intended, but then abruptly changed direction and fell (at a right angle to the rigging line) towards the bucket truck. The upper part of the tree section struck the elevated boom arm and slid down the sloped arm towards the bucket, striking the victim and bouncing him out of the bucket (Exhibits 1 & 2). As he hung suspended from his body harness, his co-workers were able to reach and unclip him, and lay him on the road. The time was approximately 11:10 am.

Exhibit 1. The bucket truck after the victim was struck and knocked out of the bucket.
Photo used with permission.

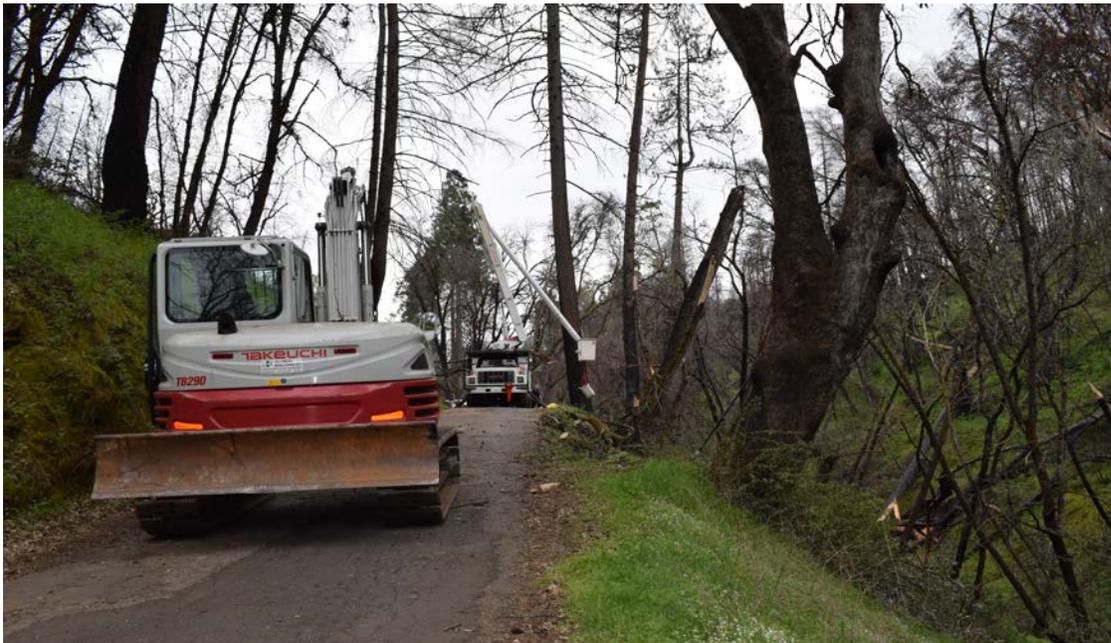
Exhibit 2. The trunk of the tree to the right of the road, and the bucket truck and mini-excavator used by the crew. Photo used with permission.
