**FATALITY ASSESSMENT AND CONTROL EVALUATION PROGRAM
(CA/FACE)**

A stationary engineer died when the multi-piece tire
and wheel he was disassembling exploded

Case Report: 19CA002

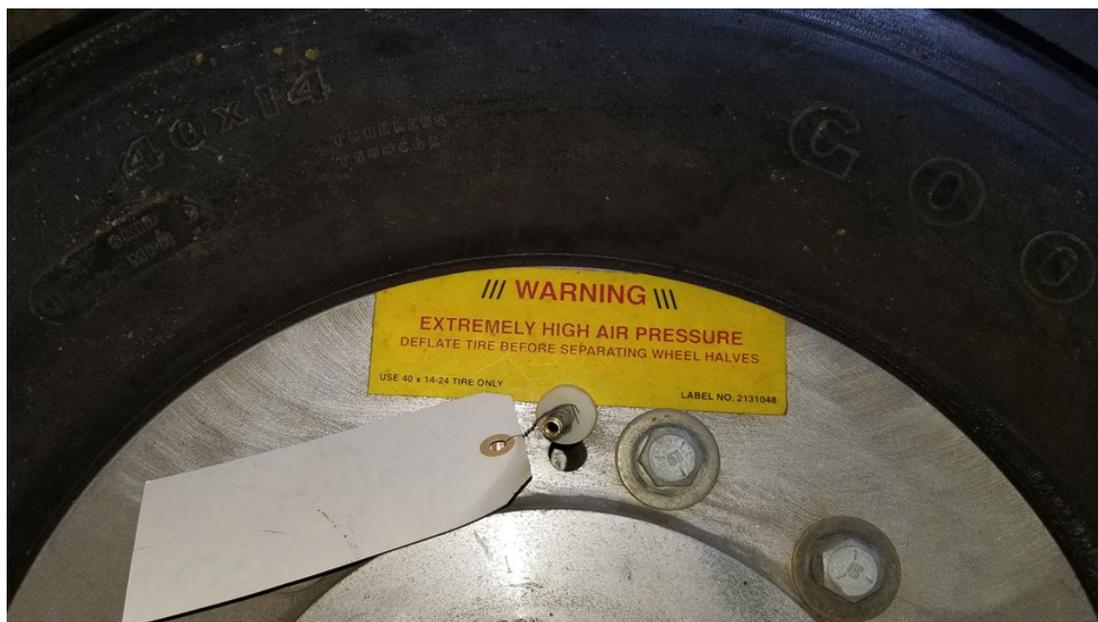
Discussion: In this incident, the victim and co-worker began working on the wheel assembly without deflating the tire. The employer had written safety procedures and training that included the deflation of tires, and the victim had performed this task many times in the past. According to employer procedures, the workers on the previous shift were responsible for deflating the tire prior to removal from the boarding bridge. It is not known why the tire was not deflated at the time it was removed and placed in the maintenance shop. It is also not known if the victim assumed that the tire was deflated prior to beginning work. The warning label (Exhibits 5 & 6) regarding deflation was present on the tire, and the valve was still present.

Exhibit 5. Warning sticker placed on all tire/wheel assemblies used on passenger boarding bridges.

Recommendation #1: Implement policies and procedures as part of a safety program to ensure that tires are deflated prior to wheel disassembly.
