**FATALITY ASSESSMENT AND CONTROL EVALUATION PROGRAM
(CA/FACE)**

A water truck operator died after being struck by a pressurized hose
Case Report: 19CA003

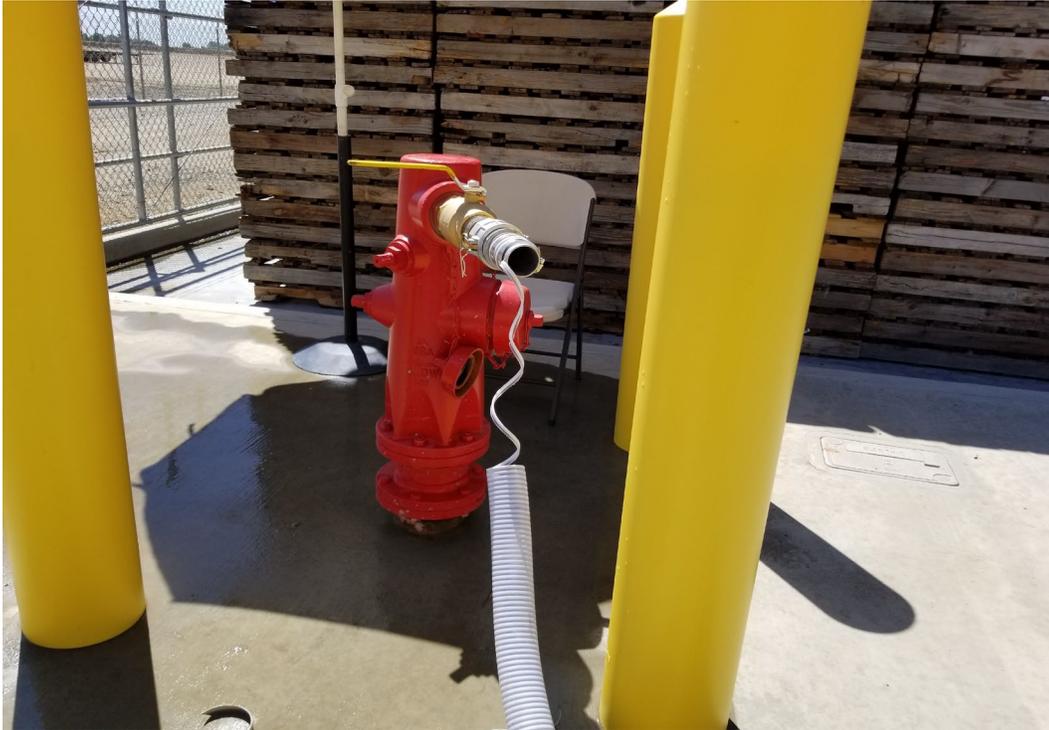
On the day of the incident, the victim was filling the water truck from the hydrant of the neighbor's water tank (Exhibit 1). The victim used a thermoplastic rubber bulk water discharge hose with polyethylene helix reinforcement that was provided with the water truck (Exhibit 2). This hose was only designed to withstand a maximum working pressure of 50 psi, which was in the range of the normal groundwater supply. He connected the hose to the truck and hydrant, then opened the hydrant's outlet ball valve. Unlike the normal procedure, the victim did not open the inlet ball valve on the truck (Exhibit 3). As he was attempting to fill the truck, the hose burst and struck the victim, causing him to fall to the ground and strike his head. The safety supervisor was walking by the water truck and noticed the victim on the ground. The supervisor shut the hydrant off and notified another manager who then called 911. The supervisor performed CPR on the victim until the paramedics arrived and transported him to a local hospital. He died from his injuries two days later.

Exhibit 1. The fire hydrant involved in the incident.

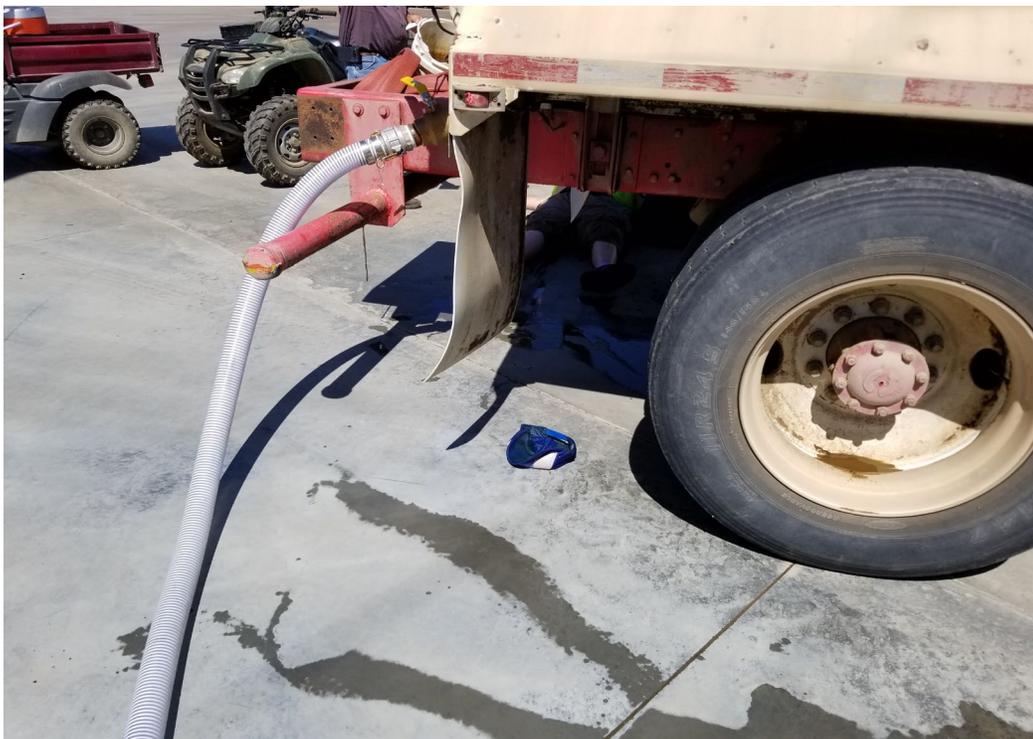
Exhibit 2. The hose connected to the water truck.

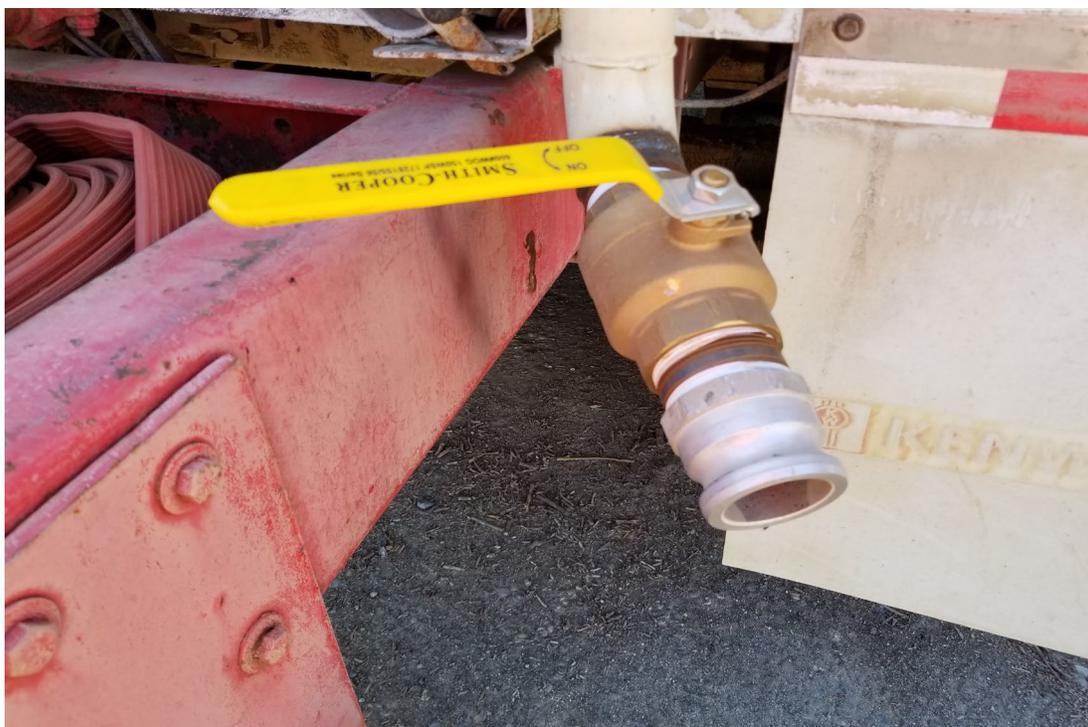
Discussion: In this incident, the victim began transferring water from the hydrant without first opening the intake ball valve on the truck. Because this valve was not turned on first, pressure in the hose caused it to swell and then burst, knocking the victim to the ground.

Exhibit 3. The inlet ball valve on the rear of the water truck.

Recommendation #2: Implement policies and procedures as part of a safety program to ensure that unsafe conditions are identified, and safe work practices are followed.

The victim was an experienced seasonal employee and had transferred water safely on numerous occasions in the past. However, this type of water transfer was not the typical source that was used. The employer had written safety procedures and training that included the safe transfer of water. Their correct procedure was to first connect the hose to the water tank hydrant outlet ball valve, then to the inlet ball valve on the truck. Once the hose was secured in place, the ball valve on the truck was to be opened first, followed by the ball valve on the hydrant. In this incident, the victim connected the hose to the truck and hydrant, then he opened the water tank valve but did not open the valve on the truck. Although the employee had received safety training, there was no communication or method to ensure that the proper procedure occurred. For example, written check-off sheets and/or periodic and regular safety audits with direct observation can be used to ensure that safe work practices are followed. In addition, employee safety training should be verified through written testing, oral confirmation, or demonstration. If these procedures had been implemented, the victim may have realized that the truck valve was not open, and this incident could have been prevented.

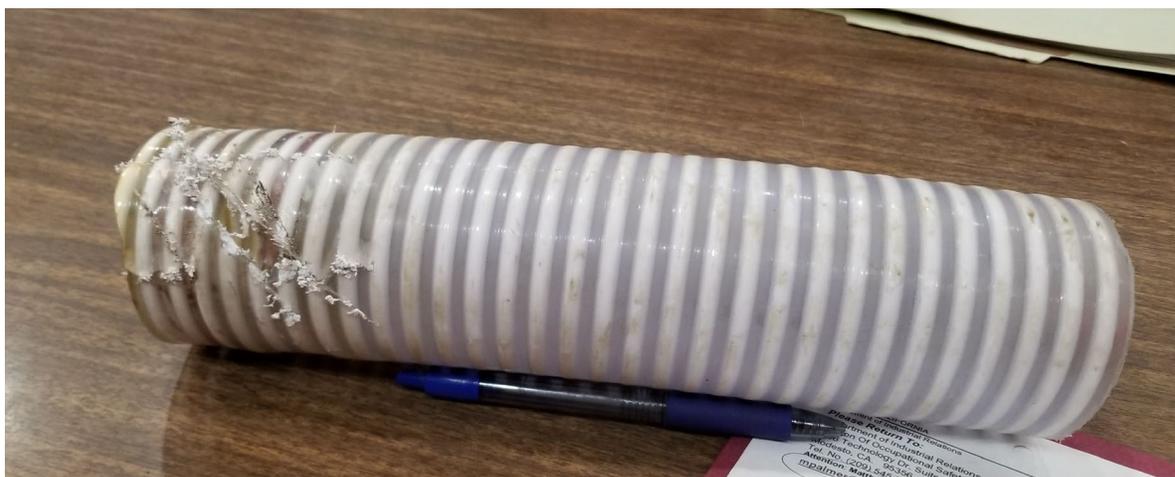
Discussion: In this incident, the hose used to transfer water from the water tank to the truck was a thermoplastic rubber bulk water discharge hose with polyethylene helix reinforcement (Exhibit 4). This type of hose can only withstand a maximum working pressure of 50 psi. A more adequate hose would have been an ethylene propylene diene monomer (EPDM) bulk water discharge hose with spiral-ply synthetic fabric reinforcement, a vinyl nitrile water discharge hose with wire helix reinforcement, or a polyvinyl chloride (PVC) bulk water hose with a rigid PVC helix reinforcement. EPDM bulk water discharge hoses are used for pumping water in quarries, mines, construction sites, and other abrasive environments and can withstand working pressures up to 300 psi. This type of hose was not on the truck and thus not available for the victim to use. Had a hose with the proper design been used to fill the truck, pressure from the hydrant would not have caused the hose to burst, thereby preventing this incident.

Exhibit 4. A portion of the hose involved in the incident.

Recommendation #1: Ensure that the machinery and equipment provided to transfer high-pressure water can safely withstand all reasonably anticipated loads.
