REPORT#: 23CA005

REPORT DATE: April 10, 2025

A Welder Dies from Methylene Chloride Exposure While Removing Oil Residue from the Inside of a Motor Oil Tank — California

Fatality Assessment and Control Evaluation (FACE) Program

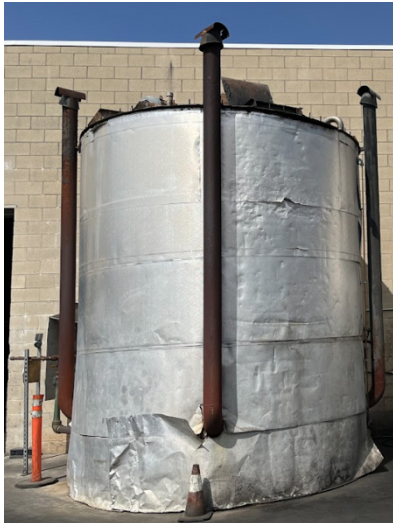
The incident scene was an empty motor oil tank located at an oil manufacturing facility (Exhibit 1). The tank was 20 feet high by 10 feet wide and was used to prepare motor oils. The tank did not have a ladder, and the only entrance was through a manhole located on the top of the tank. There were no confined space warning signs on or around the tank.

Exhibit 1: Exterior of the oil tank. Photo courtesy of the CA/FACE program.

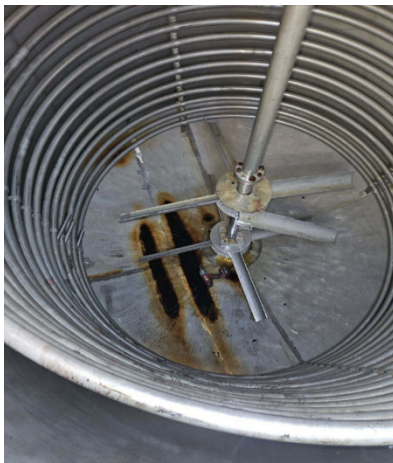
A few days prior to the incident, an oil company employee (oil mixer) noticed a bolt came through a hose, indicating that a blade inside the tank may have come loose (Exhibit 2). The victim was called by the oil company to inspect and repair the blades. On the day of the incident, the motor oil tank was empty, and

Exhibit 2: Blades inside the motor oil tank. Photo courtesy of the oil company.

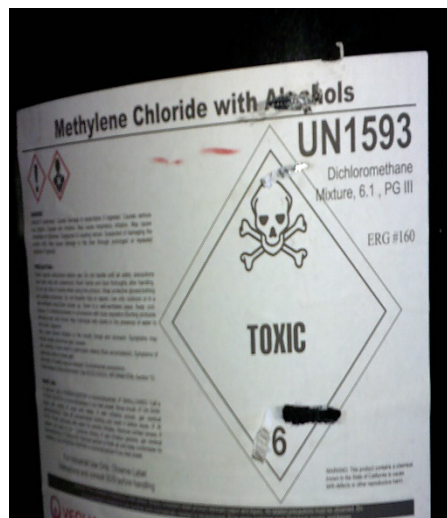
The victim inspected the work area and told the warehouse cleaner that he was slipping on the oil residue left at the bottom of the tank. The victim requested a liquid product to remove the oil residue. The cleaner gave the victim a 5-gallon container (product name unknown) that contained methylene chloride that had been purchased more than 1.5 years prior to the incident and was stored onsite. There was a warning label on the outside of the container (Exhibit 3). Based on the police report, the warehouse cleaner mentioned to the victim that the container was almost empty and an alternative procedure to clean the oil tank (self-heating system to evaporate the residual oil) could be used instead. However, this procedure was not implemented on the day of the incident, and the victim used the product with methylene chloride. According to the warehouse cleaner, the victim used approximately two cups of the methylene chloride product to clean the bottom of the tank.

Exhibit 3. Label on the outside of the container. Photo courtesy of the police department.

Recommendation #1: Avoid purchasing, storing and/or using products that contain methylene chloride.

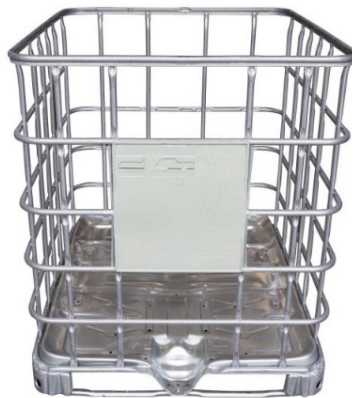
According to the police report, police officers arrived on the scene at 11:42 a.m. They were dispatched to respond to a man down inside an oil tank. Multiple fire engines and personnel responded and arrived on the scene at 11:46 a.m. Emergency responders, along with the employees of the oil company, used a forklift, tie-down straps and a cage to successfully extract the victim (Exhibit 4). The victim was pronounced dead at the scene at 12:29 p.m.

Exhibit 4: A steel cage like the one used to lift the victim up and down with a forklift.
Photo courtesy of Global Industrial.
