SUBJECT: A heavy equipment operator died when the dump truck he was backing slid down an embankment and then tumbled over.

SUMMARY
California FACE Report #02CA001

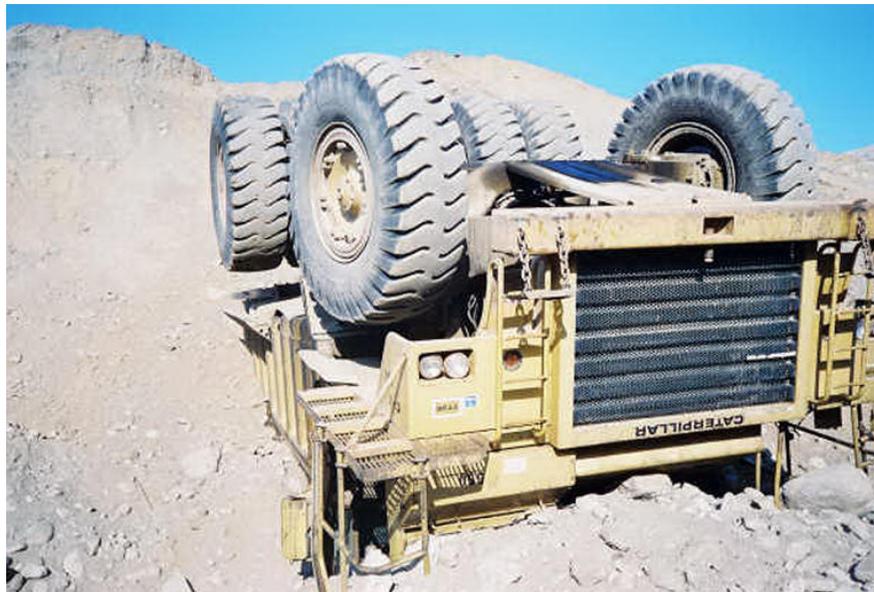
02CA001
Exhibit #2

The ground beneath the rear tires gave way and the dump truck started to slide down the embankment. It continued down the embankment slowly for about 50 feet, then the rear of the bed of the truck wedged into the dirt causing the front of the truck to go vertical and then it rapidly turned over rear to front with the victim belted in the cab. The dump truck finally came to rest in an upside down position with the cab intact. Witnesses to the incident ran to the dump

View of the truck as it came to rest after tumbling over the embankment.

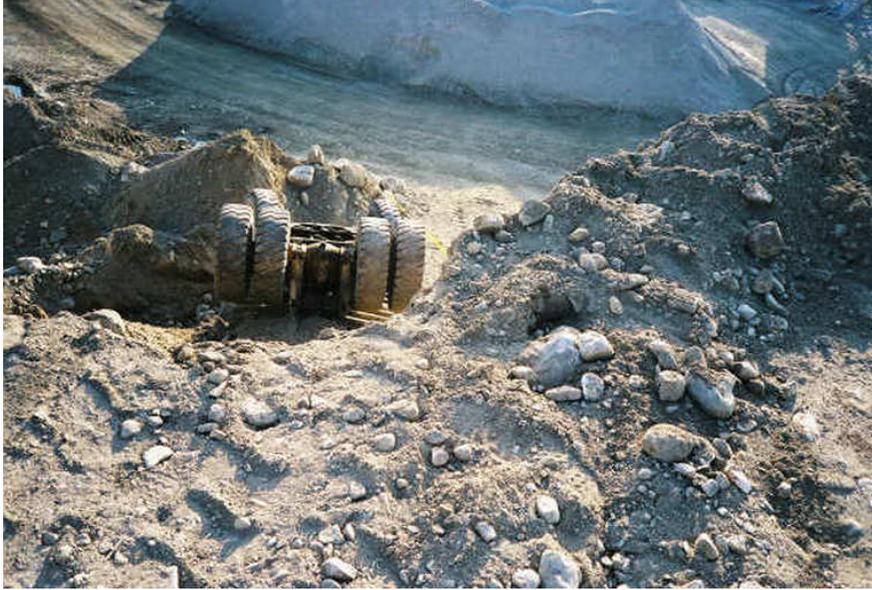
02CA001
Exhibit #3

View of the truck looking down from the top of the embankment.

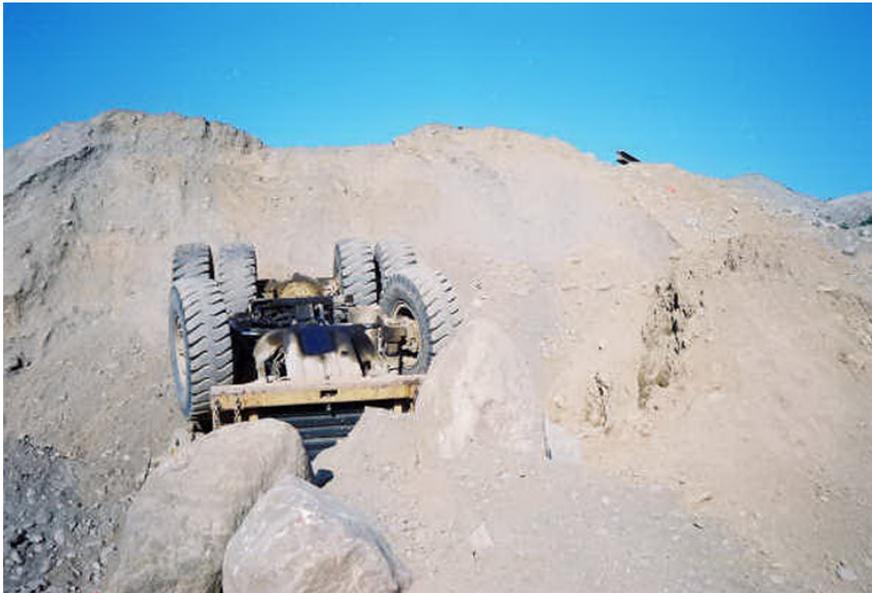
02CA001
Exhibit #4

View of the truck looking up from the bottom of the embankment.

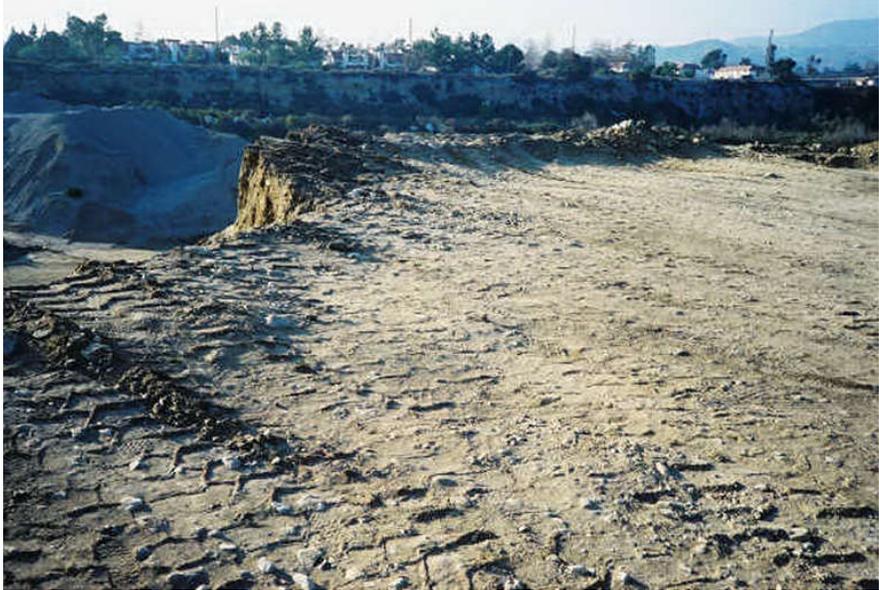
02CA001
Exhibit #5

The site of the incident was a gravel pit that crushed rock and dirt. The rock and dirt were excavated in a separate area of the pit, then transported by truck to a designated area called the "dump pad" which was located on top of an embankment approximately 70 feet high (**see Exhibits #5&6**). Trucks would back up to the dump pad and dump their load as close to the edge of the embankment as possible. A bulldozer would then push the rock and dirt over the embankment and reestablish the berm. A berm is a mound of gravel and dirt at the edge of an embankment that is piled high enough to prevent trucks from over-traveling and over-turning. The truck involved in this incident was a 58 ton rock dump truck that was constructed for this purpose only and not subject to vehicle registration. The victim was not required to have a special license or certification to operate the truck.

Discussion: Berms, when properly installed, should prevent trucks from over-traveling and over-turning at dumping locations. In this particular case, the berm was inadequate in height and width to stop the truck. Had the berm been properly installed at this job site, this incident might have been prevented.

View of the area looking north where the truck went over the embankment.

Recommendation #1: Ensure berms are adequately built to prevent trucks from over-traveling and over-turning at dumping locations.

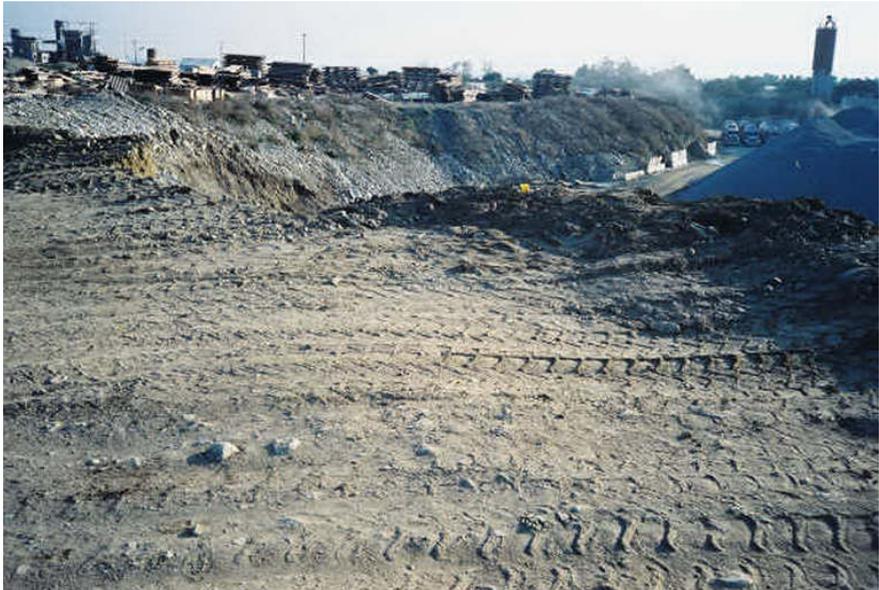
02CA001
Exhibit #6

View of the area looking south where the truck went over the embankment.
