SUBJECT: A welder dies after being crushed by a hydraulic door on a scrap metal shredding machine.

SUMMARY
California FACE Report #02CA004

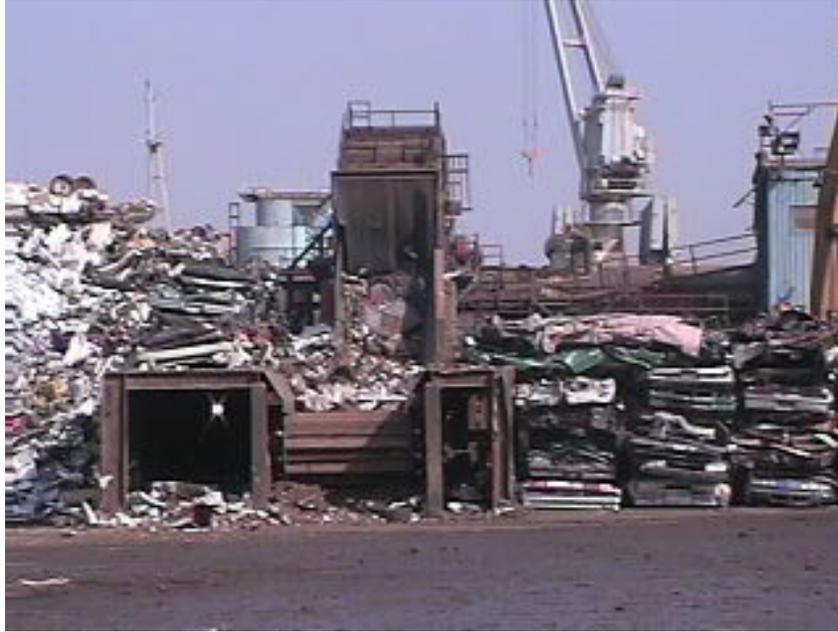
02CA004
Exhibit #1

The site of the incident was a 27-acre full-service scrap metal facility that processed, recycled and exported all grades of ferrous metal. The machine involved in this incident was a ferrous metals shredder referred to as the "Mill" (**exhibit #1**). The mill consisted of an 8 foot wide conveyor made of connected metal pans running on a track, a hooded hopper that contained a metal shaker, drum and hammers, and a hydraulically operated rejection door (**exhibit #2**). Material placed on the conveyor would be fed into the hopper (**exhibit #3**) where it would be shredded by hammers attached to a rotating drum (**exhibit #5**). Whenever pieces of metal were unable to be shredded by the hammers, the operator of the system would open the hydraulically operated throw-out door, which flips down, to allow the unshredded metal to by-pass the hammers and be recycled (**exhibit #6**). The shaker would take the shredded material and give a uniform feed to a conveyor belt where the material would pass through a series of magnets to separate ferrous metal from non-ferrous pieces.

Front view of the shredding machine called the "Mill" involved in this incident.

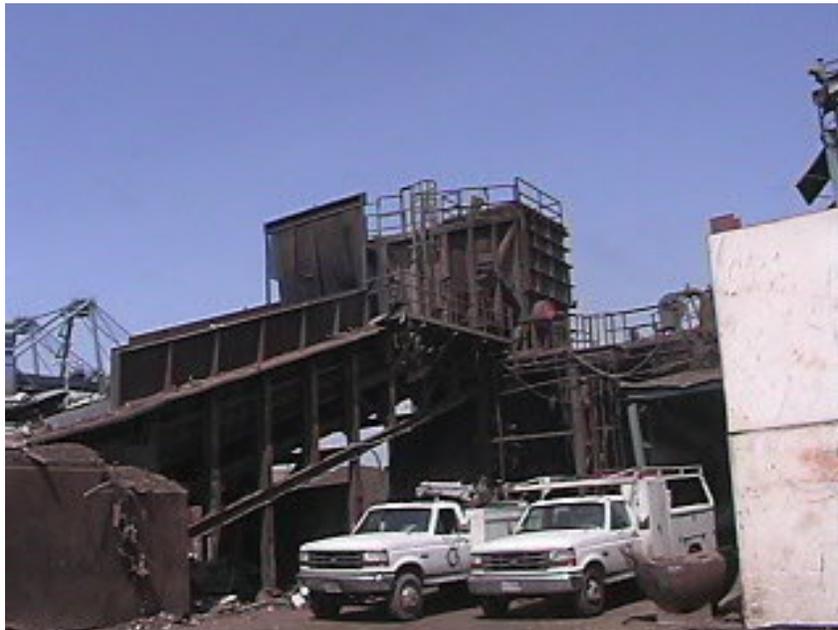
02CA004
Exhibit #2

Side view of the mill showing the conveyor rail and hopper.

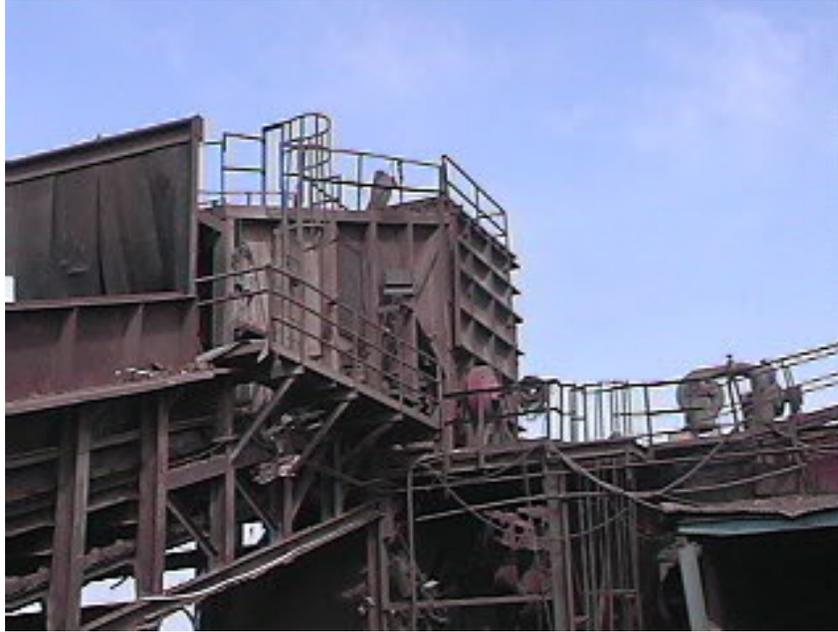
02CA004
Exhibit #3

View of the hopper containing the metal shaker, drum, hammers and throw-out door.

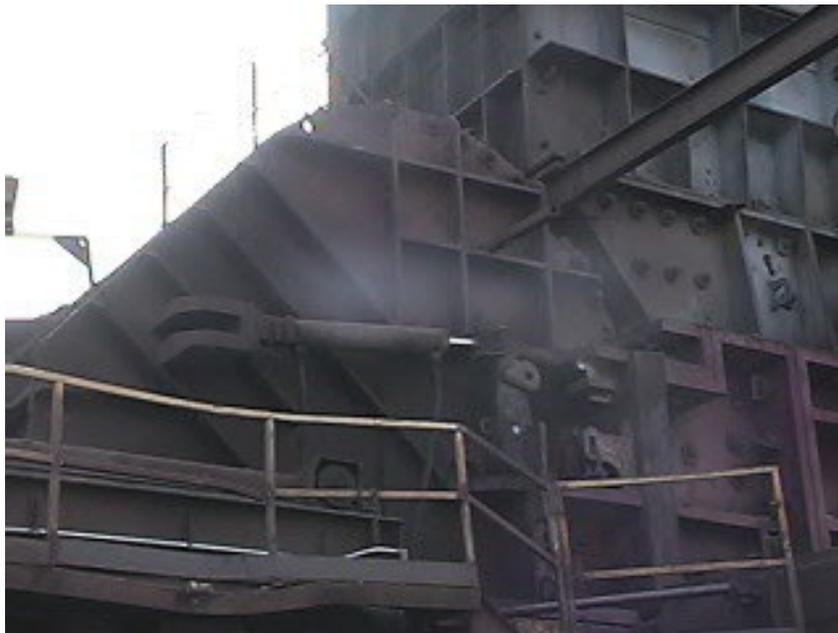
02CA004
Exhibit #4

View of the hydraulic cylinder used to open and close the throw-out door.

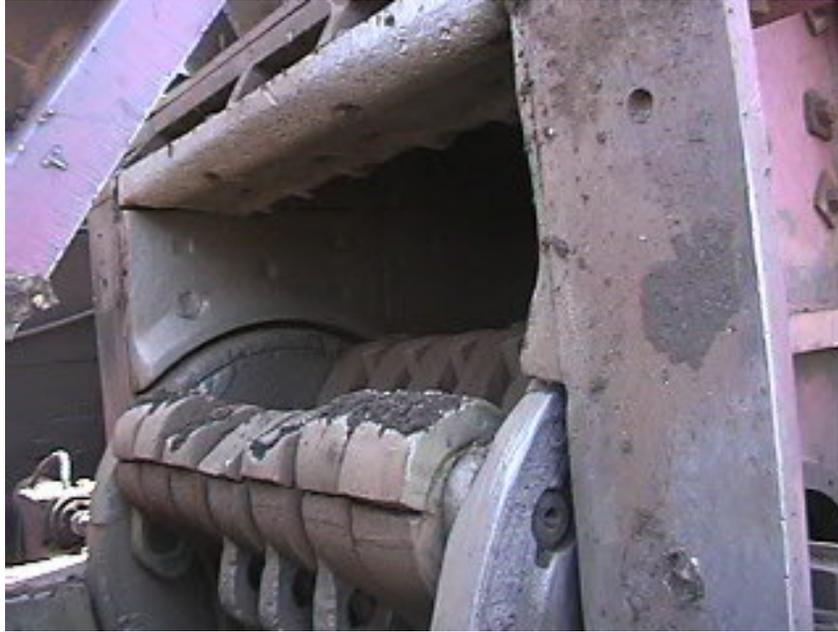
02CA004
Exhibit #5

Left side view of the drum and hammers within the hopper.

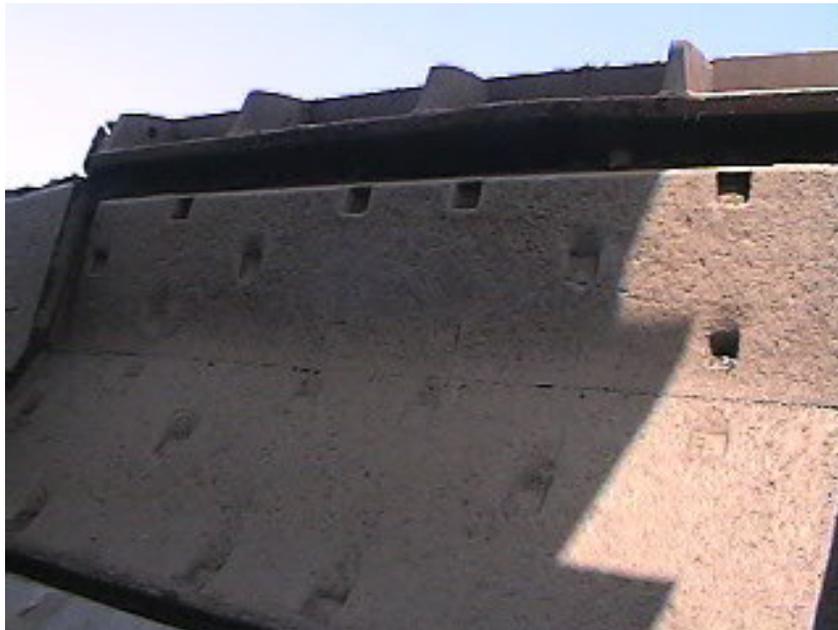
02CA004
Exhibit #6

On the day of the incident, the mill had just been started and was shredding pieces of ferrous metal being fed into the hopper by the conveyor. When the operator of the mill opened the throw-out door to allow the unshredded metal to be recycled, the throw-out door jammed with a piece of metal, preventing it from closing. The un-jamming of the hydraulic door was a common task that until this time had been performed without incident. The owner of the mill did not consider the frequency of the jams to be unusual for this type of machine or this type of work.

The victim was sent to remove the jam by his supervisor. The victim had performed this maintenance activity frequently in the past. He got a ladder, torch and padlock and went to the hopper. The victim used the ladder to gain access to the jammed door. Although two co-workers stated that the victim told them that he had locked out the system, the system had not been locked-out or de-energized. The victim laid across the top edge of the door and cut away the obstruction with the torch. When the piece of metal was cut away, the hydraulic door, which was still under pressure, closed upward on the victim. The supervisor, who was observing the operation, was knocked off the ladder he was standing on when the door slammed shut. He sustained a severe back injury. A co-worker was able to activate the hydraulic door and release the pressure on the victim. He was then removed from the door to an adjacent catwalk where CPR was performed. The paramedics arrived and checked for spontaneous pulse and respiration and found none. He was pronounced dead at the scene. The lock that was supposed to be used to lock out the system was recovered from the victims clothing.

Right side view of the hydraulic throw-out door that crushed the victim.

Recommendation #2: Ensure employees block mechanisms from moving prior to performing repairs or maintenance.

Discussion: Even though a mechanism may be disconnected, drained, isolated, dissipated, or turned off, it still may be necessary to block the device if it is capable of movement. Many manufactures make blocking devices for their products used in conjunction with other machines. A blocking device is added protection to assure no unwanted movement especially when employee safety is involved. Had a blocking device been used to prevent the throw-out door from moving, this incident might have been prevented.

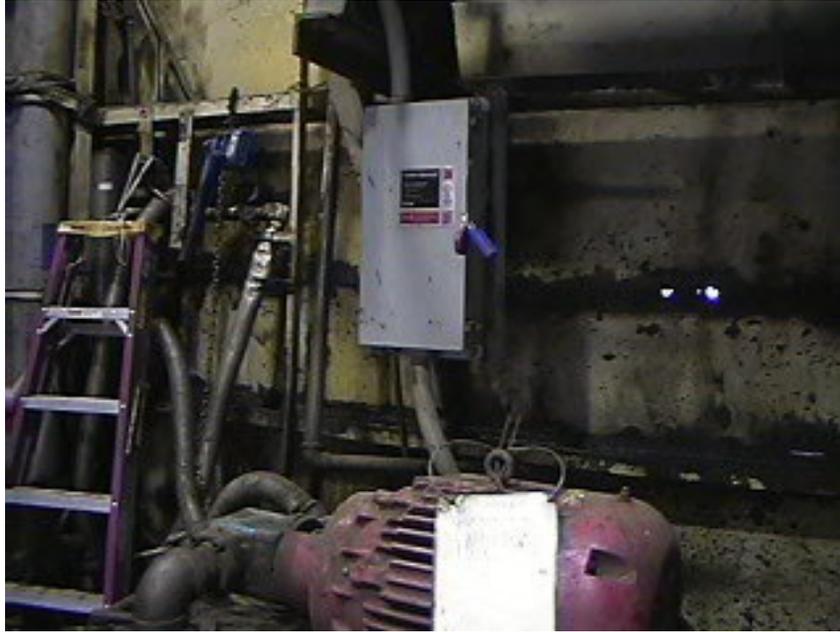
02CA004
Exhibit #7

View of the electrical panel and motor controlling the hydraulic system.

Recommendation #1: Ensure all employees follow the company's established procedures for de-energizing of energy sources and lockout / tagout.

Discussion: It is essential that machinery should be de-energized, disengaged, or isolated prior to any cleaning or maintenance. In addition, the source of energy must be locked out so others cannot re-energize the machine when an employee is in an area of danger. It is also necessary to place tags at the energy sources to warn others that the machine is locked out of service. The company had an extensive written lock out/tag out procedure in which the victim was trained. Employers need to ensure that employees are properly implementing required safety procedures.
