SUBJECT: An apprentice mechanic died when crushed in a machine that stacks wooden pallets.

SUMMARY
California FACE Report #03CA003

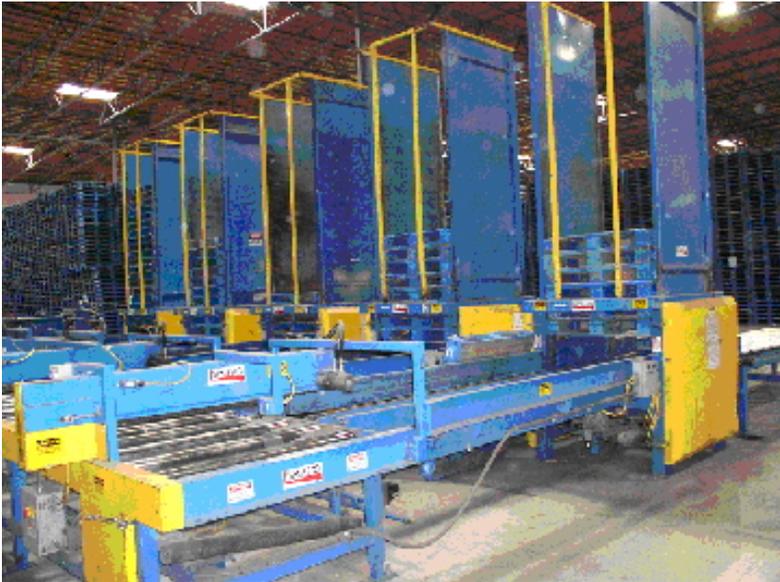
**03CA003
Exhibit #1**

On March 17, 2003, at approximately 8:00 p.m., a 44-year-old apprentice mechanic was killed when he got caught in the hydraulic mechanism of a pallet stacking machine (**Exhibit #1**). The CA/FACE investigator learned of this incident on March 27, 2003, through the Legal Unit of the Division of Occupational Safety and Health (Cal/OSHA). On April 23, 2003, the CA/FACE investigator traveled to the victim's place of employment where he interviewed company personnel and employees who responded to the incident. The investigator also inspected the incident site and took pictures of the machine involved in the incident.

View of the pallet stackers from the front or loading end.

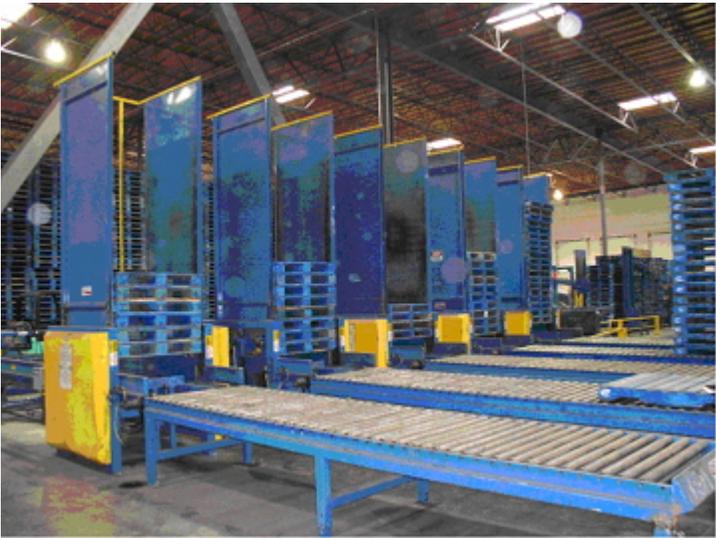
**03CA003
Exhibit #2**

The site of the incident was a warehouse complex. The facility within the complex where the incident occurred manufactured, inspected, repaired, and distributed wooden pallets. It used a high-speed pallet sorting and stacking machine for this process. The fully automated system took the sorted pallets off a roller conveyor and stacked them to a designated number (1-20) (**Exhibit #1**). The automated system was controlled through a series of electric eye sensors. When the pallet passed the first sensor, the automatic device used to pull the pallet into place was activated. When the pallet was pulled in place, another sensor was activated to start the stacking cycle. The hydraulic stacker lifted the pallet onto lifting dogs, and then went back down completing the cycle (**Exhibit #4**). Lifting dogs are mechanical holding devices that grasp an object (usually on its edge) and hold it in place. A chain mechanism took the pallet into the stacking mechanism and passed another sensor, which counted the number of pallets stacked. When the desired number of pallets was reached, the machine ejected the stack onto the outgoing roller conveyor for removal and storage or shipping (**Exhibit #2**).

View of the pallet stackers from the rear or unloading end.

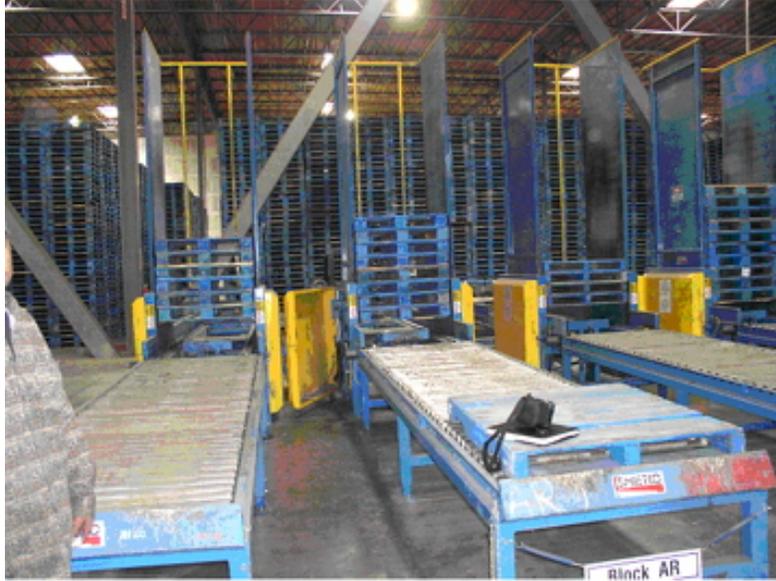
Exhibit #3

View of the pallet stacker involved in the incident.

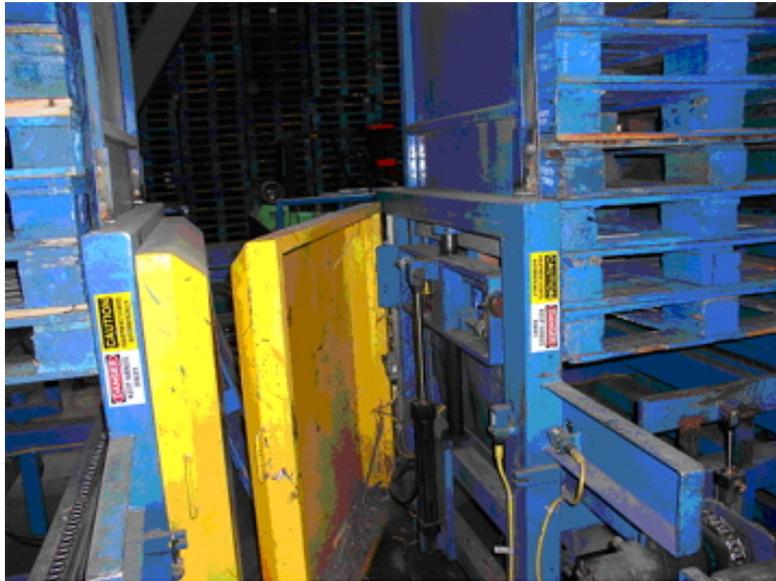
Exhibit #4

View of the hydraulic mechanism and electronic eyes used in the stacking process.

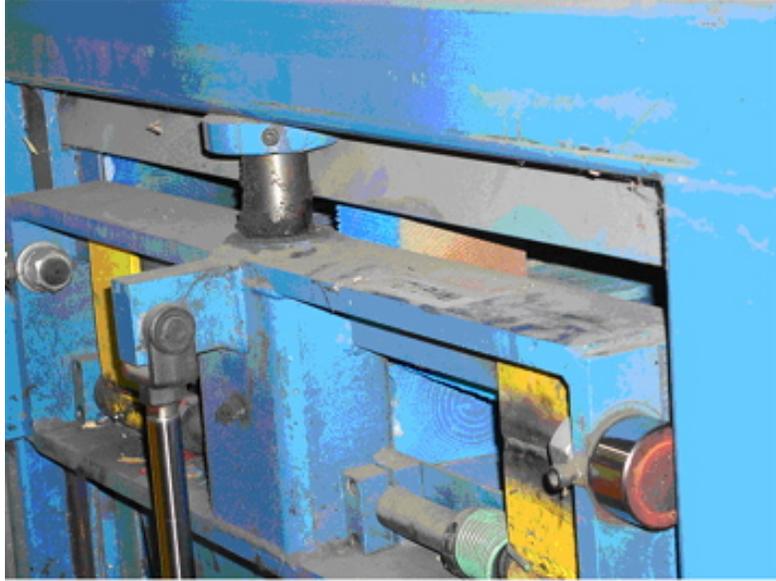
03CA003
Exhibit #5

A view of the hydraulic mechanism that crushed the victim.

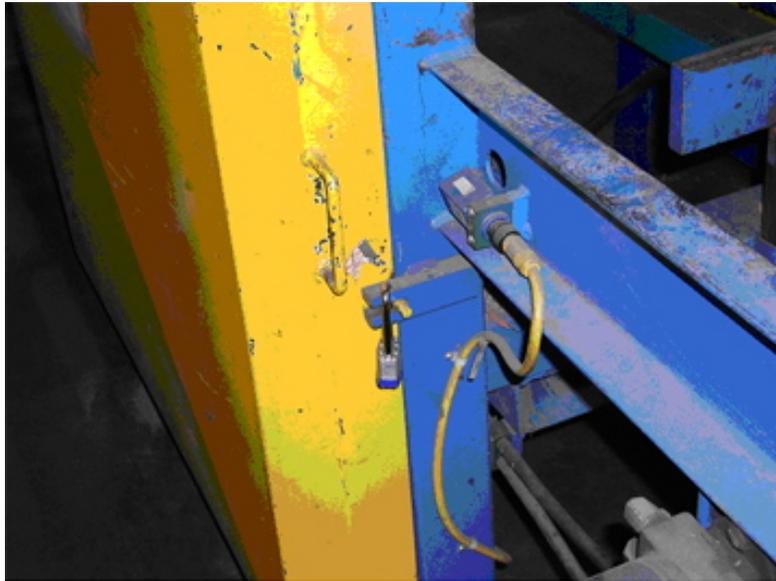
03CA003
Exhibit #6

A view of the electronic eye sensor that activates the hydraulic mechanism.
