SUBJECT: A butcher died after getting his hand caught in a meat grinder.

SUMMARY
California FACE Report #03CA008

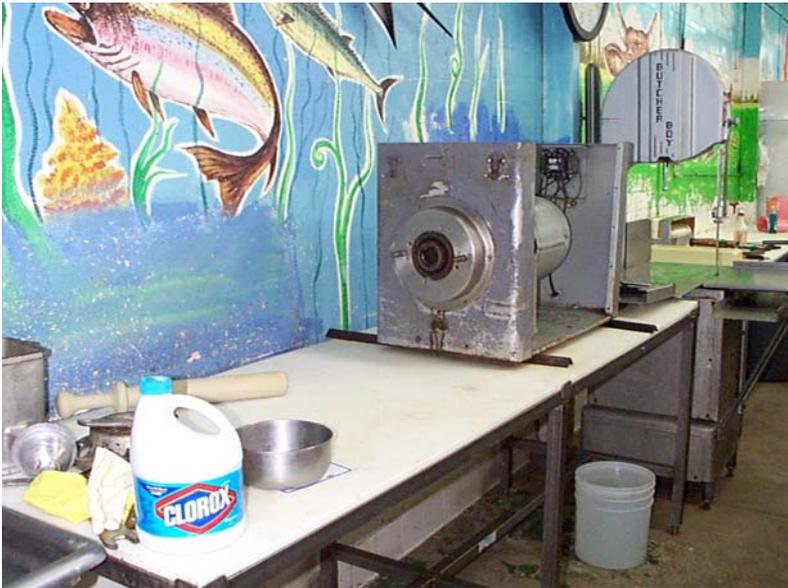
03CA008
Exhibit #1

The site of the incident was a small grocery and meat market that was privately owned. The machine involved in the incident was a screw type meat grinder (**Exhibit #1**). The meat grinder was discarded before this investigation took place. It is not known if the meat grinder had an interlock safety switch that shut off the power when the feed pan was removed, or if the switch was faulty, or if it had been by-passed.

On the day of the incident, the victim was grinding meat for sausages using the market's meat grinder. According to a market employee, the victim had finished grinding the meat and was cleaning the grinder. The victim removed the food tray and put his hand inside the bowl of the meat grinder to remove a piece of meat that was stuck inside. Two employees of the market, who heard the victim scream, responded to his aid and tried to remove the victim's hand from the meat grinder but were unsuccessful. The paramedics were called and had to disassemble the meat grinder and take part of it with the victim as they transported him to the hospital. The victim went immediately into surgery, but died the next day.

A picture of what was left of the meat grinder after the incident. The grinding mechanism was removed by the paramedics and transported to the hospital with the victim.

Recommendation #1: Ensure users of meat grinders disconnect or lockout and tagout the power source before starting the cleaning process.

Discussion: The cleaning of a meat grinder should always include the disconnection from its energy source to prevent any contact with moving parts. An energy control procedure would give specific safety instructions to those using the store's meat grinder on how to properly disconnect the power source before cleaning. This should be part of an employer's Injury and Illness Prevention Program (IIPP). Employers can ensure employees follow safe work practices through programs of training, supervision, rewards, and progressive disciplinary measures. Employers who allow others to use their equipment should develop a contractual agreement between the parties that includes an agreement that safety procedures are to be followed when using equipment, in this case safety procedures for using and cleaning a meat grinder.

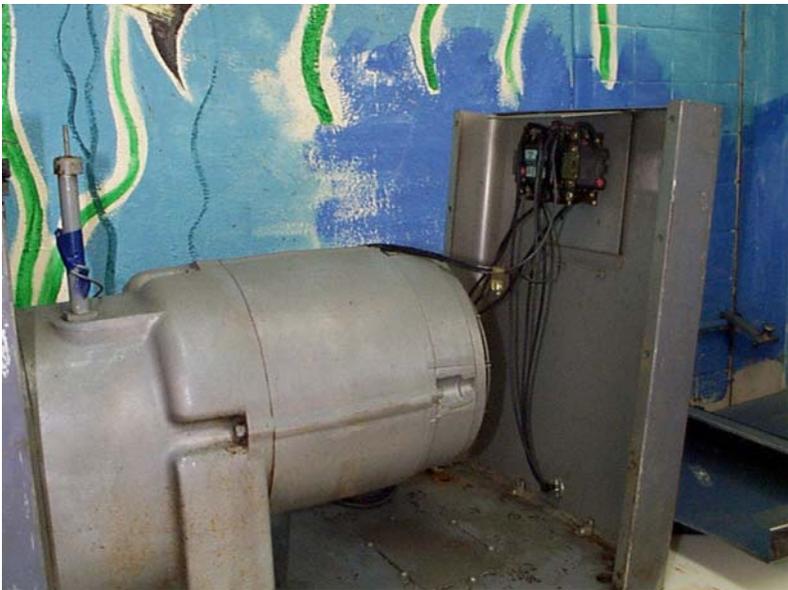
03CA008
Exhibit #2

A picture of the meat grinder’s motor that was involved in the incident.
