TO: Director, National Institute for Occupational Safety and Health

FROM: California Fatality Assessment and Control Evaluation (CA/FACE) Program

SUBJECT: An automotive mechanic died when the vehicle he was working under slipped off a lift and fell on him.

SUMMARY
California FACE Report #03CA010

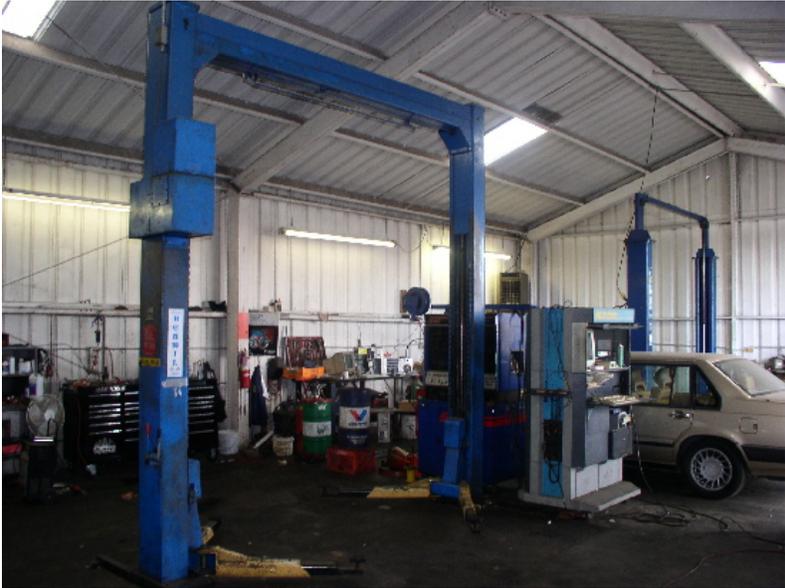
03CA0010
Exhibit #1

The site of the incident was an automotive repair shop which had eight bays and six lifts. The automotive lift involved in this incident was a 2-post, surface-mounted hydraulic lift with a capacity of 7,000 pounds that was manufactured around 1964 (**Exhibits #1, 2, & 3**). The vehicle involved in this incident weighed less than 7,000 pounds. The lifting arms on the lift were the outrigger type that were adjustable to accommodate the vehicle being lifted. The lifts were installed in the shop by the previous owner. The present owner had no manuals or books on the lift involved in this incident.

A picture of the automotive lift involved in this incident.

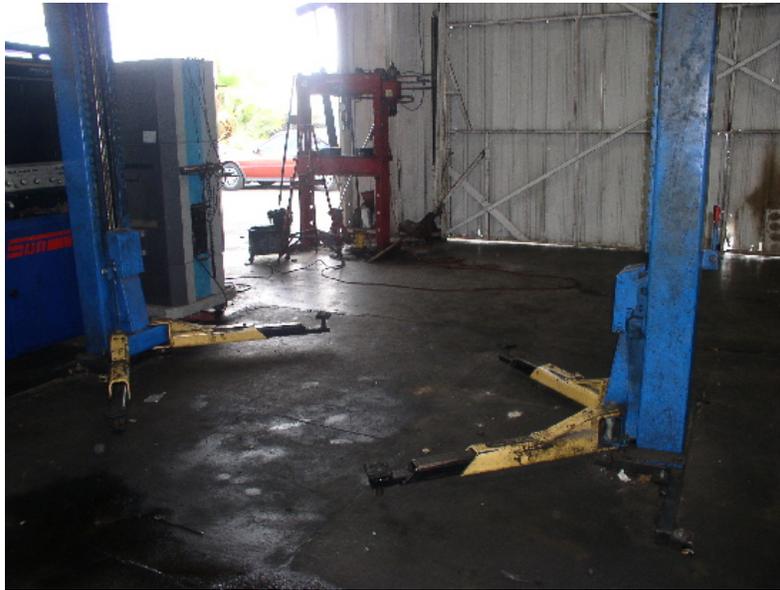
Exhibit #2

A picture of the automotive bay and lift with the adjustable lift arms.

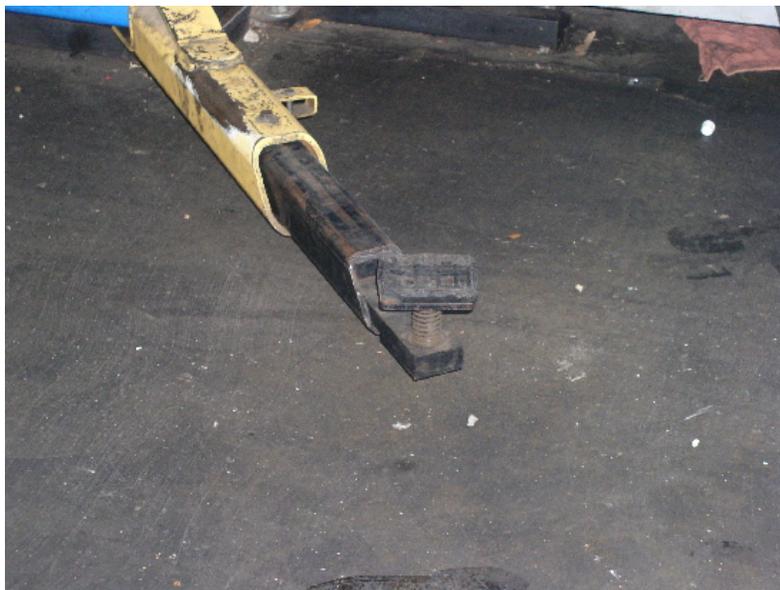
Exhibit #3

A picture of the automotive lift arm with the adjustable pad on the end.
