**SUBJECT:** A saw operator dies when struck by an aluminum plate that fell from a vacuum crane.

**SUMMARY**  
**California FACE Report #04CA002**

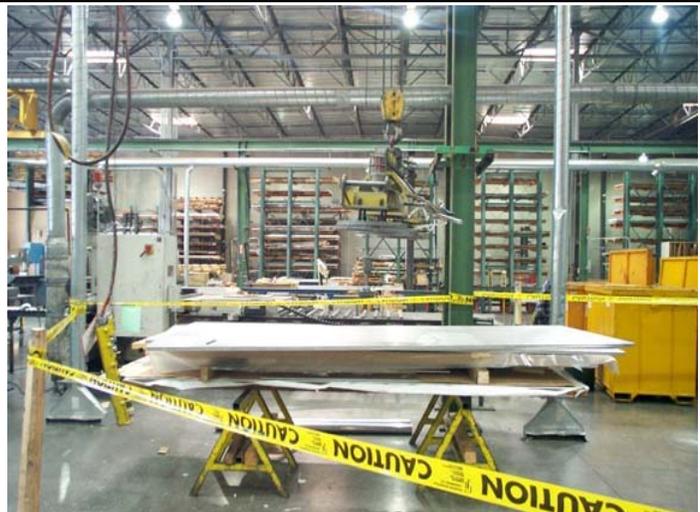
Exhibit 1. The work area where the incident took place..

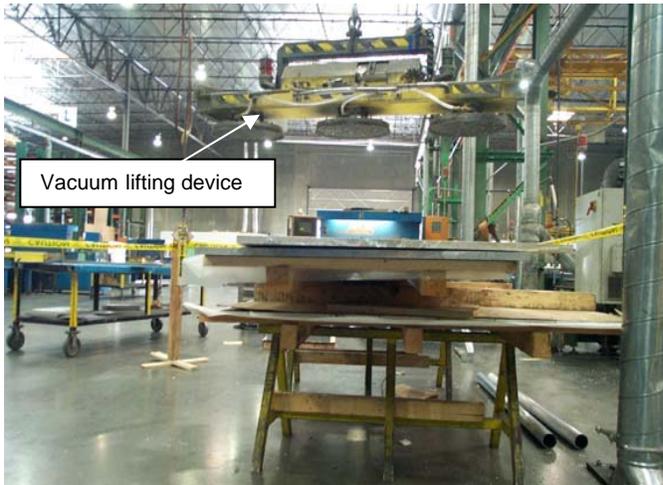
Exhibit 2. The three-cup vacuum lifting device suspended above the aluminum plates.

The site of the incident was a large industrial warehouse. Within the warehouse was a metal cutting room where the incident took place. The machine involved in the incident was an overhead crane rated for three tons. Attached to the hook of the crane was a three-cup vacuum lifting device. Floor-to-ceiling shelves containing aluminum plates were located along a back wall. The saws used to cut the plates into the desired size were located along a side wall. The aluminum plates involved in this incident measured 12 feet long by 4 feet wide and 1 inch

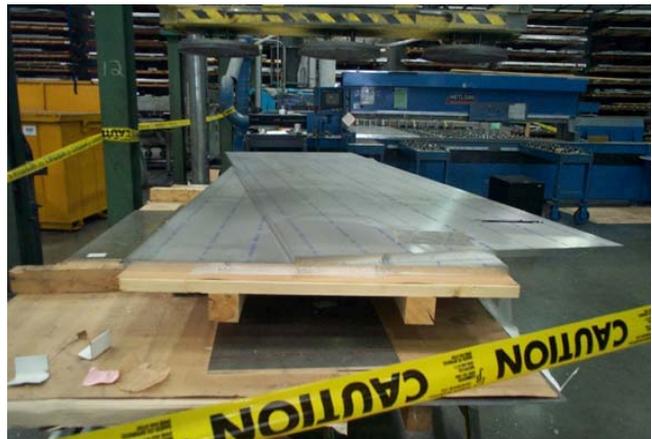
Exhibit 3. The aluminum plates involved in the incident.

The inspection of the incident scene showed two aluminum sheets on a wooden pallet on two metal saw horses directly below the crane hook holding the three-cup suction device. The top aluminum plate was not in line with the bottom plate and had markings on the top of it consistent with the suction cups. On the bottom of the top plate near the edge was a small amount of blood. Safety goggles were stuck between the two aluminum sheets. According to his co-workers, the victim always wore his safety goggles when he was working.

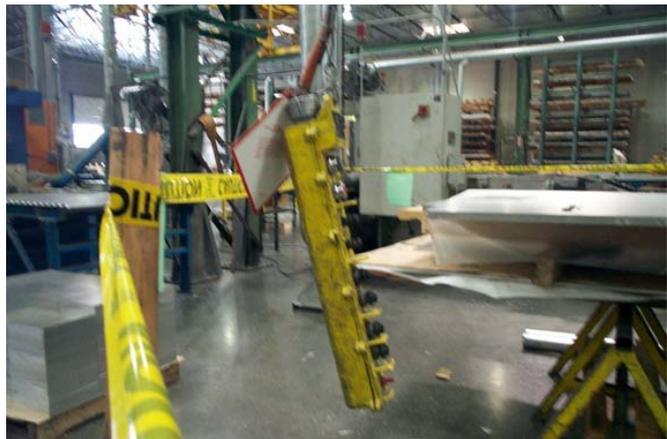
The controls to the crane were inspected and the stop button was depressed. The employer of the victim requested an independent company to test and inspect the overhead crane involved in this incident. A vacuum leak down test was performed to determine how long the suction cups could hold a load after the loss of power. Two tests were performed and the load was held for only 13 seconds and 7 seconds, respectively. Inspection of the crane discovered cracks in the rubber of the suction cups and one suction cup had a cut completely through it. One vacuum hose was found to be defective because of a cut and another one was loose. The inspection also noted the vacuum lift mechanism was tied into the main power cut-off to the crane instead of having a separate power supply. The manufacturers set-up instructions for the vacuum lifting device did not specify a separate power source for the lift. The evidence suggests that the victim was moving an aluminum plate to be cut by the saw. The victim was using the overhead crane with the three-cup suction device attached to the crane hook. When he raised the top aluminum plate the bottom plate shifted. The victim raised the top plate approximately 30 inches from the bottom plate, and then pushed the “off” button on the crane control. He then placed himself underneath the top plate for unknown reasons. With the crane power supply off, the hold on the top plate was lost more quickly than normal, due to the damaged suction cups and defective vacuum lines, and it dropped, striking the victim.

Exhibit 4. The crane controls.

Discussion: In this particular case, the vacuum lift was wired directly to the crane's main power supply. This meant that every time the crane was shut off, the vacuum lift was also shut off. The crane can still be in use suspending a load with the power shut off, however, in order for the vacuum lift to work properly, it must have power supplied to it at all times during normal operation.

The power source for the vacuum lift attached to the hook of the crane should have had its own power supply.

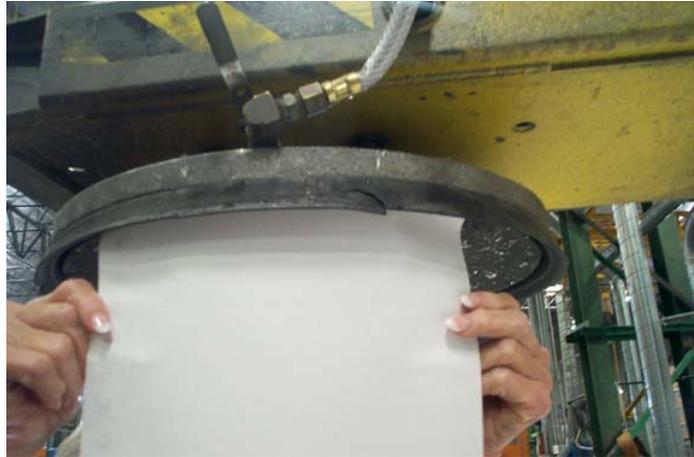
Exhibit 5. The damaged suction cup.

Discussion: The crane involved in this incident had numerous defects which should have rendered it unsafe to use. Scheduled documented maintenance and documented inspections must be performed on all cranes in order to prevent such oversights. When defective equipment is found during the inspection process, it should be removed from service until it can be repaired. Had this crane been properly inspected and maintained, this incident might have been prevented.
