**SUBJECT:** Two maintenance mechanics died when a suspended steel dock plate fell on them.

**SUMMARY**  
**California FACE Report #04CA013**

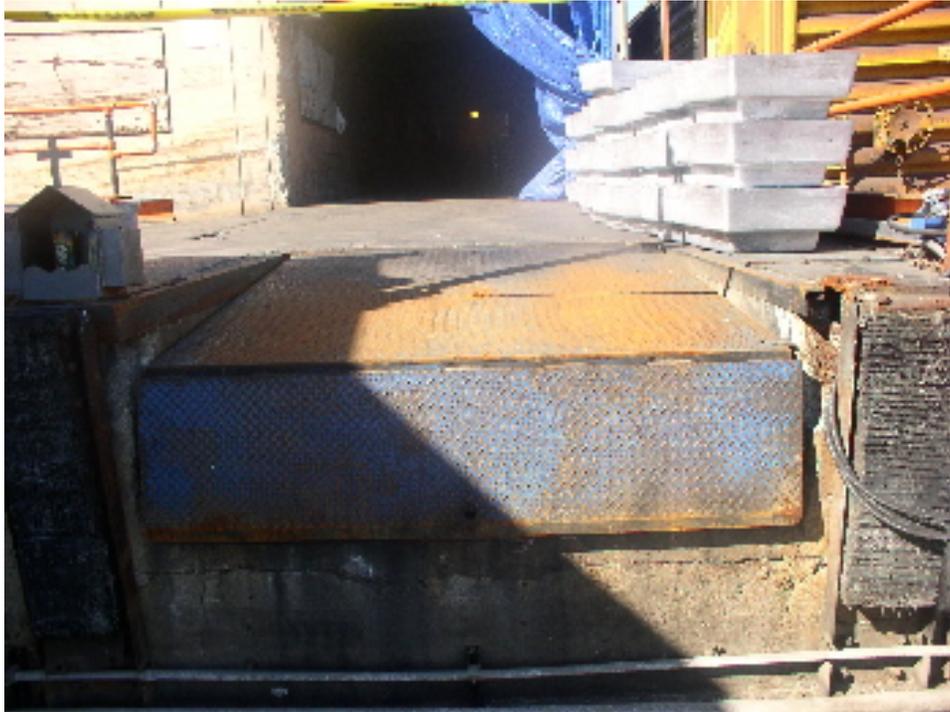
**Exhibit 1**

The site of the incident was a loading dock at the rear of the business. The mechanical device involved in this incident was a piece of machinery referred to as a “dock leveler.” Dock levelers allow forklifts to enter and exit the beds of trucks and trailers by bridging the gap between the loading dock and truck beds and trailers. The hydraulic mechanism that raised and lowered the dock plate was underneath the plate. The plate also had a safety bar attached to its underside that, when engaged, supported the plate.

The dock leveler involved in this incident

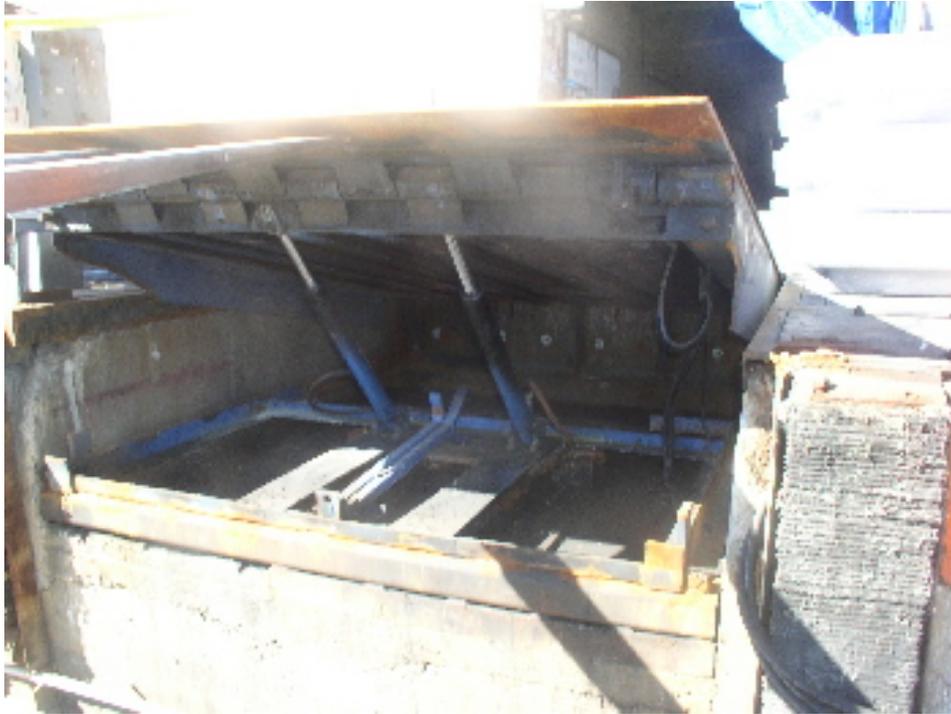
**Exhibit 2**

While the dock plate remained suspended, the victims moved under the dock plate and started connecting the hydraulic hoses without first engaging the safety bar or blocking the plate in the raised position. The weld that attached the pipe to the top of the dock plate broke and the dock plate fell, striking both victims in the back. One victim was struck but fell away from the dock plate while the other remained trapped underneath. Another employee working in the vicinity heard the loud noise and came over to investigate. The employee used a forklift to raise the dock plate off the trapped victim. The paramedics responded and administered CPR to both victims. One victim was transported to the hospital via ambulance in full cardiac arrest. The other victim was air lifted to the hospital. Both victims died as a result of their injuries.

The dock leveler in the raised position supported by a forklift showing the area underneath the dock plate.

Discussion: The company had a standard procedure for the removal, repair, and replacement of the dock levelers. The replacement portion of the procedure required the use of a forklift to raise and hold the dock plate until it was secured in place with the built-in safety bar. This procedure was one that had been developed by the dock leveler manufacturer and had been used in the past without incident. If a standard procedure is going to be changed, a thorough analysis of the changes should be performed prior to implementation to ensure that any hazards are abated.

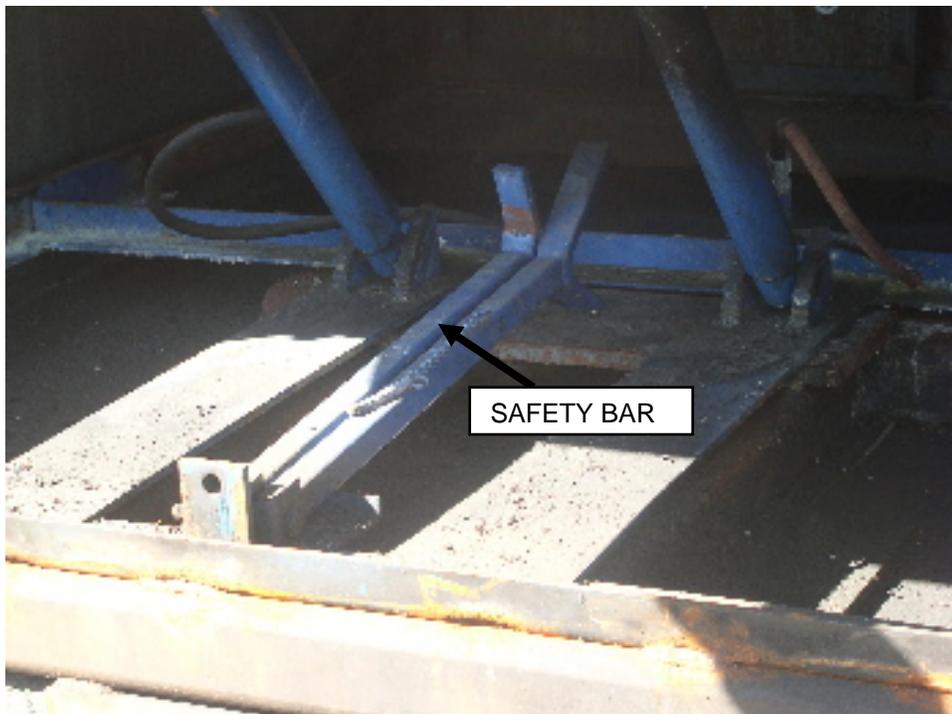
**Exhibit 3**

The safety bar used to hold the dock plate in the raised position when access is needed underneath.

Discussion: Employees should never place themselves under a suspended load without first securing the load to ensure it will not move or fall. The dock leveler had a safety bar that could have been used to support the dock plate in a raised position. Blocks, chocks, cribbing, and safety bars are all devices used to accomplish this goal. Had the victims used any one of these devices, this incident might have been prevented. Safe work practices can be enhanced through programs of task-specific training, supervision, rewards, and progressive disciplinary measures.

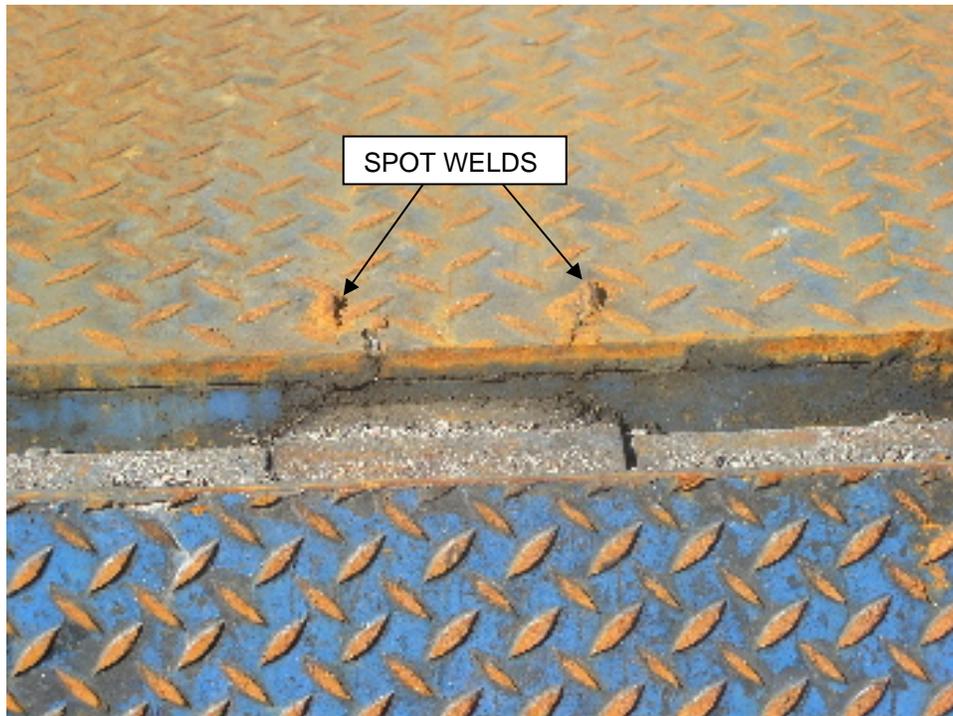
**Exhibit 4**

The spot welds on top of the dock plate where the pipe was welded.
