**SUBJECT:** A Heavy Equipment Mechanic Died When a Scraper Tire Exploded.

**SUMMARY**  
**California FACE Report #06CA004**

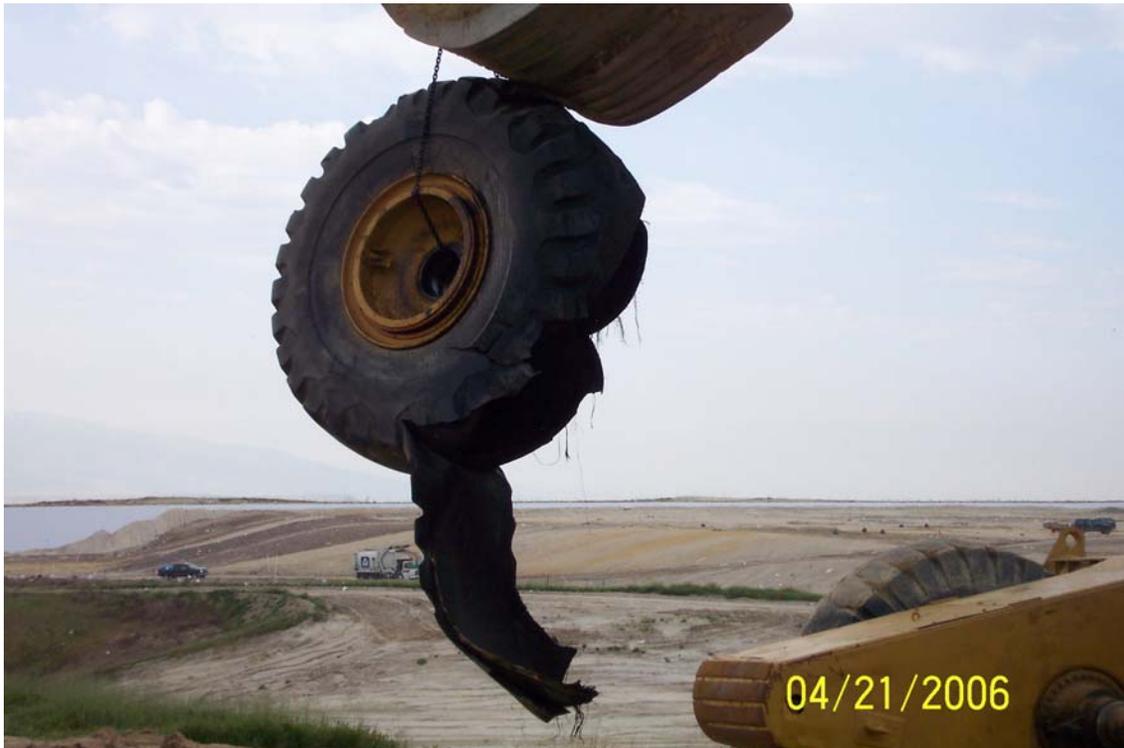
It was concluded that the use of a torch to cut the brake drum ignited the tire material which then generated combustible vapors, leading to the explosion. Removing the valve stem from the tire valve and keeping it out while work is being performed on the tire or tire components will prevent any pressure buildup in the tire and prevent another incident like this one.

**Exhibit1. A picture of the tire that exploded.**

**Recommendation #1: Ensure that all heavy equipment tires are deflated and the valve stem removed prior to any work being performed on the tire or attached components.**

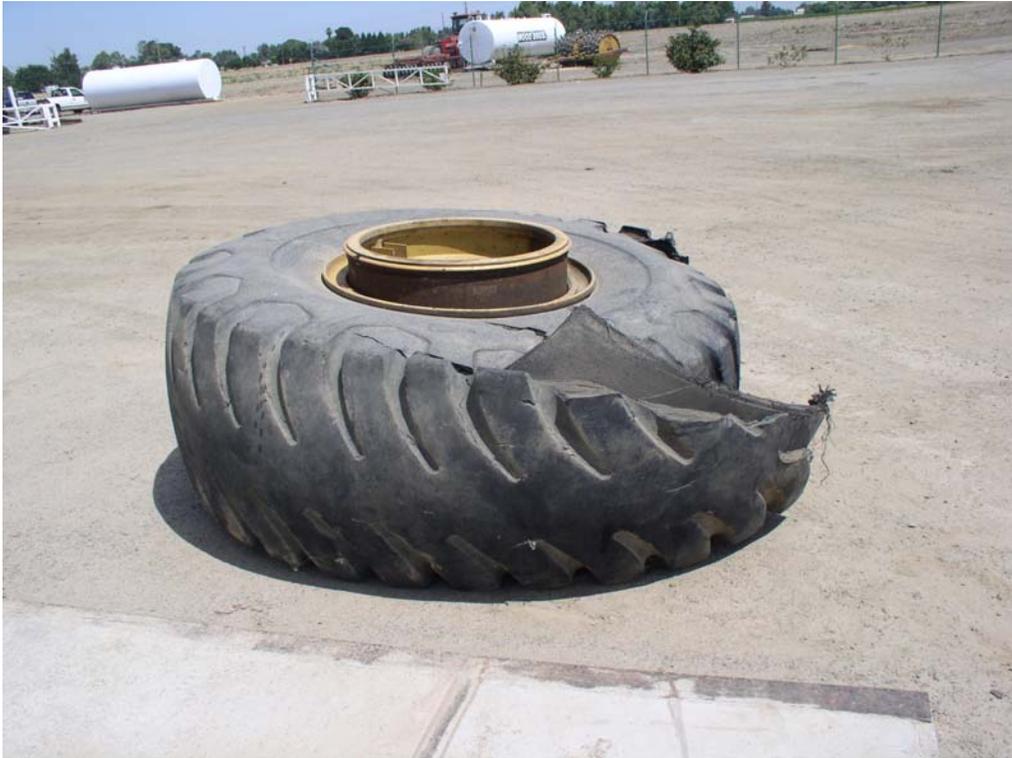
**Exhibit 2. A picture of the tire and wheel assembly after the explosion.**

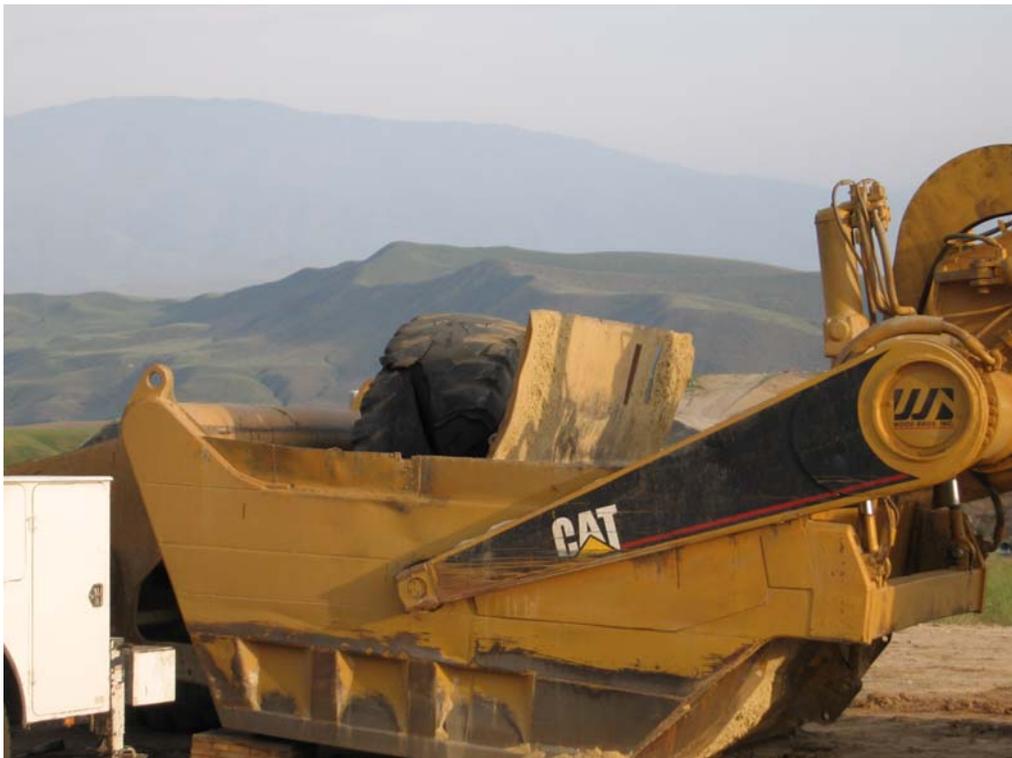
After the assembly was removed from the scraper, the victim attempted to remove the brakes from the hub but they would not come off. The victim retrieved a cutting torch from the truck, heated the brake assembly, and cut the drum into three sections. The brakes and drum did not come loose even after several attempts of heating and hammering. The victim decided to quit for the day and was picking up his tools and cleaning the work area when the tire suddenly exploded without warning. The victim was not working on the tire but was near it when the explosion occurred. The explosion was so great that the tire and entire wheel, hub, and brake assembly shot approximately 15 feet into the air and landed in the back of the scraper (Exhibit 3).

**Exhibit 3. A picture of the tire after it exploded and landed inside the scraper.**

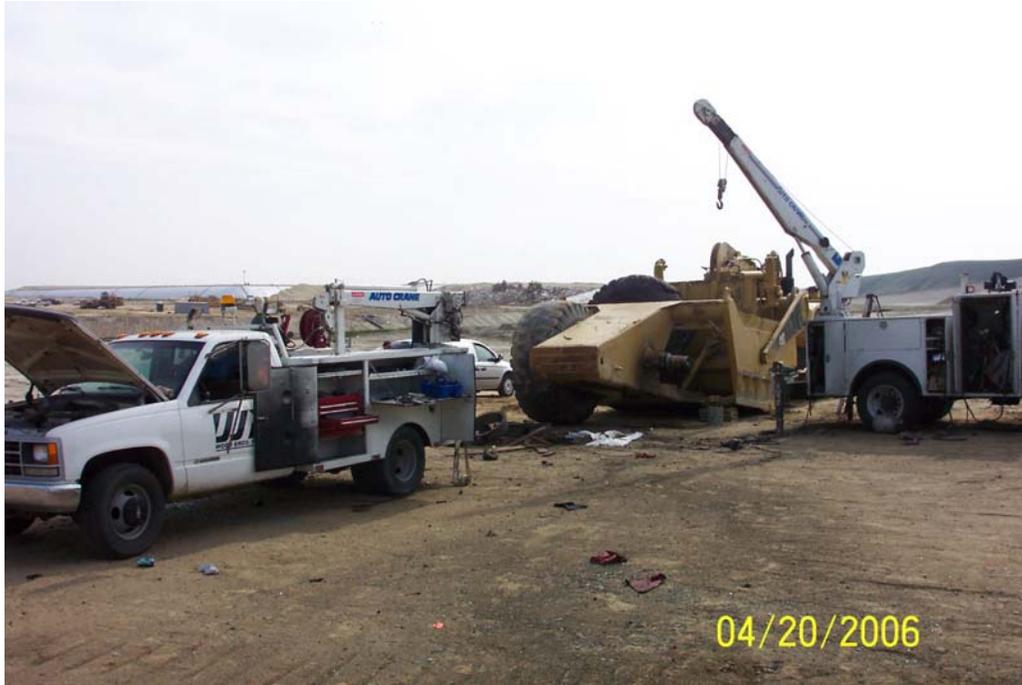
**Exhibit 4. A picture of the incident scene.**
