**SUBJECT:** An electrician was electrocuted while repairing a lighting circuit

**SUMMARY**  
**California FACE Report #06CA007**

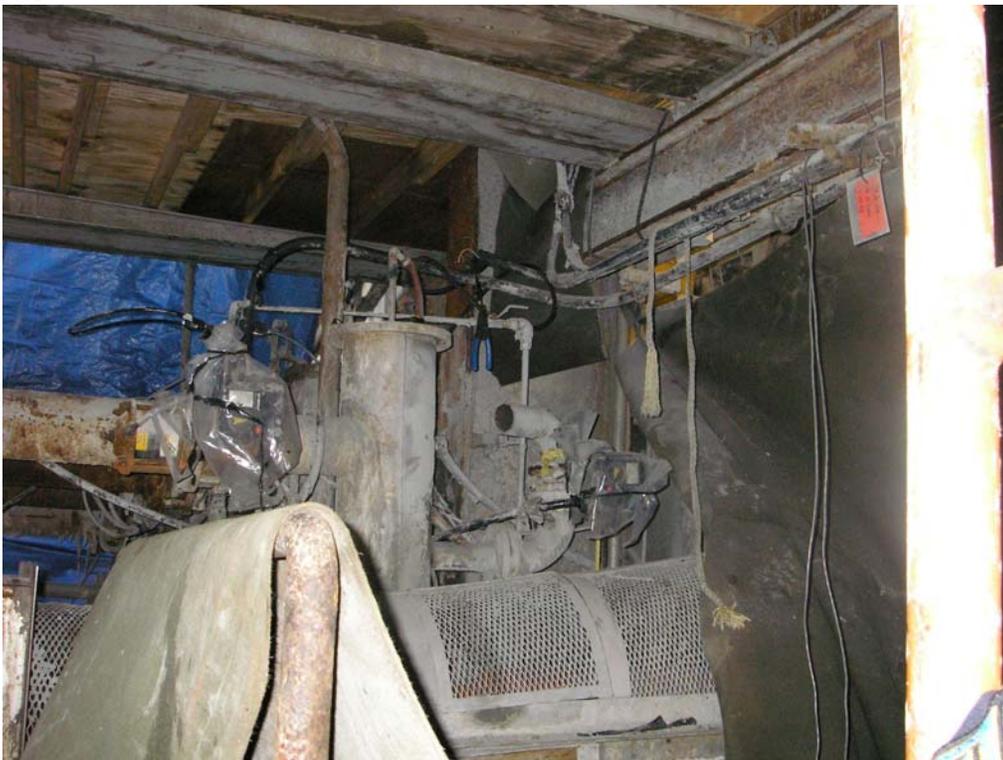
The site of the incident was a large industrial factory that made newsprint out of recycled paper. The incident took place on the second floor of the mill building. The factory was undergoing renovation with replacement and repair of the steel beams in the walls, floors, and ceilings of the mill building's third floor. The incident occurred at ceiling level on the second floor of the mill building.

**Exhibit 1. A picture of the area where the victim was working.**

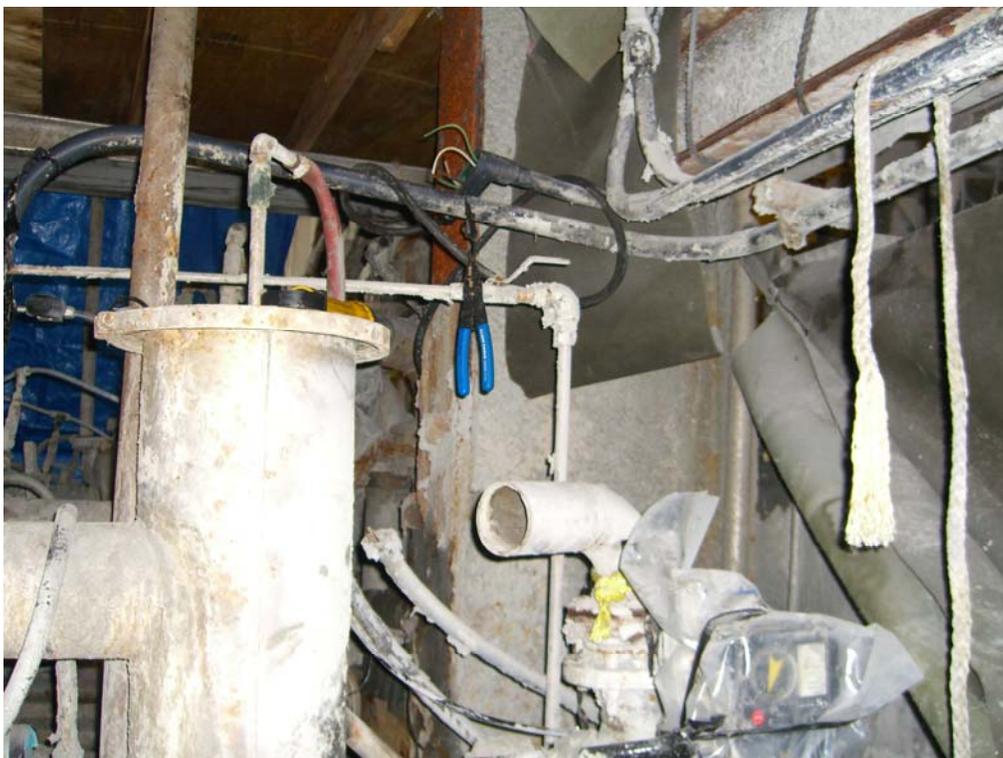
After the victim was removed from the incident scene by the paramedics, the victim's employer and local police did a preliminary investigation. They found the victim's pliers that were used for stripping electrical wire, still attached to a wire from the damaged circuit at ceiling level. Closer inspection showed that there were burn marks on the pliers and a pipe, indicating that contact was made at these points. The physical evidence indicated that the victim climbed up on the contractor's scaffold and then climbed onto a piece of machinery to gain access to the damaged lighting circuit. While the victim was working on the energized circuit, his pliers made contact with the pipe, completing a circuit, and he was electrocuted. It is not known how long he remained in contact with the energized system. It appears that when the electrical breakers finally tripped, cutting off the electrical current to the circuit, the victim fell off the machinery

and landed on the scaffolding planks just below him, where he was found by his supervisor. An inspection was conducted of the junction box where the circuit breakers were housed and it was determined that the circuit had not been manually turned off or locked out and tagged prior to the start of work. The circuit had been tripped when the victim made contact with the energized line. The victim's circuit tester, which is intended to be used to verify that a circuit has been de-energized before work, was found in his locker after the incident.

**Exhibit 2. A picture of the victim's pliers attached to a wire.**

### **Recommendation #1: Ensure that workers follow established lockout/tagout procedures for control of hazardous energy when working on electrical circuits.**

Although the employer in this case had a lock out/tag out program, it was not being used when the victim was working on the energized lighting circuit that was damaged by a contractor. Had the victim followed the company's policy and procedures, this incident might have been prevented. Employers can enhance worker compliance with safe work practices through programs of task-specific training, supervision, recognition, and progressive disciplinary measures.
