**SUBJECT:** A Packer in a Manufacturing Facility Dies When He is Struck by a Pipe that Rolled off a Storage Rack.

**SUMMARY**  
**California FACE Report #07CA003**

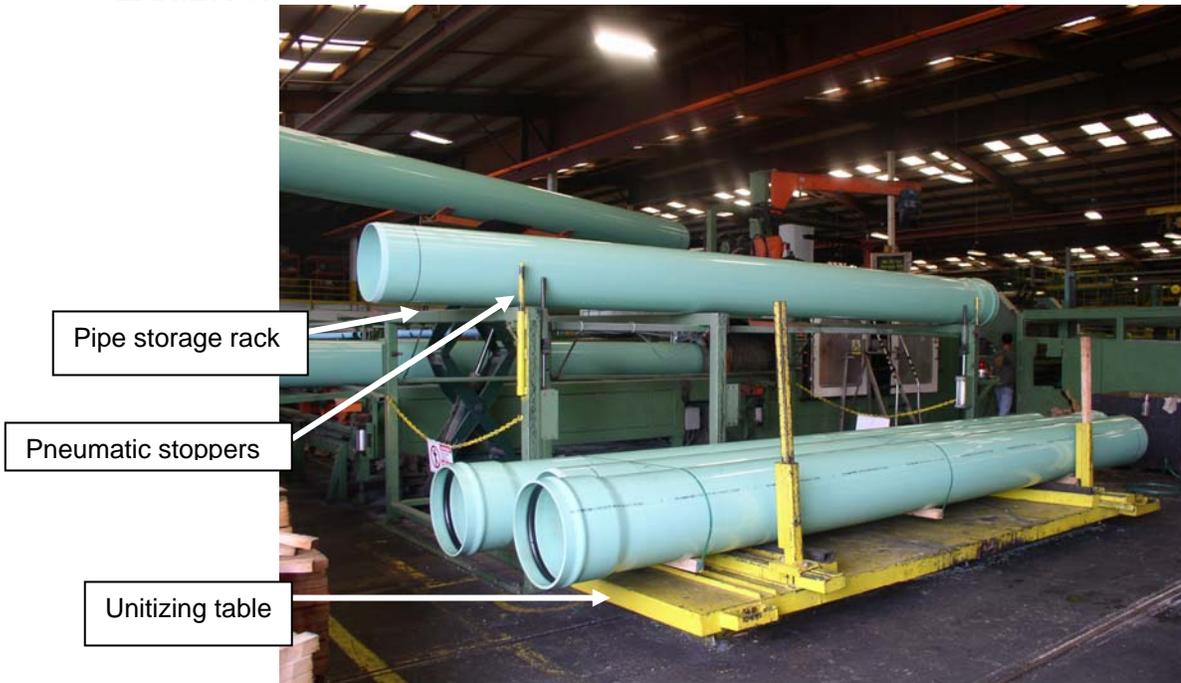
Discussion: The pipe was gravity fed onto the pipe storage rack. Therefore, a stopping device was necessary to prevent the pipes from rolling off the other end. In this particular case, the storage rack was equipped with pneumatic stoppers. Video surveillance showed that pipes would occasionally roll off the rack and onto the bundling table because the stoppers were jammed or stuck in the down position. Daily or pre-shift testing of the system to ensure that the stoppers are operating properly, would be a safety measure that could be taken to ensure employee safety. Additional safety devices, such as a sensor system that alerts the operator whenever the stoppers fail to activate and shuts down the turntable feed system so pipe are not fed onto the pipe storage rack, would also ensure employee safety. Changing out the old pneumatic valves that operate the stoppers to a push button type that is spring loaded to the open position would also help ensure the stoppers are in the correct position. Manually installed stoppers are also an alternate safety measure that will stop pipes from rolling off the rack.

Exhibit1. The pipe storage rack and unitizing table.

**Recommendation #1: Ensure that safety measures are in place to prevent pipes from rolling off a storage rack to a bundling table prior to anyone entering the area.**

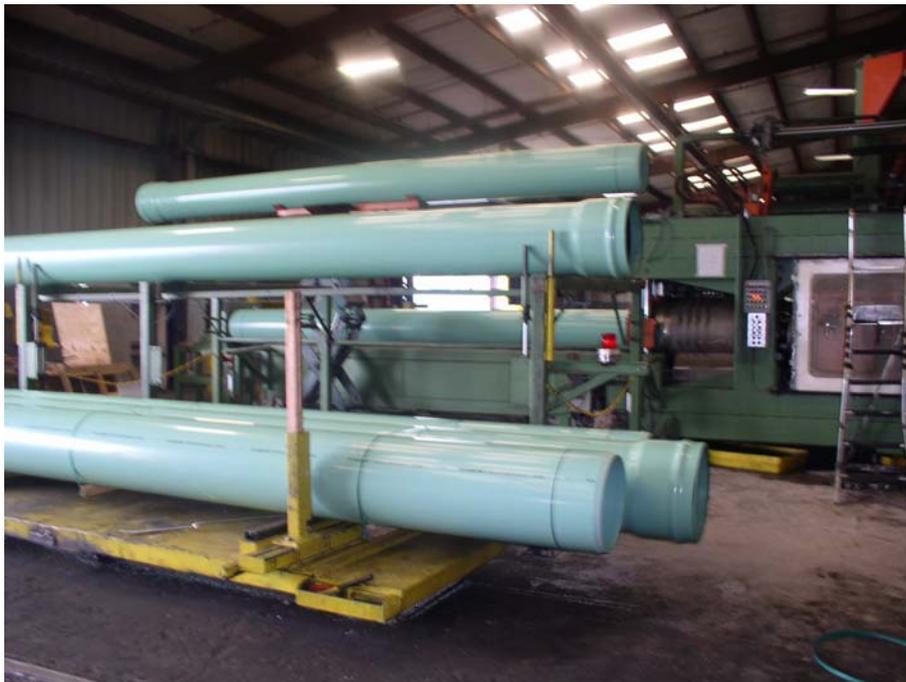
Exhibit 2. The pipe storage rack and unitizing table from a different angle.

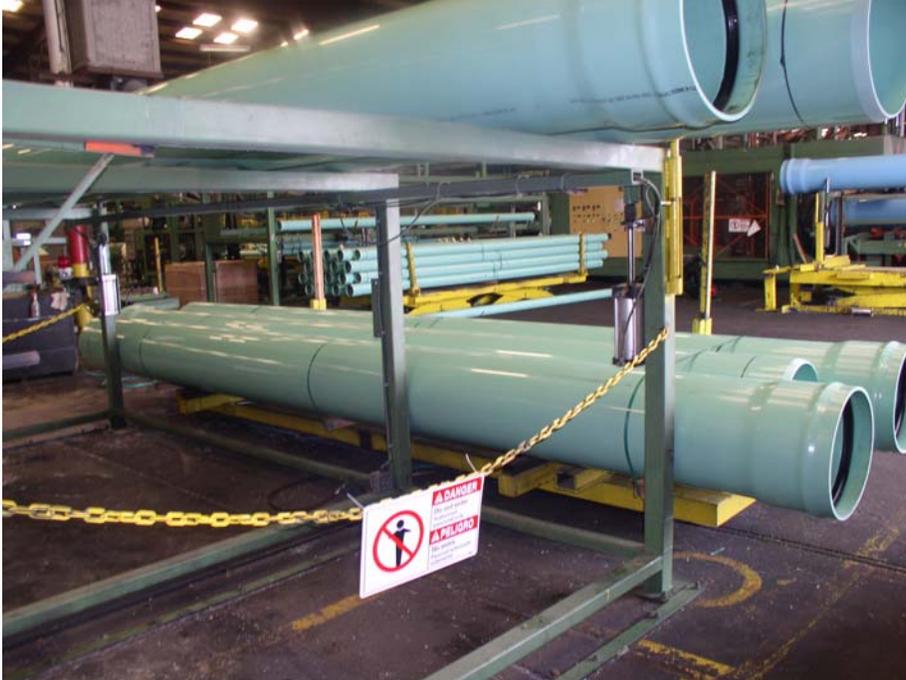
the same time, the automatic system behind him fed another pipe onto the storage rack. The pneumatic stoppers were not in an upright position to stop the pipe's movement, and it rolled off the storage rack, fell downward striking the victim in the back of the head, and then rolled onto the unitizing table. The surveillance video showed that approximately 35 minutes elapsed before the victim was discovered. Once the victim was discovered by co-workers, they rendered aid by checking for vital signs and placing a blanket over him, and called 911. The paramedics and fire department arrived and pronounced the victim dead at the scene.

Exhibit 3. The area under the pipe storage rack where the victim was leaning over the pipe when the incident occurred.

Employers who use surveillance video in their workplace may want to consider reviewing the tapes to identify new and ongoing hazards that may not have been identified during normal inspections. In this particular case, the victim was stenciling by hand the pipes that did not come out clear. Better maintenance or replacement of the automatic stencil machine could be the engineering control. Having the stenciling operation performed away from the pipe storage could be the administrative control.

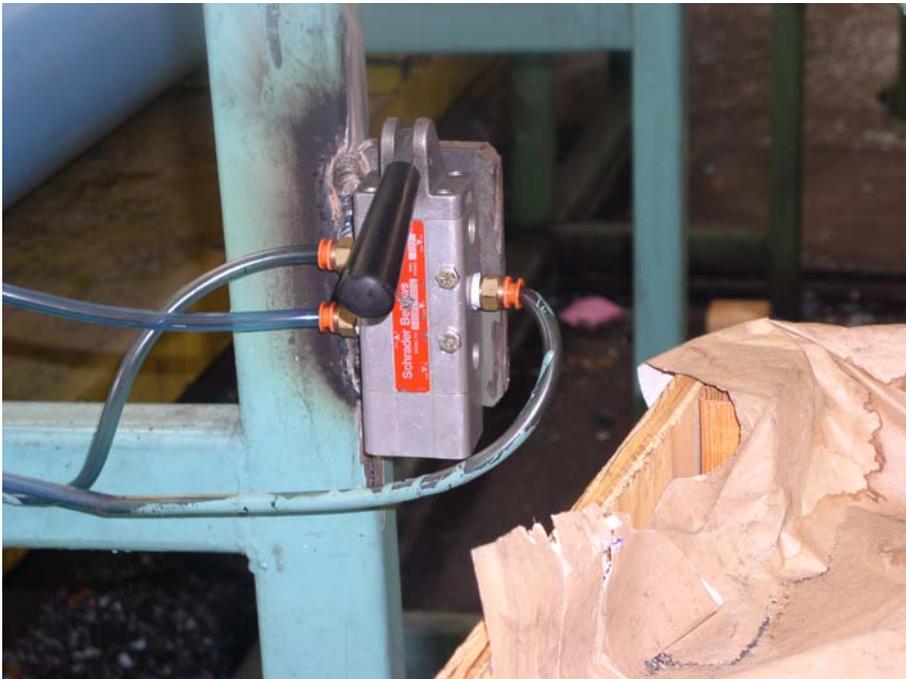
Exhibit 4. The switch used to activate the pipe storage rack stoppers.

**Recommendation 2: Develop, implement, and enforce a written hazardous energy control program for the area under the pipe storage rack.**

Discussion: In this particular case, the employees were working with a hazardous energy that was not properly identified, i.e., the rolling pipes on the pipe storage rack. Employers who have employees that work with hazardous energy should develop and implement a written hazardous energy control program that identifies and labels all hazardous energy sources, and de-energizes, isolates, blocks, and/or dissipates all forms of hazardous energy before work begins. The employer should identify the activities that place the workers in hazardous situations and go through a stepwise program to first try to eliminate the hazard entirely. If that is not possible, the employer needs to implement engineering or administrative controls that will abate the hazard.
