**SUBJECT:** An Ironworker Dies When He Falls 50 Feet Through a Floor Opening.

**SUMMARY**  
**California FACE Report #07CA009**

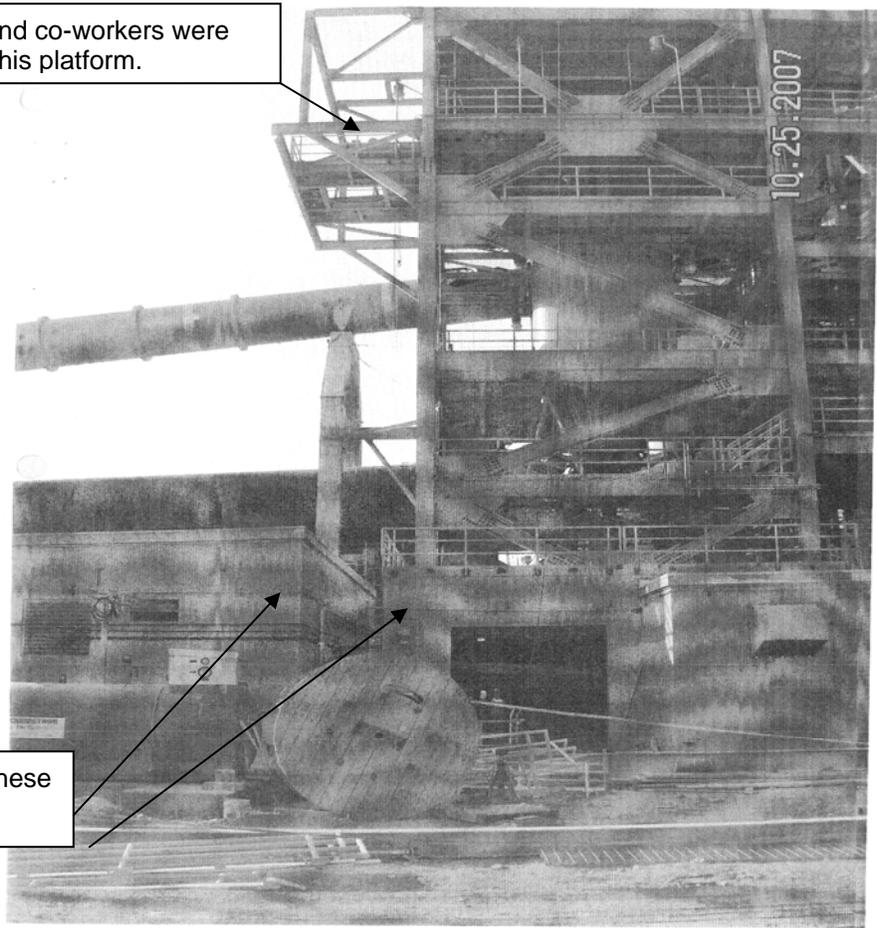
**Exhibit 1. The structure involved in the incident.**

The victim and co-workers were working on this platform.

The victim landed between these two buildings when he fell.

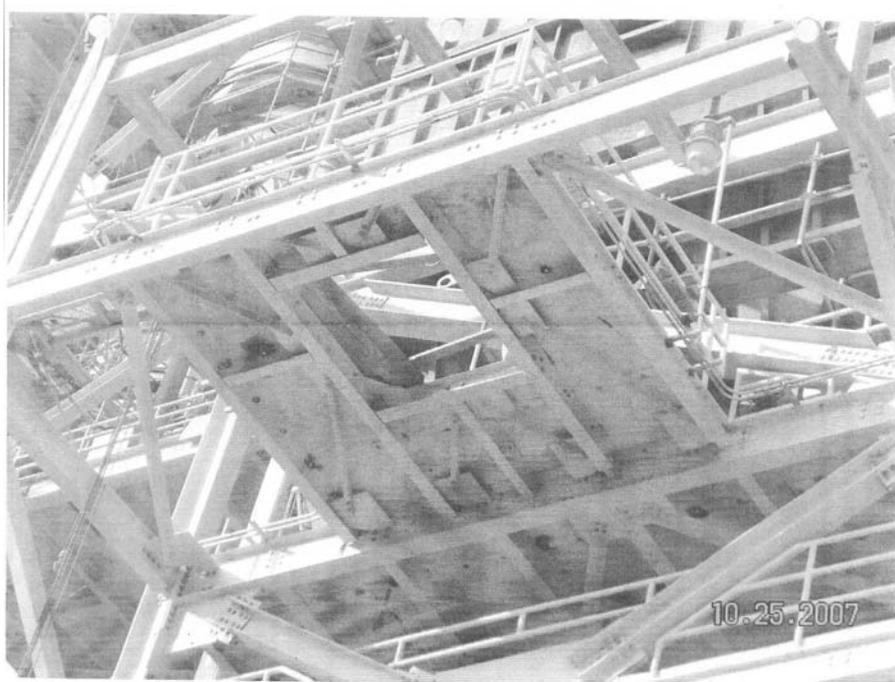
**Exhibit 2. View looking up at the floor opening on the platform through which the victim fell.**

Discussion: When employees work around an elevated floor opening, proper procedures must be followed in order to provide a safe and healthy work environment. The floor opening must be covered to prevent workers from falling through it. The covers should be capable of safely supporting whichever is greatest: 400 pounds, or twice the weight of the employees, equipment, and materials that may be imposed on any one square foot area. The cover must be secured in place to prevent accidental removal or displacement. Additionally, it should be clearly marked with letters not less than one inch high and in a language the workers can understand, stating: "Opening-- Do Not Remove." In this case, the hole was covered but not marked, and the evidence

suggests that the victim and co-workers either removed the cover of the opening in order to accomplish their task, or the cover had already been removed prior to their entering the balcony. In either case, personal fall protection equipment should be used properly to prevent falls through unguarded floor openings. The victim and co-workers had safety harnesses on with lanyards but they did not tie off when they were working around the floor opening. Employers can enhance worker compliance with safe work practices through programs of task specific training, supervision, recognition, and progressive disciplinary measures.

**Recommendation #1: Ensure that proper procedures are followed when employees are working around elevated floor openings.**
